SAFETY INFORMATION NOTICE

Cliff Edge Effect

No. 3947-S-00

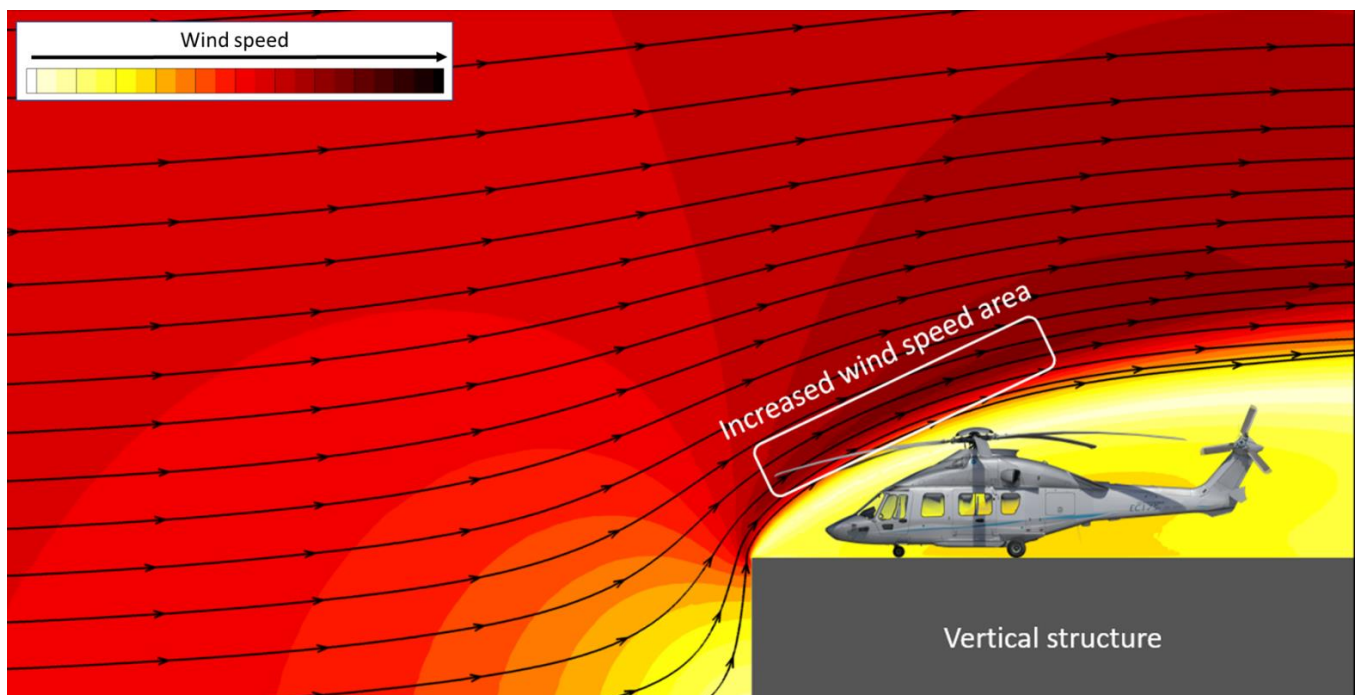
Below is an illustration of such a phenomenon, with a simplified analysis of a theoretical laminar wind blowing on a vertical structure from the left.

In the example above, with the aircraft located close to the edge of the vertical structure, the local speed and direction of the wind affecting the front of the main rotor disk are significantly impacted: speed is increased and wind direction is changed.

Thus, the local speed and direction of the wind can be locally outside the applicable limitations defined in the Flight Manual and in the maintenance documentation, potentially resulting in damage to the aircraft and/or injuries to people.

Airbus Helicopters would like to draw customer's attention to the fact that the increased wind speed area is affecting the aerodynamic loading of the blades and therefore should be taken into consideration to comply with the applicable wind limitations. Consequently, if the wind conditions get close to the applicable limitations, Airbus Helicopters recommends moving the aircraft as far as possible from the edge of the vertical structure. If necessary, secure the aircraft as soon as possible with mooring kits in accordance with the applicable technical documentation.
