**ALERT SERVICE BULLETIN**

**429-19-47**

**MODEL AFFECTED:** 429

**SUBJECT:** TAIL ROTOR GEARBOX SUPPORT RETAINING RIVETS, INSPECTION OF.

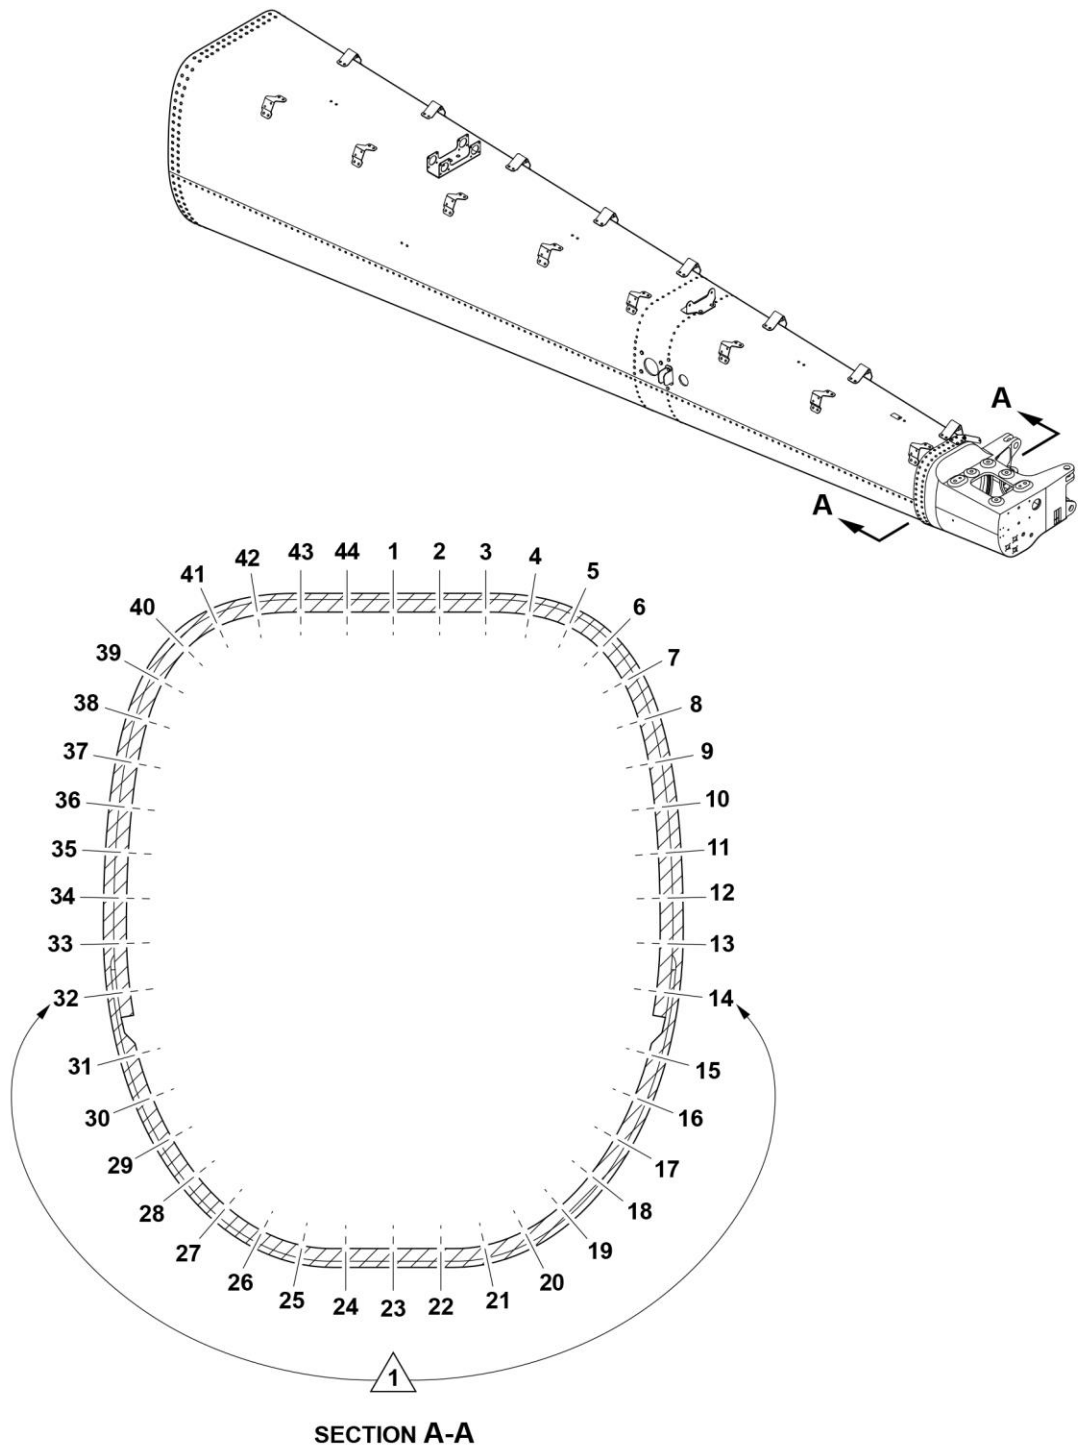
**Figure 1 – Rivet Identification**

Bell has received reports of failed rivets at the joint between the tailboom skin and the tail rotor gearbox supports 429-034-701-101 or 429-035-705-101. To address this, Bell is issuing this bulletin to mandate a recurring inspection of the rivets located in that joint. Applicability of this bulletin to any spare part shall be determined prior to its installation on an affected helicopter.

7. Do a tactile check of all the rivets identified in Figure 1 by pulling on each rivet tail.
8. Using Figure 1 to identify the position of the rivets, note the position of any discrepant rivet found during steps 5, 6, and 7 in Table 1.

Perform tactile check on indicated rivet tails.

- a. Determine if the discrepant rivets are failed or if they are of improper length.
  - (1) If the rivets are of improper length, replace the rivets per BHT-ALL-SRM, Chapter 3 and proceed to step 10.

- d. Plot the location of the gaps by using Figure 1 and Table 1.
- e. If no gaps or if gaps measuring 0.005" (0.127 mm) or less are found, replace the discrepant rivets per BHT-ALL-SRM, Chapter 3 and proceed to step 10. If gaps in excess of 0.005" (0.127 mm) are present, proceed to the next step.

- g. Repair the gaps and replace rivets in accordance with the approved Bell structural repair scheme that will be provided after having submitted the repair request in step 9.f and proceed to step 10
