Airworthiness Directive

Docket No. 96-CE-46-AD; Amendment 39-9884; AD 97-01-13

Airworthiness Directives; Cessna 100, 200, 300, and 400 Series Airplanes
PDF Copy (If Available):

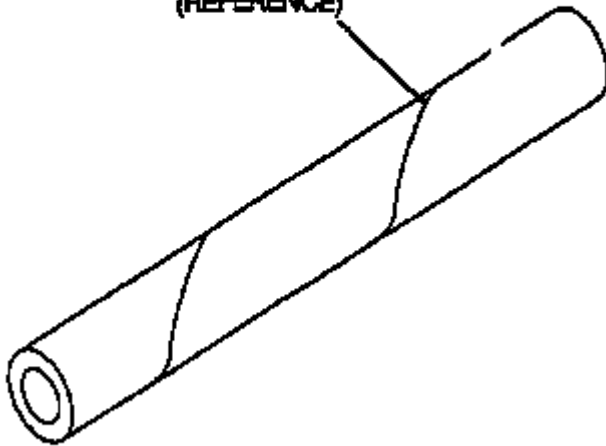
**AD 97-01-13
Figure 1**

The FAA has recently received several incident reports of fuel flow blockage to the engines of certain Cessna 208 series airplanes. Examination of the Cessna part number (P/N) S51-10 rubber hoses installed on these airplanes revealed a deterioration to the point of delamination of the inner tube from the external wrap. This rubber hose is utilized on fuel, oil, and hydraulic hoses on Cessna 100, 200, 300, and 400 series airplanes. This kind of deterioration eventually causes the rubber hose to collapse, which could result in failure of the fuel, oil, or hydraulic systems.

NOTE 2: Figure 1 of this AD is included to show the diagonal or spiral external reinforcement wrap on the hose that is referenced in the check required by paragraph (b) of this AD.

**REINFORCEMENT
WRAPPED IN ONLY ONE
(DIAGONAL) DIRECTION
(REFERENCE)**

**OLD STYLE S51-10 HOSE
WITH REINFORCEMENT
WRAPPED IN ONLY ONE
(DIAGONAL) DIRECTION THE
LENGTH OF THE HOSE
(REMOVE AND REPLACE WITH
REPLACEMENT STYLE HOSE)**

(c) Prior to further flight after the check required by paragraph (b) of this AD, replace any Cessna P/N S51-10 that has a diagonal or spiral pattern external reinforcement wrap with a Cessna P/N S51-10 hose that has a criss-cross pattern external wrap. Accomplish this replacement in accordance with the ACCOMPLISHMENT INSTRUCTIONS of the applicable service bulletin in paragraph (b) of this AD.

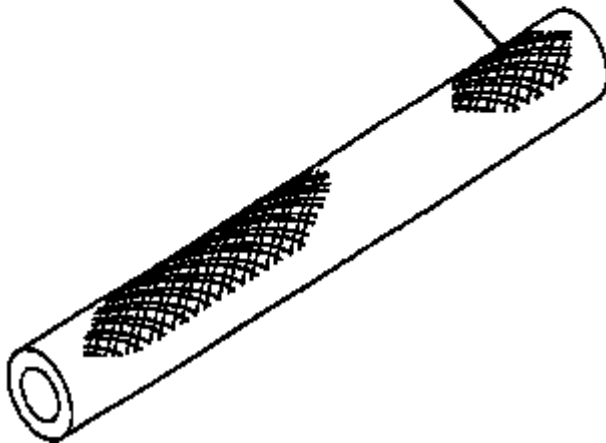
**CRISSCROSS
OR BRAIDED
REINFORCEMENT
(REFERENCE)**

**REPLACEMENT STYLE S51-10
HOSE WITH A CRISS-CROSS
OR BRAIDED REINFORCEMENT
PATTERN**
