A/C TYPE EC 155B
 A/C REGN 9M-SAS S/N 6583
 TYPE OF CHECK _____

DEFECT AND RECTIFICATION WORKSHEET/CERTIFICATE OF RELEASE TO SERVICE

No. 67-002

SUBJECT:	ROTOR FLIGHT CONTROLS
	Roll, Pitch and Yaw Series Actuators

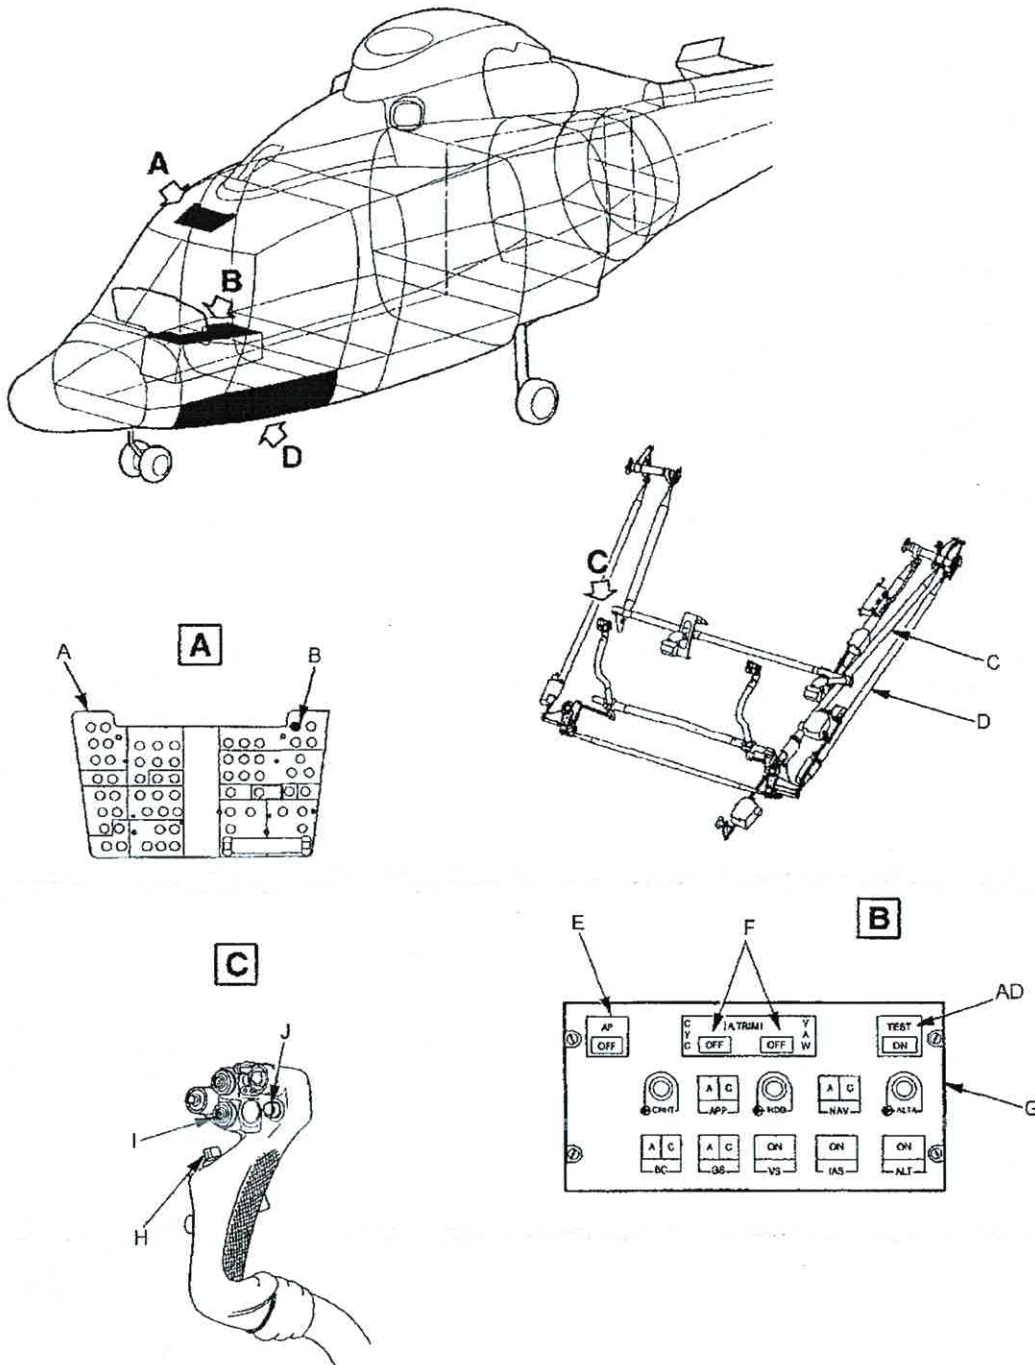
Figure 1

If the rod of pitch actuator (C) does not extend, it is likely that the electrical connectors of left roll (D) and pitch (C) series actuators are interchanged.

2.B.4. Functional test of pitch series actuator (C) (Figures 1 and 2):

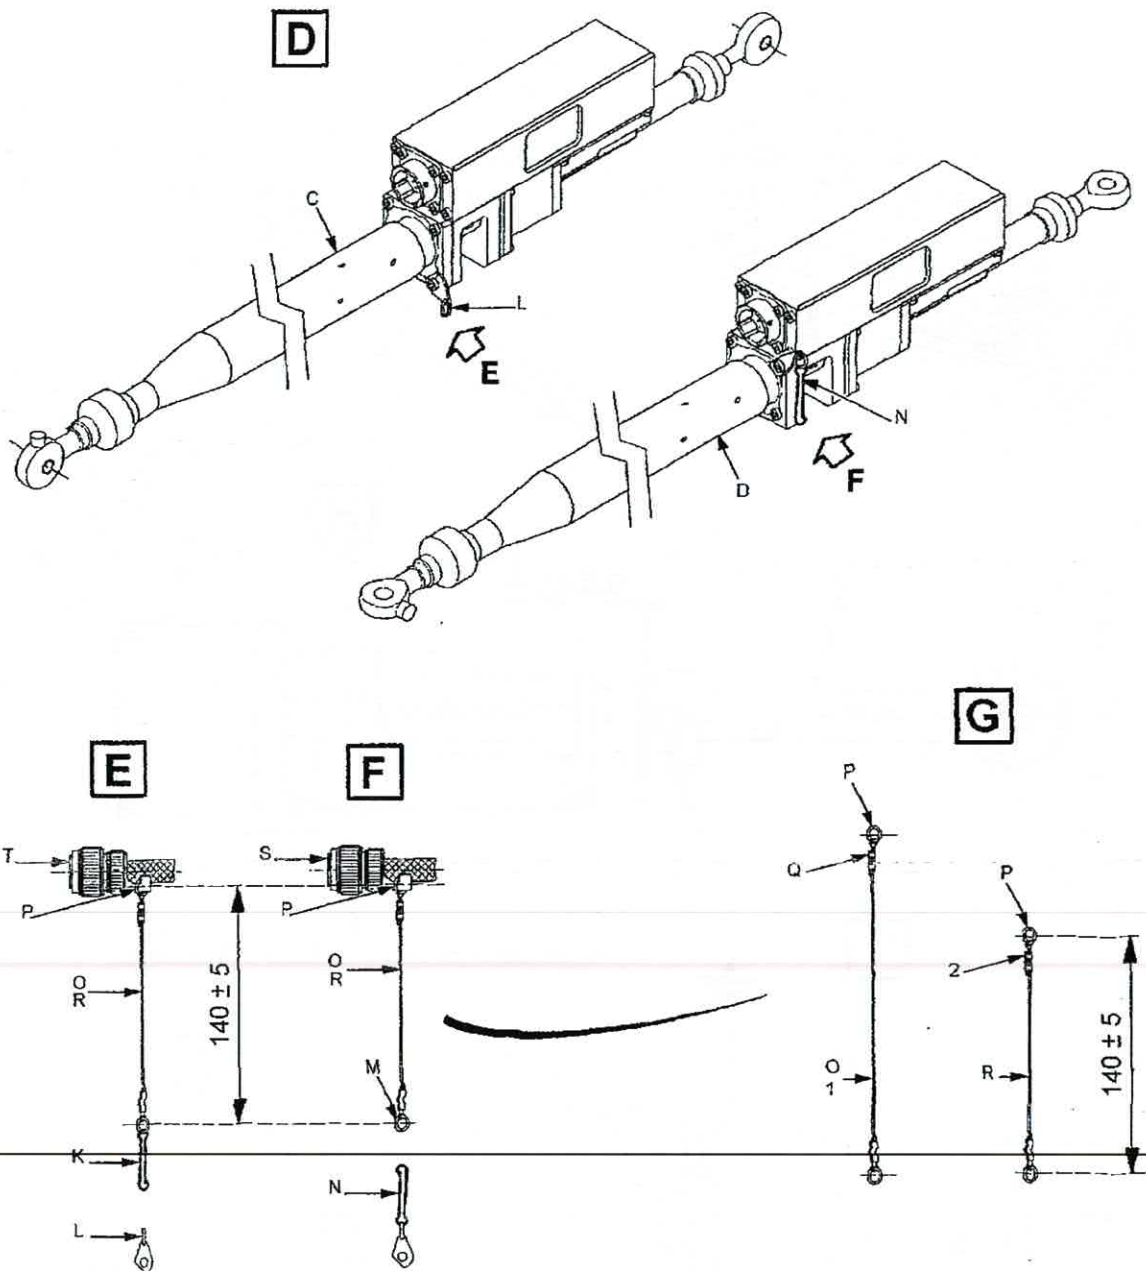
Figure 2

- There is a risk of interchanging the electrical connectors of the left roll and pitch series actuators despite the existing nylon index cables. These nylon index cables are not in accordance with the assembly standard (cables too long compared to the assembly drawing) which involves the risk of interchanging the two electrical connectors). Interchanged installation of these two electrical connectors can cause instability of the aircraft during the take-off phase when the Automatic Flight Control System (or backup SAS) is engaged. During this phase and according to the response time of the pilot, this instability can lead to a significant reduction of the safety margins.

- electrical connector "7C-P1" (S) is connected to left roll series actuator (D),
- electrical connector "11C-P1" (T) is connected to pitch series actuator (C).

Check the length of nylon index cables (O).

- 1) Nylon index cable (O) is 140 ± 5 mm long: the cable length is correct.
 - Leave as is.
- 2) Nylon index cable (O) is longer than 140 ± 5 mm.
 - Comply with paragraph 2.B.3.

- Cut nylon cable (O) or (1) on one end, flush with bushing (Q).
- Retain ring (P).
- Slip new bushing (2) on the cable end.
- Knot ring (P) to the shortened end of nylon cable (R), so that the length between both rings is 140 ± 5 mm.
- Crimp bushing (2) using crimping pliers (6) to wedge the two cable end pieces.

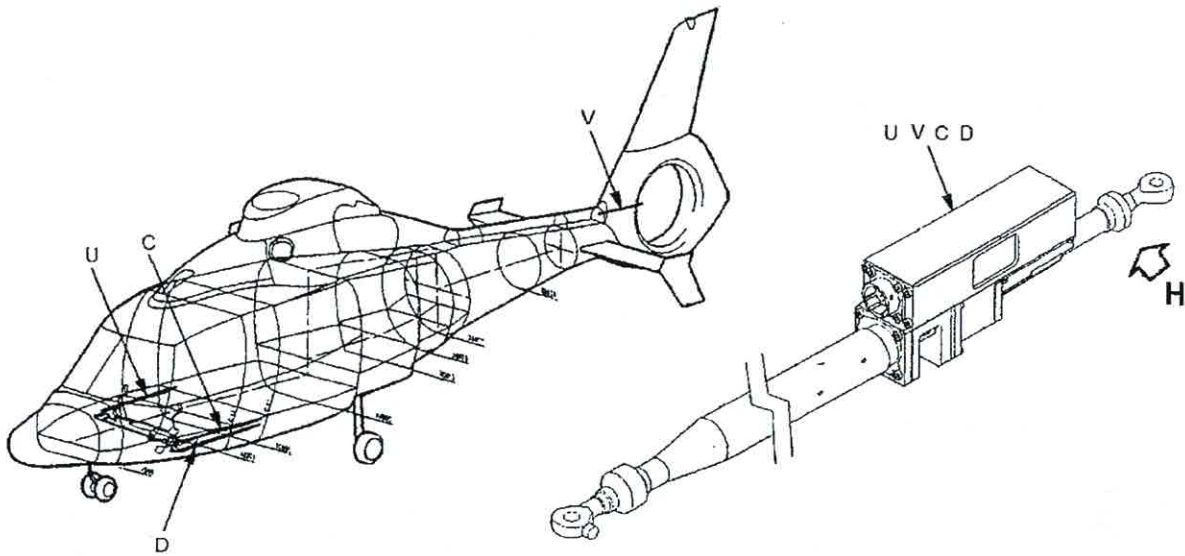
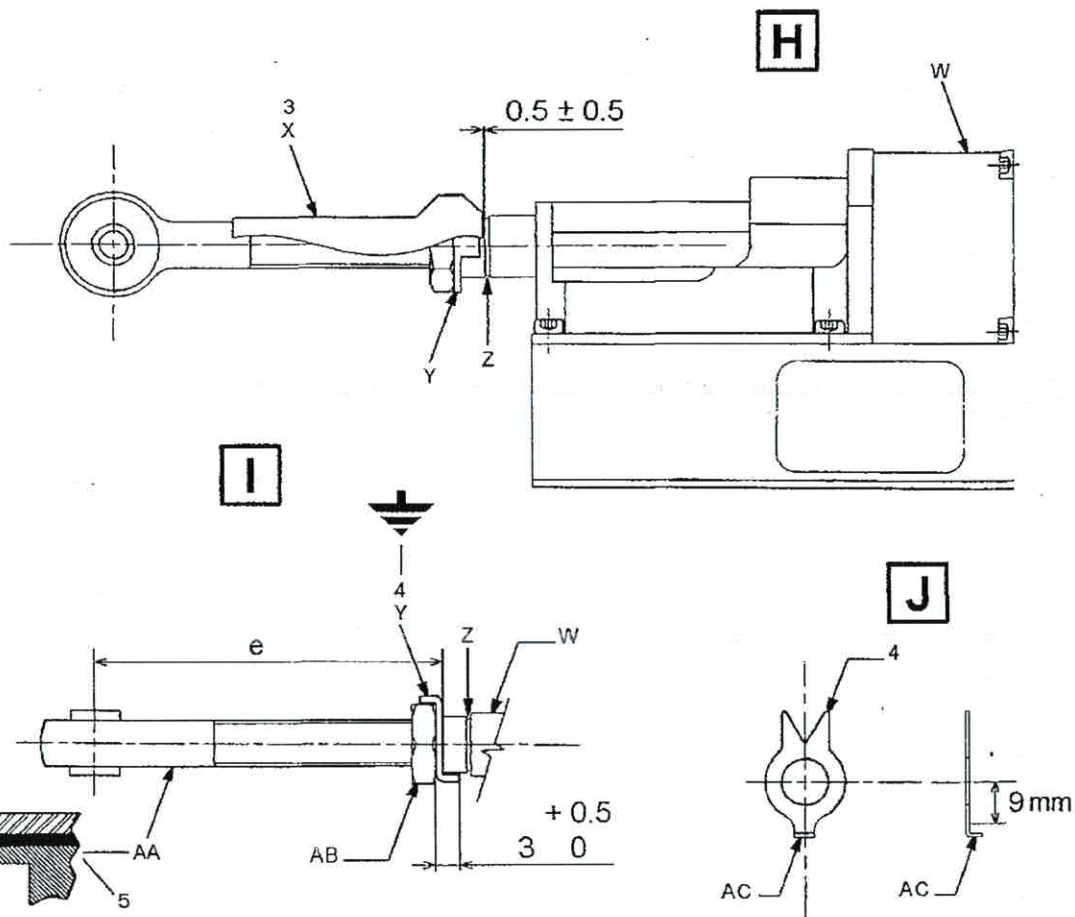
Figure 3

- There is a risk of interference between the lockwasher of the rod / end-fitting coupling and the body of the pitch, left roll, right roll or yaw control series actuators, due to faulty adjustment of the lockwasher. The reduction of the travel of the series actuator is detected by the Automatic Flight Control System when the lockwasher overlaps onto the effective travel of the series actuator by more than 1.5 mm. When this type of fault is detected, the pilot loses the AFCS assistance on the affected channel.

- The heat shrink sleeve is missing on the rod / end-fitting coupling of the series actuator.
- In some cases the lockwasher is not bent over which can cause the loss of the tightening torque load of the lock nut of the rod / end-fitting coupling of the series actuator, and induce insignificant play, which is not detected by the pilot. There is no risk of losing the adjustment of the end-fitting provided that the lock nut, which is part of the half-rod / end-fitting coupling on the opposite end of the series actuator, is correctly locked.

2.B.1.a. Check that heat shrink sleeve (X) is installed on series actuator (W)

Check that lockwasher (Y) is correctly bent over and does not overlap onto groove (Z) of the rod of series actuator (W) (Detail I).

- a) that lockwasher (Y) or heat shrink sleeve (X) does not overlap onto groove (Z) of the rod of series actuator (W) (Detail H),
- b) that there is no distortion or abnormal kink on heat shrink sleeve (X).

2.B.1.b. Removal / installation of the lockwasher (Detail I).

- . When locking adjusted lockwasher (4), make sure that the bent part of the shortened portion measures 3 mm (+0.5 / 0) (Detail I).
 - . Install heat shrink sleeve (3) as per MTC Work Card 20.02.06.410, in such a way that heat shrink sleeve (3) does not overlap onto groove (Z) of the rod of series actuator (W) (Detail H).

Cut bent portion (AC) so as to ensure a length of 9 mm from the center of lockwasher (4) up to the end of the shortened part.
