A/C TYPE EC 155B  
 A/C REGN 9M-SAB S/N6583  
 TYPE OF CHECK \_\_\_\_\_

DEFECT AND RECTIFICATION WORKSHEET/CERTIFICATE OF RELEASE TO SERVICE

<b>AIRWORTHINESS DIRECTIVE</b> <b>No F-2004-013 R1</b>		Distribution : <b>A</b>	Issue date : May 26, 2004	Page : 1 / 2
	Direction générale de l'aviation civile France  <input checked="" type="checkbox"/> on behalf of EASA, the Primary Airworthiness Authority for the affected product.  <input type="checkbox"/> as the Registration Airworthiness Authority for the affected aircraft.	This Airworthiness Directive is published by the DGAC :		Translation of «Consigne de Navigabilité» of same number. In case of difficulty, reference should be made to the French issue.	
GSAC Publication	<b>No person may operate an aircraft to which an Airworthiness Directive applies, except in accordance with the requirements of that Airworthiness Directive, unless otherwise agreed with the Authority of the State of Registry.</b>				
Corresponding foreign Airworthiness Directive(s) : <b>Not applicable</b>		Airworthiness Directive(s) replaced : <b>F-2004-013 original issue</b>

**SUBJECT :** ROTORS FLIGHT CONTROL  
Collective low pitch value reduction

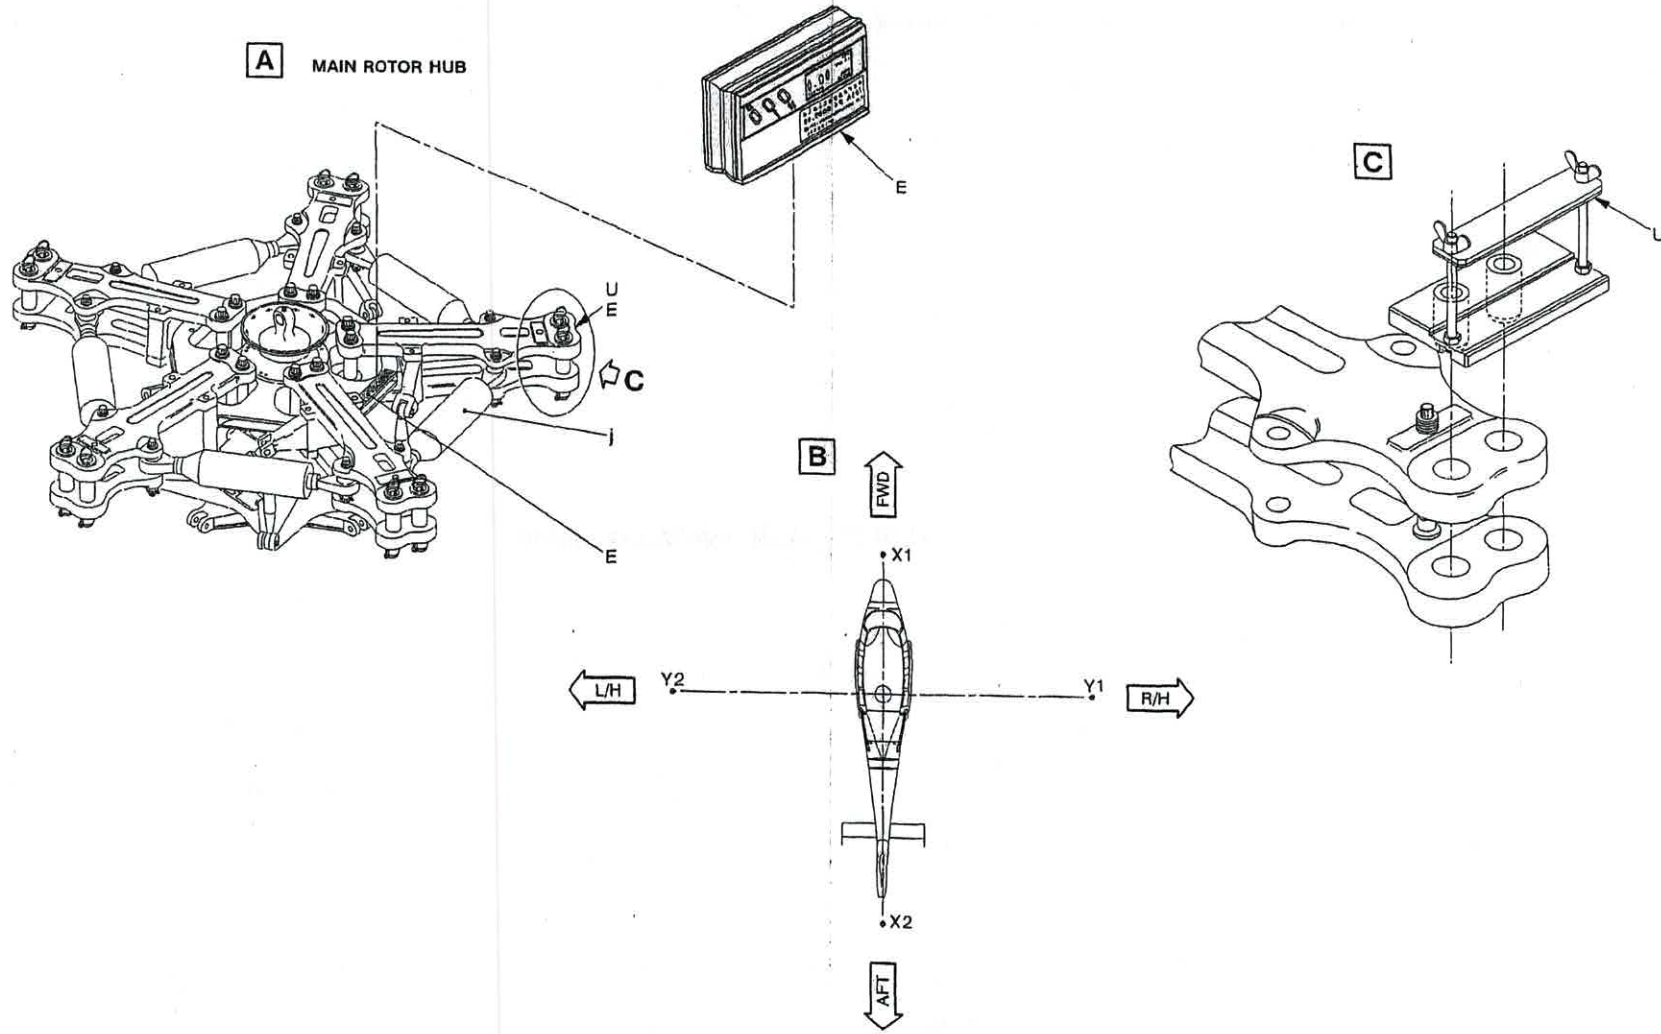
- Rotate rotor to set clinometer (E) in position X1 as per Figure 1 detail B.
- Adjust side jacks in order to obtain 0° reading on clinometer (E).
- Rotate rotor to set clinometer (E) in position X2 as per Figure 1 detail B.

- Record value and adjust side jacks in order to obtain medium setting (X2-X1)/2.
- Secure side jacks.
- Rotate rotor to set clinometer (E) in position Y1 as per Figure 1 detail B.

- Adjust aft jack in order to obtain 0° reading on clinometer (E).
- Rotate rotor to set clinometer (E) in position Y2 as per Figure 1 detail B.
- Record value and adjust aft jack in order to obtain medium setting (Y2-Y1)/2.

- Secure aft jack.
- Rotate rotor to ensure that in positions X1, X2, the reading difference on clinometer (E) is comprised within +/- 0° 5' tolerance.
- Rotate rotor to ensure that in positions Y1, Y2, the reading difference on clinometer (E) is comprised within +/- 0° 5' tolerance.

### 2.B.2.b. Low pitch stop rigging post-MOD 0767B62 (Figures 1 and 2)

- Set collective lever to low pitch in order to obtain a collective pitch of  $-1^{\circ}45'$  or  $-9'$  (yellow sleeve, mean value recorded on azimuths  $12^{\circ}$  and  $192^{\circ}$ ) on clinometer (E).
- Secure lever in this position via the friction lock.
- Replace lockwasher (a) by washer (2).
- Bring setting screw (b) into contact on collective lever pin.
- Tighten locknut as per Work Card 20.02.05.404 (MTC).
