ALERT TELEX

No. 31A005 R1

AIRCRAFT: EC 155 Civil Versions: B-B1.

SUBJECT: INDICATING AND RECORDING SYSTEMS
Landing Gear Extension Inoperative

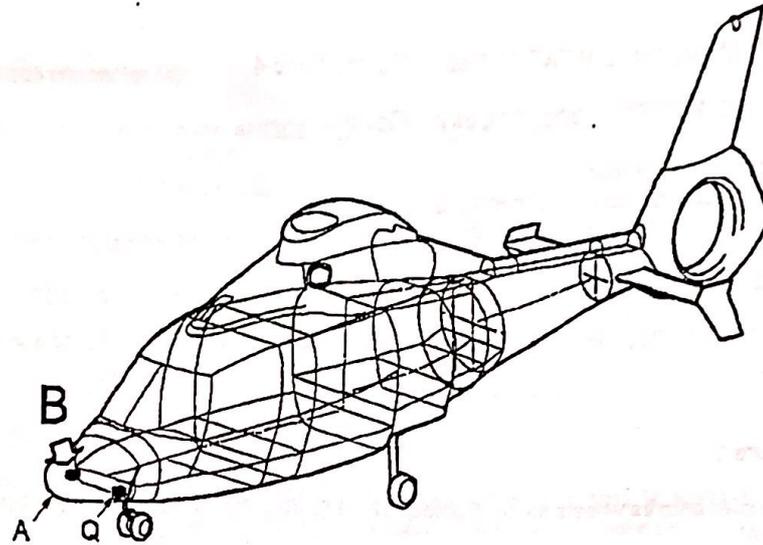
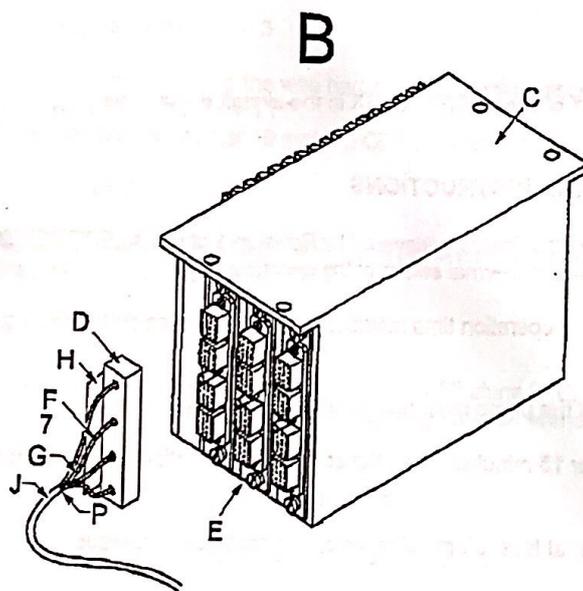
FIGURE 1

Figure 1: Drawing showing the location of ancillary system unit 10 alpha and overhead panel 12 alpha on aircraft.

- Open radome (A) to gain access as per Detail B to ancillary system unit 10 alpha (C), located on the right side of the helicopter, beneath the horizontal support member of electrical master box 4 alpha.

- Unplug connector 10 alpha 2 (D) from fixed connector 10 alpha 2 (E).
- Remove:
 - . Identification marker 10 alpha 2 CP1 and retain it.
 - . Cable clamp (F) that retains the harness and green protecting sheath (G) on clamping block (H), at the rear of connector 10 alpha 2 (D).
- Remove the cable clamps which retain the green protecting sheaths (G) and (J) to move the wires (their electrical markers are listed below) aft of connector 10 ALPHA 2 CP1 and to remove them from wire harness 10 alpha 2 CP1, at intersection (P) of protecting sheaths (G) and (J) (as per Figures 1 and 3).

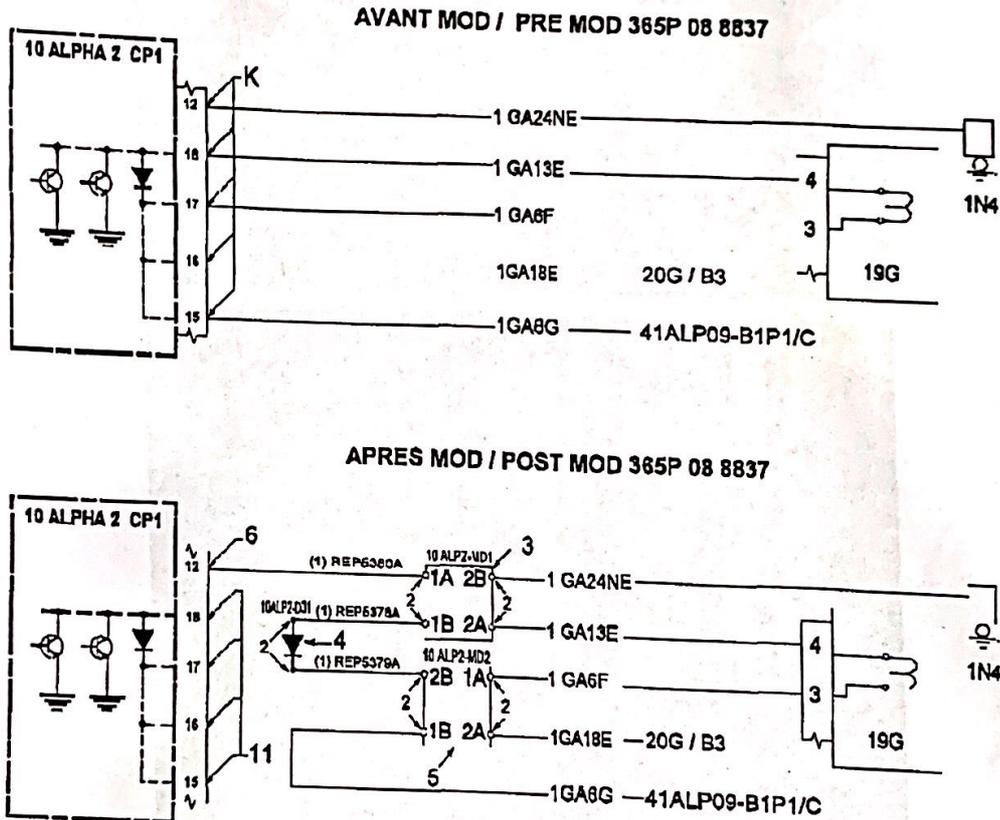
FIGURE 2

Figure 2: Wiring diagram of connector 10 alpha 2 CP1 pre and post modification 365PCS 76 023.

- Unplug the following wires from connector 10 alpha 2 CP 1:
 - . Wire 1GA24NE from terminal 12,
 - . Wire 1GA6G from terminal 15,
 - . Wire 1GA18E from terminal 16,
 - . Wire 1GA6F from terminal 17,
 - . Wire 1GA13E from terminal 18.

- Connect wires: 1GA6F, 1GA6G, 1GA13E, 1GA18E, 1GA24NE, REP5378A, REP5379A
REP5380A.

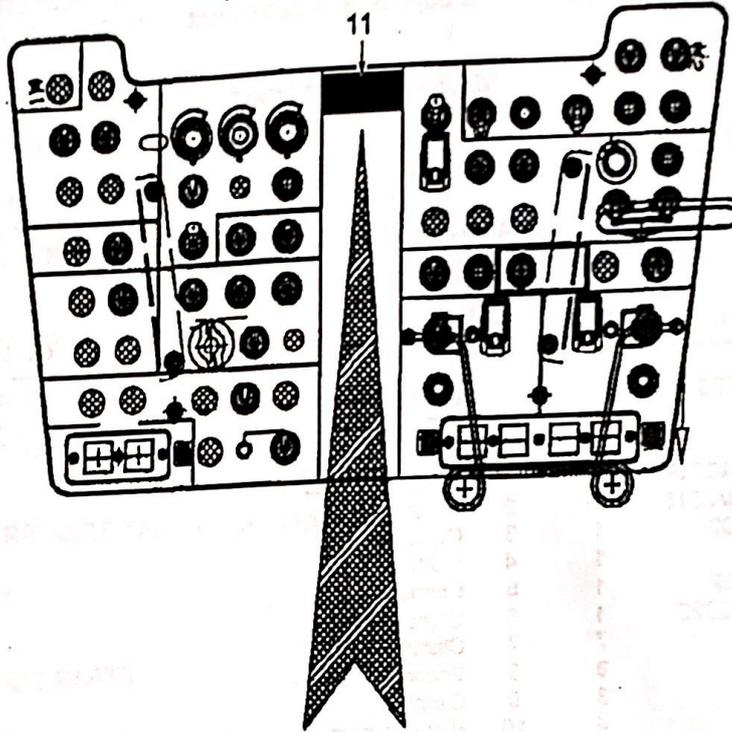
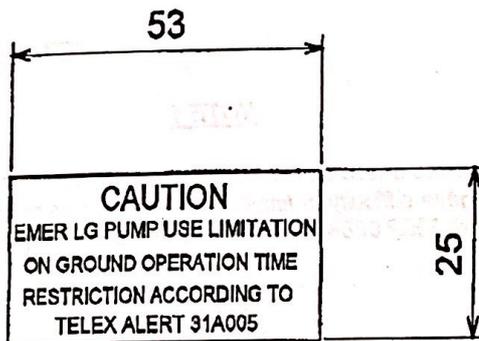
Location of the "LIMITATION" label

Figure 4: Drawing:

- . shows the location of the "limitation" label on the overhead panel in the cockpit,
- . specifies the dimensions of the "limitation" label and the text to be marked on it.

- Make a self-adhesive label:
 - . In accordance with required dimensions,
 - . text in white letters on red background.

- Affix the "LIMITATION" label (11) to overhead panel 12 alpha in the cockpit, as shown on Figure 4.
