A/C TYPE EC 155BA/C REGN 9M-SAS (6583)

## DEFECT AND RECTIFICATION WORKSHEET/CERTIFICATE OF RELEASE TO SERVICE

**SUBJECT: INDICATING AND RECORDING SYSTEMS**  
Modification of the Power Supply to Landing Gear PCB 10 and 11 ALPHA

<b>SUBJECT:</b> NAVIGATION
<p>PELICAN RACK - Improved Air Ventilation System</p> <p><i>TRACK P/N C1284TBA S/N 285 FITTED.</i></p> <p><i>FRE MOD 0739B98.</i></p>
Corresponds to MOD 0739B98

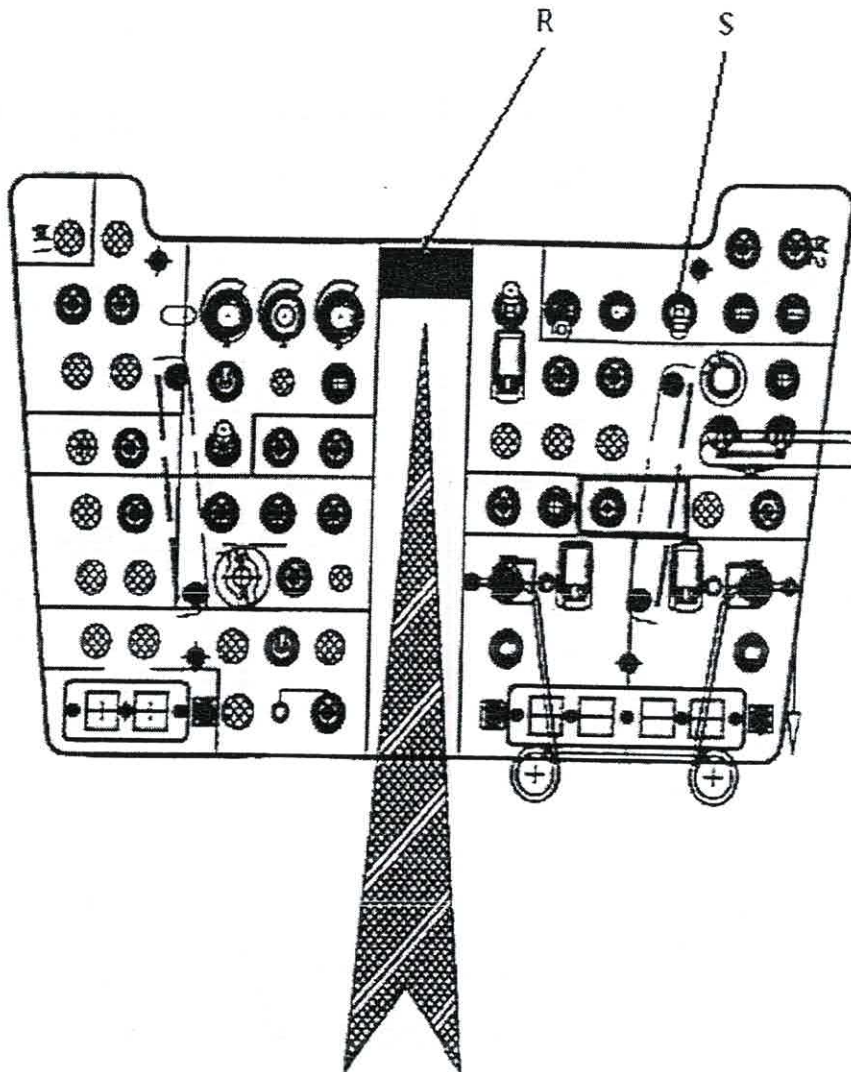
Figure 5

**CAUTION**  
EMER LG PUMP USE LIMITATION  
ON GROUND OPERATION TIME  
RESTRICTION ACCORDING TO  
TELEX ALERT 31A005

- Remove overhead panel 12 ALPHA.
- On "L/G PUMP" switch (S).
- Disconnect wire 1GA56F from contact 1B and connect it to contact 1C.
- Fit crimp contacts (3) to wire 1GA64E (8).
- Connect wire 1GA64E (8) to contacts 1B and 2C.
- Install clamps (4) to hold the wires on the harness of 12 ALPHA.
- Install overhead panel 12 ALPHA.
- Remove "LIMITATION" label (R) from overhead panel 12 ALPHA.
