A/C TYPE EC 155 B  
 A/C REGN 9M-SAS S/N 6583  
 TYPE OF CHECK \_\_\_\_\_

DEFECT AND RECTIFICATION WORKSHEET/CERTIFICATE OF RELEASE TO SERVICE

**No. 76A001**

<b>SUBJECT: ENGINE CONTROLS</b>	
Modification of "OFF/IDL/FLT" selector lifting interlocks on 12 ALPHA panel	
Corresponds to MOD 0739C36

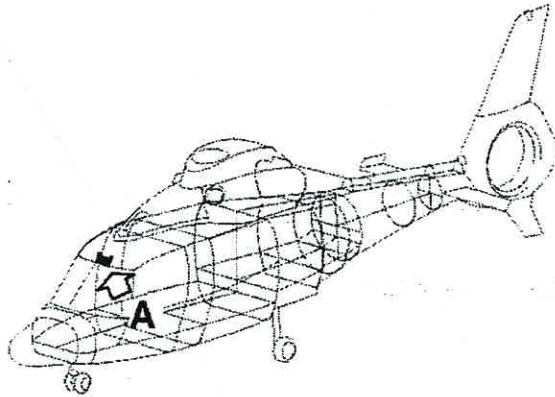
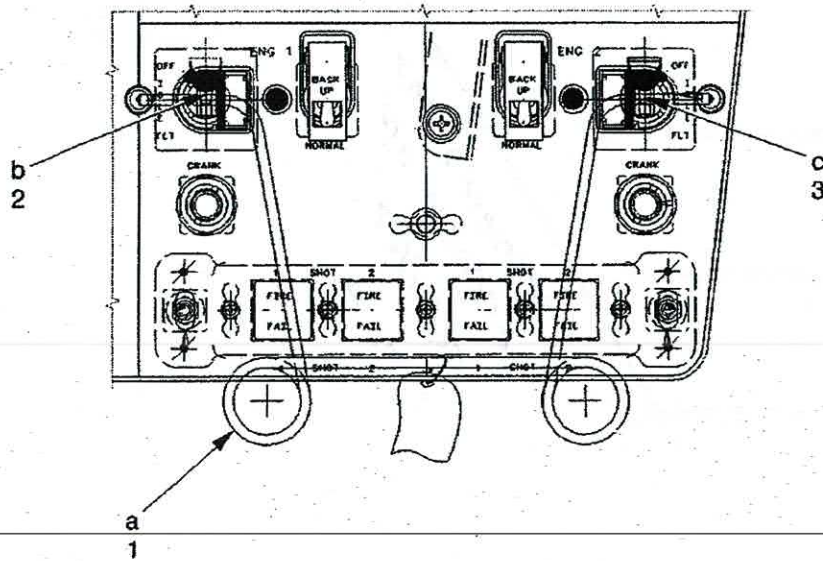
Figure 1

In flight, further to a shock on canopy, unlocking of one of the 2 engine control selectors occurred and selector flipped to IDLE. This resulted in slowing the concerned engine to idle. This was made possible by wear of selector control lever locking pins.

#### 2.B.2. Replacement selector lifting interlocks and switch guard on 12 ALPHA panel assembly (Figure 1)

- Remove switch guard (a). Scrap.
- Remove selector lifting interlocks (b) and (c) by means of tool (4).
- Scrap selector lifting interlocks (b) and (c).
- Install selector lifting interlocks (2) and (3) by means of tool (4).
- Install switch guard (1).
