A/C TYPE EC155B  
 A/C REGN 9M-SAS S/N 6583  
 TYPE OF CHECK \_\_\_\_\_

DEFECT AND RECTIFICATION WORKSHEET/CERTIFICATE OF RELEASE TO SERVICE

SUBJECT: MAIN ROTOR DRIVE

Anomaly affecting the MGB oil low pressure indication

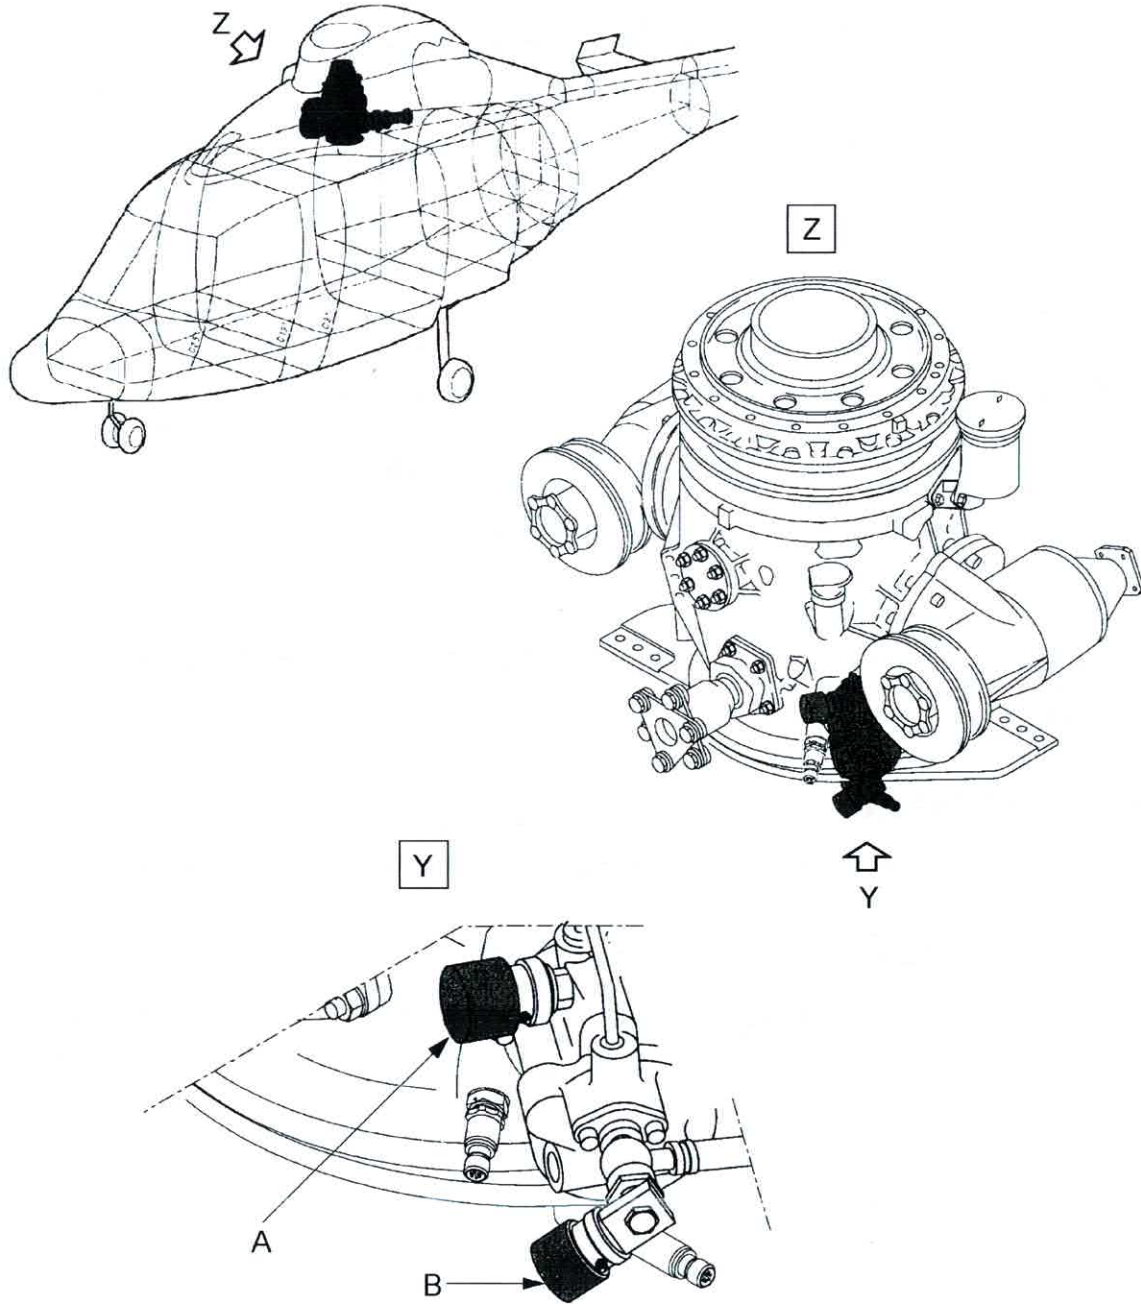
Figure 1: Pressure switch locations

#### 2.B.2 Checking the connections of the MGB oil pressure switches (Figure 1)

- Energize the helicopter electrical power systems as per Task 24-00-00-911 (EC155) or as per Work Card 24.00.00.300 (SA366, AS365 and AS565).
- Check for correct illumination of the failure warning lights that are associated with pressure switch (A) (auxiliary system) and (B) (main system). The table below provides the exact warning light designations, for each helicopter version.

- Disconnect the electrical terminal from pressure switch (A) (auxiliary system). Avoid unwanted electrical grounding when the electrical terminal is disconnected.

- Check that the failure warning light of the auxiliary system (**AUX**) is off.
  - If the extinguished failure warning light does not correspond to the failure warning light of the auxiliary system, change over the connections of pressure switch (A) (auxiliary system) and (B) (main system). (If necessary, refer to the Wiring Diagrams Manual applicable to the MGB indicating system).

- If the extinguished failure warning light corresponds to the failure warning light of the auxiliary system, re-connect the electrical terminal to pressure switch (A).

- De-energize the helicopter electrical power systems as per MET Work Card 24.00.00.300.
- Check that there are fixed and removable markings for each pressure switch (A) and (B). The markings must correspond in pairs

- If the markings do not correspond, bring the markings up to standard in accordance with the drawing provided in the Wiring Diagrams Manual applicable to the MGB indicating system.

- If there are no markings or if they have become illegible, renew the markings using an indelible felt tip pen, for example.

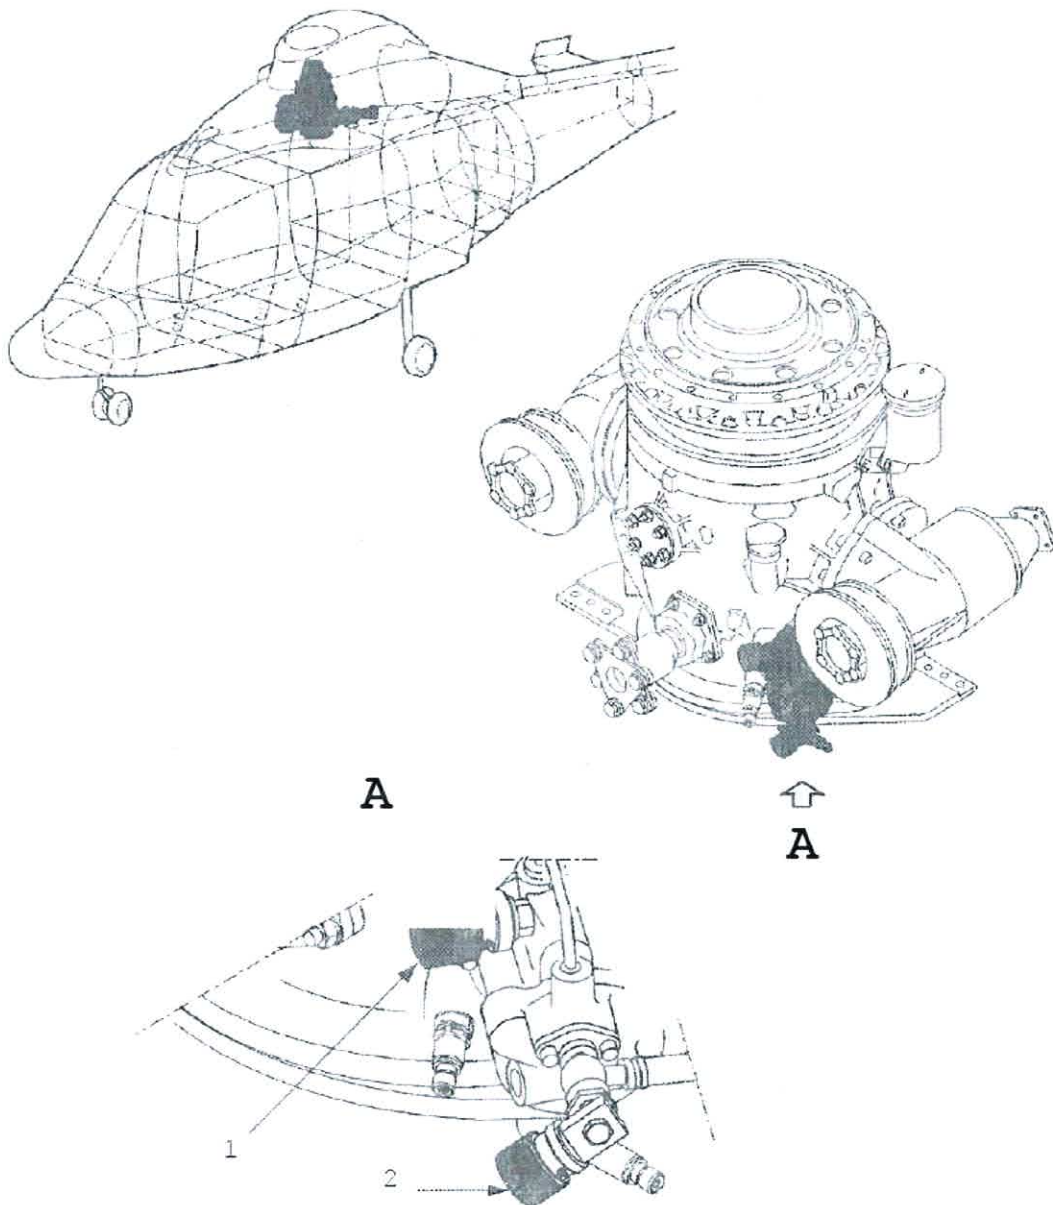
XX-XX Fig. 1

- Check for correct illumination of the failure warning lights:
  - . "MGB MAIN" ou "MGB PMP MAIN"
  - . "MGB AUX" ou "MGB PMP AUX"
- Disconnect and insulate the connection of the wire from the auxiliary system pressure switch (1) as per work card 63.20.00.405 or 63.20.01.405.
- Check that the failure warning light "MGB AUX" or "MGB PMP AUX" is switch off.
  - . If the failure warning light "MGB MAIN" or "MGB PMP MAIN" is switch off, change over the connections of pressure switches (1) and (2) (refer to MCS 63.40.00).
  - . If the failure warning light "MGB AUX" or "MGB PMP AUX" is switch off, re-connect pressure switch (1) as per work card 63.20.00.405 or 63.20.01.405.
- De-energize the helicopter electrical power systems as per work card 24.00.00.300.
- Check that there are fixed and removable markings for each pressure switch (1) and (2). The markings must correspond in pairs.

- . If the markings do not correspond, bring the markings up to standard in accordance with drawing 63.40.00 of MCS.
- . If there are no marking or if they have become illegible, renew the marking using an indelible felt tip pen.

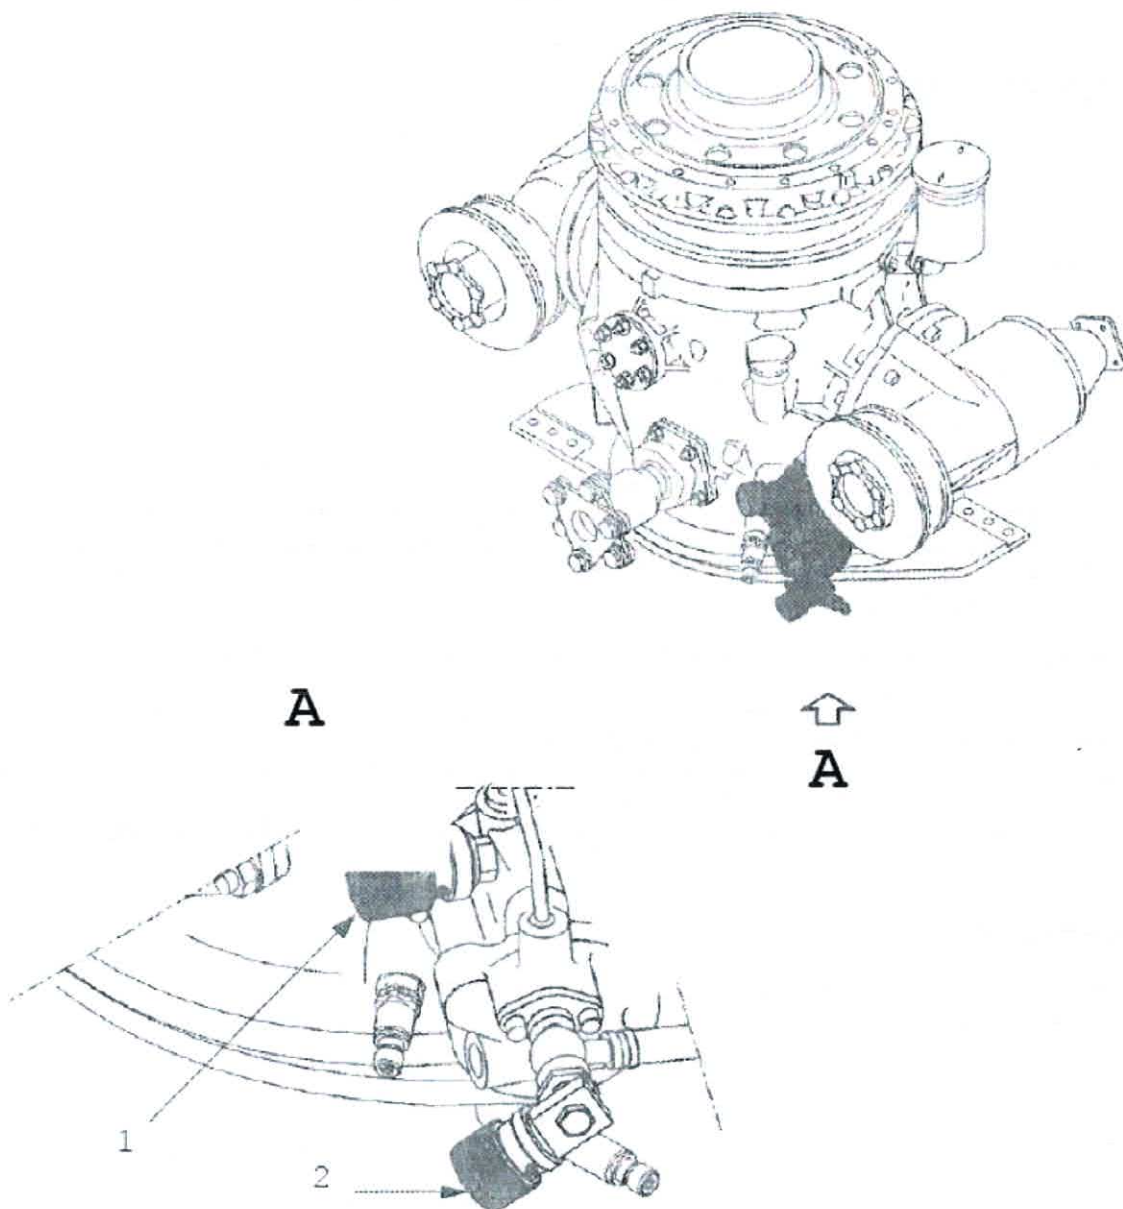
Figure 1

**PROCEDURE (Figure 1)**

- Check for correct illumination of the failure warning lights:
  - "MGB P"
  - "MGB AUX P"
- Disconnect and insulate the connection of the wire from the auxiliary system pressure switch (1)

- Check that the failure warning light "MGB AUX P" is switch off.
  - If the failure warning light "MGB P" is switch off, change over the connections of pressure switches (1) and (2) (refer to MCS 63.40.00).

- If the failure warning light "MGB AUX P" is switch off, re-connect pressure switch (1).
- De-energize the helicopter electrical power systems as per Task 24-00-00-481.

- Check that there are fixed and removable markings for each pressure switch (1) and (2). The markings must correspond in pairs.
  - If the markings do not correspond, bring the markings up to standard in accordance with drawing 63.40.00 of MCS.

- If there are no marking or if they have become illegible, renew the marking using an indelible felt tip pen.
