A/C TYPE EC155B  
 A/C REGN 9M-SAS S/N 6583  
 TYPE OF CHECK \_\_\_\_\_

DEFECT AND RECTIFICATION WORKSHEET/CERTIFICATE OF RELEASE TO SERVICE

**No. 67A003**

**SUBJECT: ROTOR FLIGHT CONTROLS**

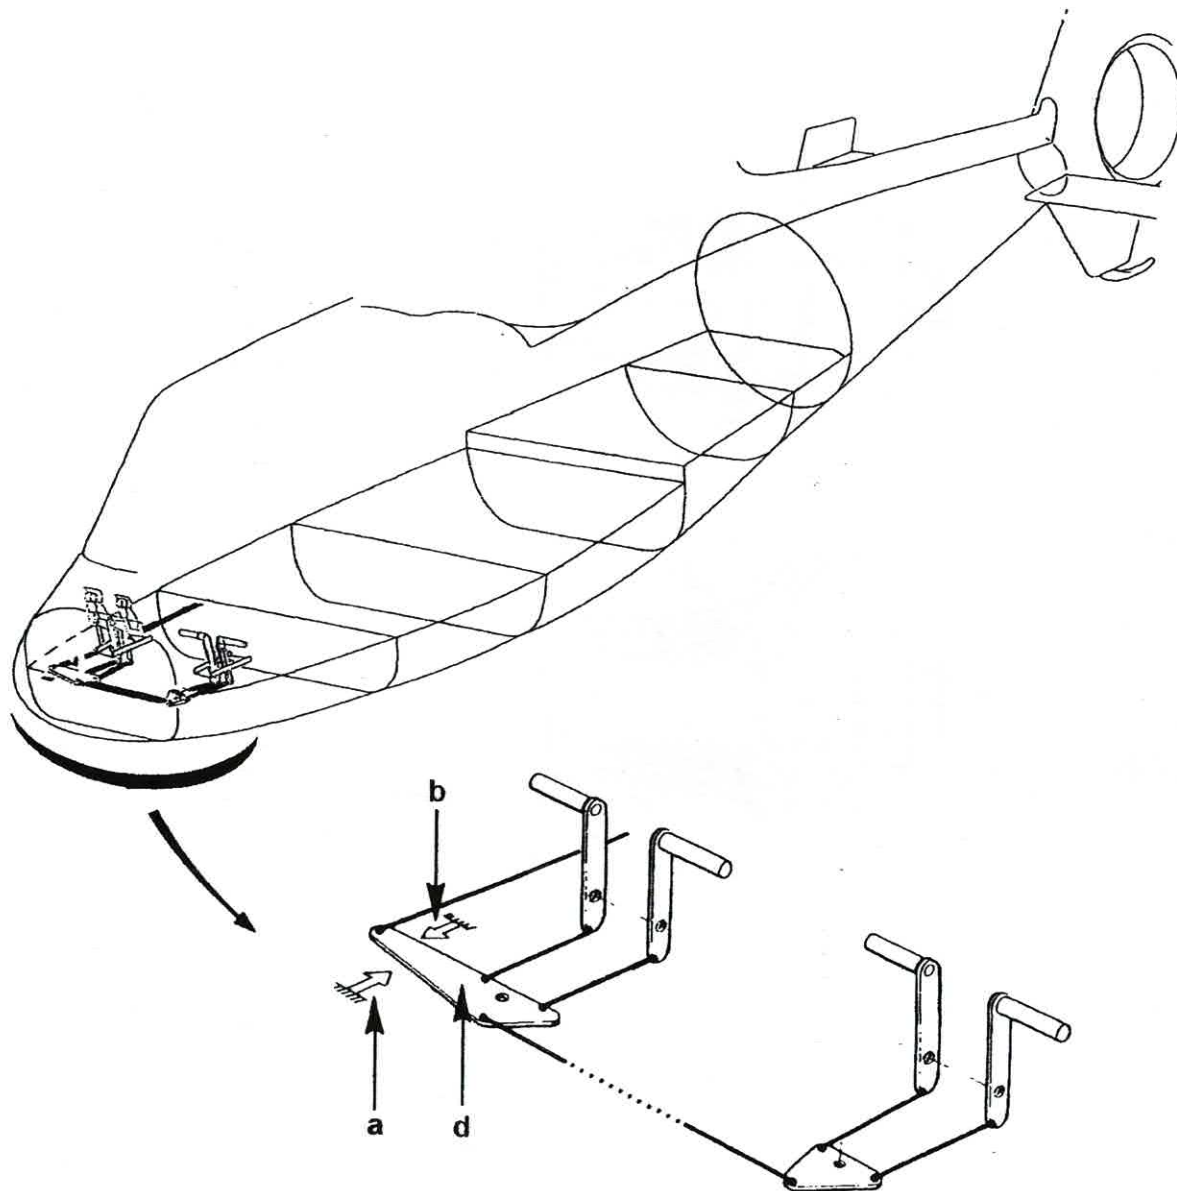
Figure 1

- Do a tactile check of the screws of the auxiliary stops (a) and (b) in order to make sure that the screws do not turn freely:

. If one or the two screws of the auxiliary stops (a) and (b) turn freely, adjust the stops in accordance with paragraph 2.B.1.b.

. If the screws of the auxiliary stops (a) and (b) do not turn, leave as is.

Adjust the auxiliary stops (a) and (b) in accordance with AMM Task 67-20-01-821:  
"Adjustment – Pedal Stops".

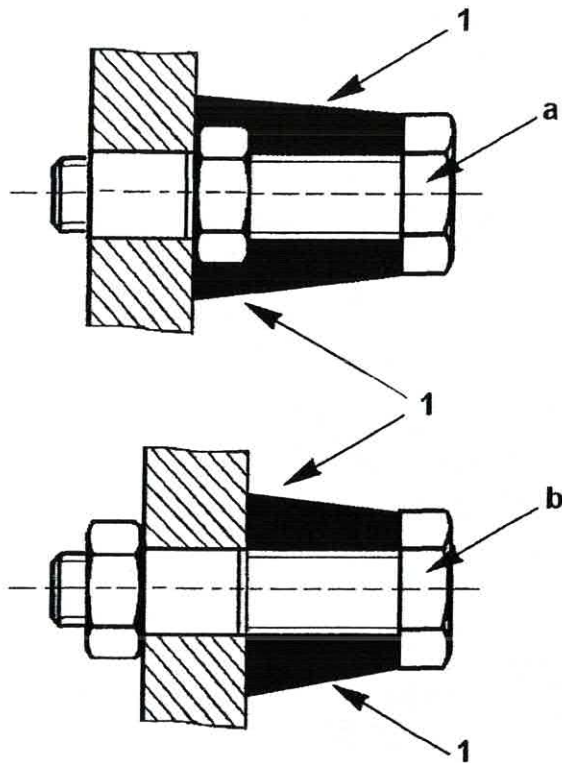
*Figure 2 is a general drawing that depicts the sealing area.  
The configuration of your aircraft is not necessarily the same as that shown on Figure 2 (location of the locknut different).  
Apply the sealing procedure to the stop screws without modifying the adjustment or configuration of your aircraft.*

Seal the screws of the auxiliary stops (a) and (b) with TECHNOVIT resin (1) to be applied to all the visible threaded sections of each screw, between the screw head and the structure to which the screw is secured. For the auxiliary stop (a) located forward of the bellcrank (d), apply the resin to the external surfaces of the locknut (see Figure 2).

During this operation, take care not to apply any resin to the surrounding components.
