[Docket No. FAA-2024-0237; Project Identifier AD-2023-00491-R; Amendment 39-22853; AD 2024-19-11]

Airworthiness Directives; Robinson Helicopter Company Helicopters

2024-19-11 Robinson Helicopter Company: Amendment 39-22853; Docket No. FAA-2024-0237; Project Identifier AD-2023-00491-R.

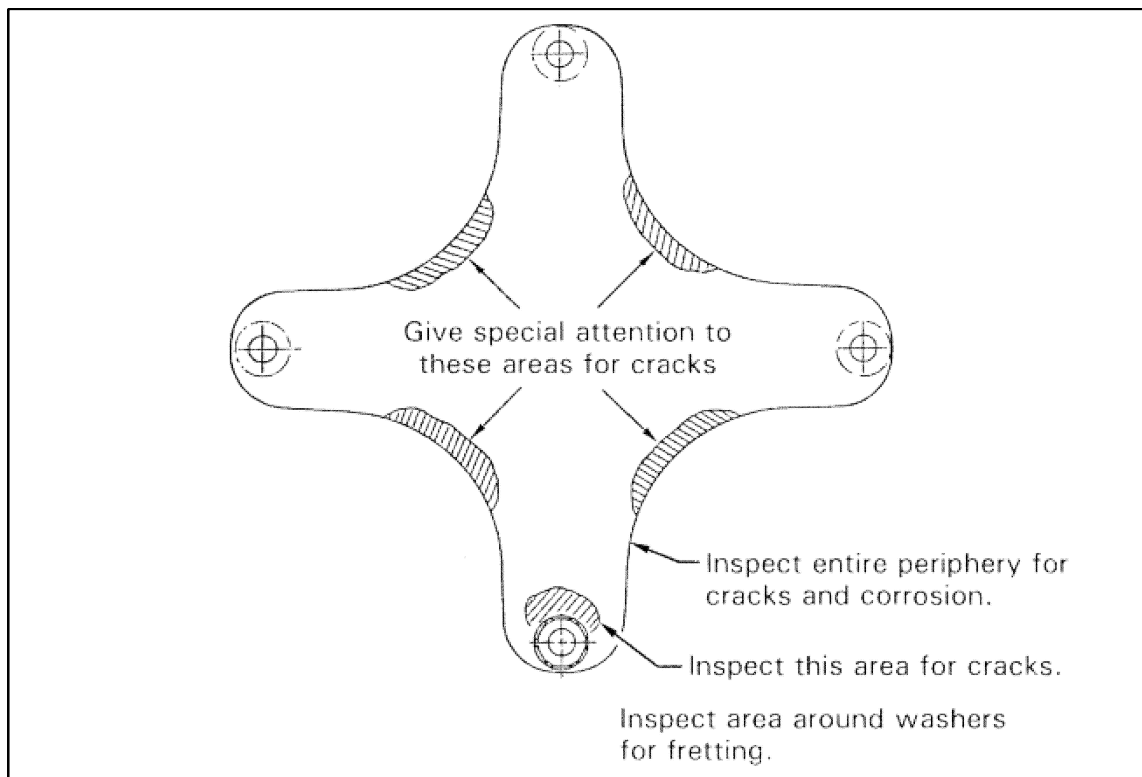
Figure 1 to Paragraph (g)(1)(i)—Flex Plate Inspection

(i) Visually inspect forward flex plate assembly (flex plate) part number (P/N) C947-1 for any loose fasteners, cracks, fretting, corrosion, wear, and to ensure that the washers are bonded to both sides of each flex plate arm, in the areas depicted in Figure 1 to paragraph (g)(1)(i) of this AD. If there is any loose fastener (can be moved by hand), crack, fretting, corrosion, or wear that consists of the washers not securely bonded to both sides of each flex plate arm, before further flight, remove the flex plate from service and replace with an airworthy flex plate.
