## Airworthiness Directive

Amendment 39-5338; AD 72-06-05 R2

Airworthiness Directives; MARVEL SCHEBLER (Facet Aerospace Products Company):  
Applies to Models MA-3, MA-3A, MA3-PA, MA-3SPA, MA4-SPA, MA4-5, MA4-5AA, MA-5,  
MA-5AA, MA-6AA and HA-6 Carburetors  
**PDF Copy (If Available):**

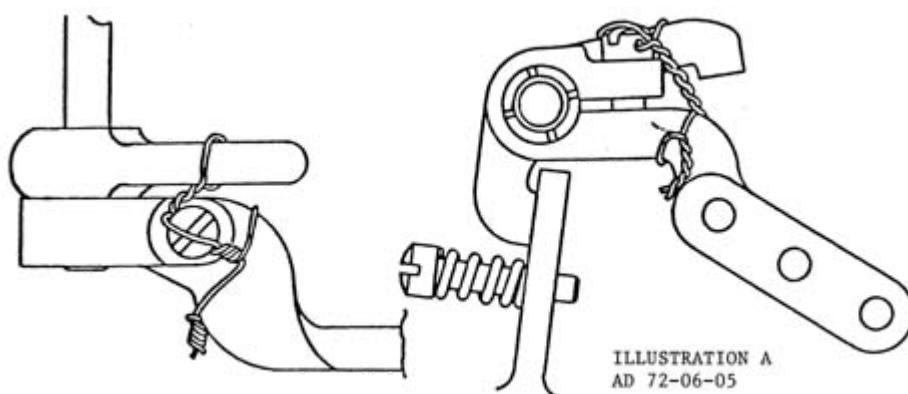
To present looseness or separation of the throttle arm, accomplish the following or any equivalent procedure approved by the Manager, New York Aircraft Certification Office, FAA, New England Region.

(2) Inspect the throttle arm on Marvel Schebler MA-3, MA-3A, MA-3PA, MA3-SPA, and MA-4SPA carburetors to determine whether it has a spotfaced or milled flat for the head of the clamping screw. Replace any arm having a milled flat with one having a spotfaced flat. If not already installed, install a Marvel Schebler P/N A15-493 clamping screw (No. 10-24 x 5/8 slotted drilled fillister head) in the throttle arm. Torque the clamping screw to 20-28 in.-lb. and inspect the slot in the end of the arm for clearance. If the slot has closed so that no clearance remains, replace the arm and retorque to the above specifications. After the specified torque is established safety wire the throttle arm and clamping screw to the throttle stop as shown in Illustration A.
