## Airworthiness Directive

Amendment 39-4658; AD 82-20-01

Airworthiness Directives; BENDIX: Applies to Bendix Engine Products Division Magnetos  
**PDF Copy (If Available):**

**82-20-01 BENDIX:** Amendment 39-4658. Applies to Bendix Engine Products Division magnetos with type designations listed below:

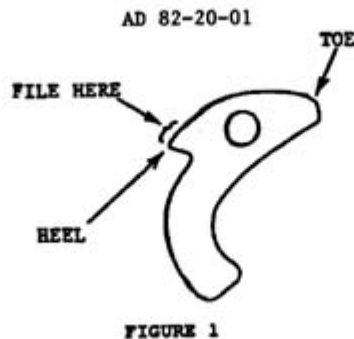
To prevent failure of impulse coupling due to improperly heat treated (soft) flyweights resulting in engine damage or failure, accomplish the following: (Ref. Bendix Service Bulletin No. 623 dated September 1982.)

3. Use finger pressure to push inward on the toe (see Figure 1) of each flyweight so that the flyweight heel protrudes outward.
4. Using a fine #1, double cut, 1/2-inch wide file at least 3/32-inch thick, pass the file across the heel of the flyweight attempting to remove material (see Figure 1). If the flyweight has been properly heat treated, the file will "glide" smoothly over the heel of the flyweight, removing no material. If the flyweight is not properly heat treated (soft), the file will not "glide" easily across the surface of the flyweight heel, and material will be removed.

5. If an improperly heat treated (soft) flyweight is found, immediately remove and replace the cam assembly and/or the impulse coupling assembly with an assembly meeting the requirements of this AD, following procedures in the magneto overhaul instructions, and
