ALERT SERVICE BULLETIN

429-21-56

MODEL AFFECTED: 429

SUBJECT: SWASHPLATE INPUT TUBES 429-001-020-101 AND -107, INSPECTION OF.

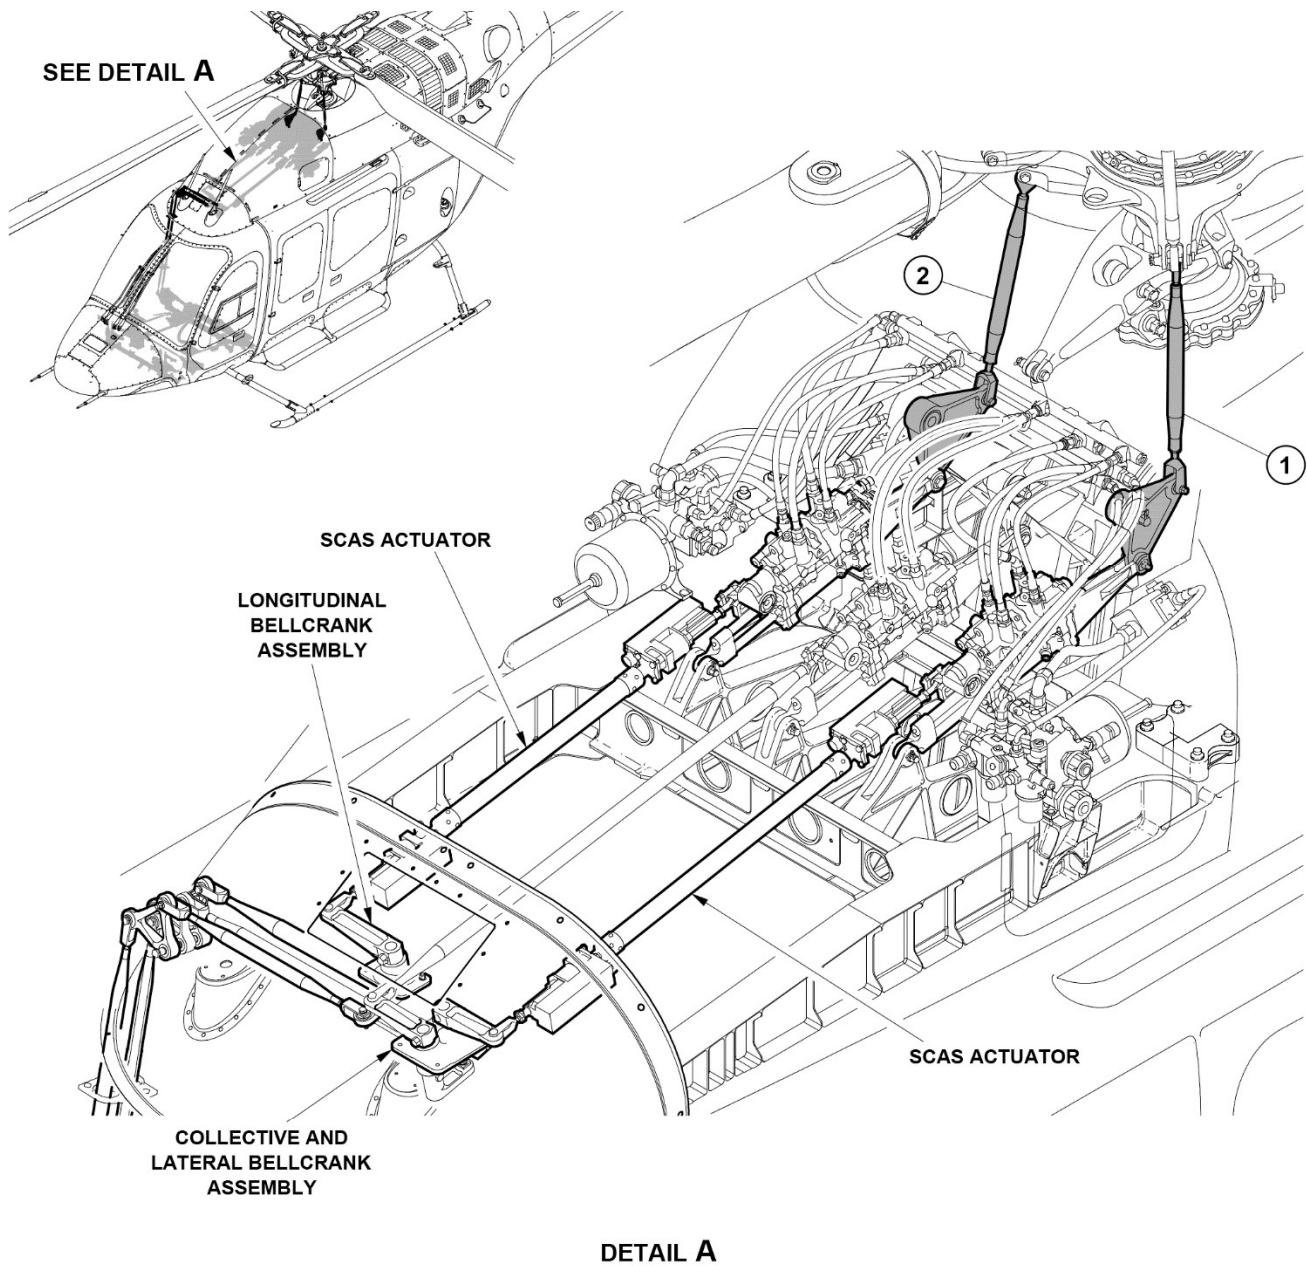
Figure 1 – Swashplate Cyclic Input Tubes

1. Swashplate input tube 429-001-020-101
2. Swashplate input tube 429-001-020-107

- a. Examine the swashplate input tube assemblies (1 and 2, Figure 1), paying particular attention to corrosion damage (as shown in Figure 2), cracks, wear, mechanical damage, and excessive axial/radial play of the rod end bearing. As required, replace or repair the part (DMC-429-A-67-10-00-11A-520A-A).
4. Complete Table 1 and submit the results by doing the following:
 - a. In the subject line of the e-mail, include the helicopter serial number, the helicopter total time since new and the ASB number (ASB 429-21-56).
 - b. If a defect is found during the inspection, provide the details such as the wear or damage measurements and high quality photos.
 - c. Send the e-mail to productsupport@bellflight.com.

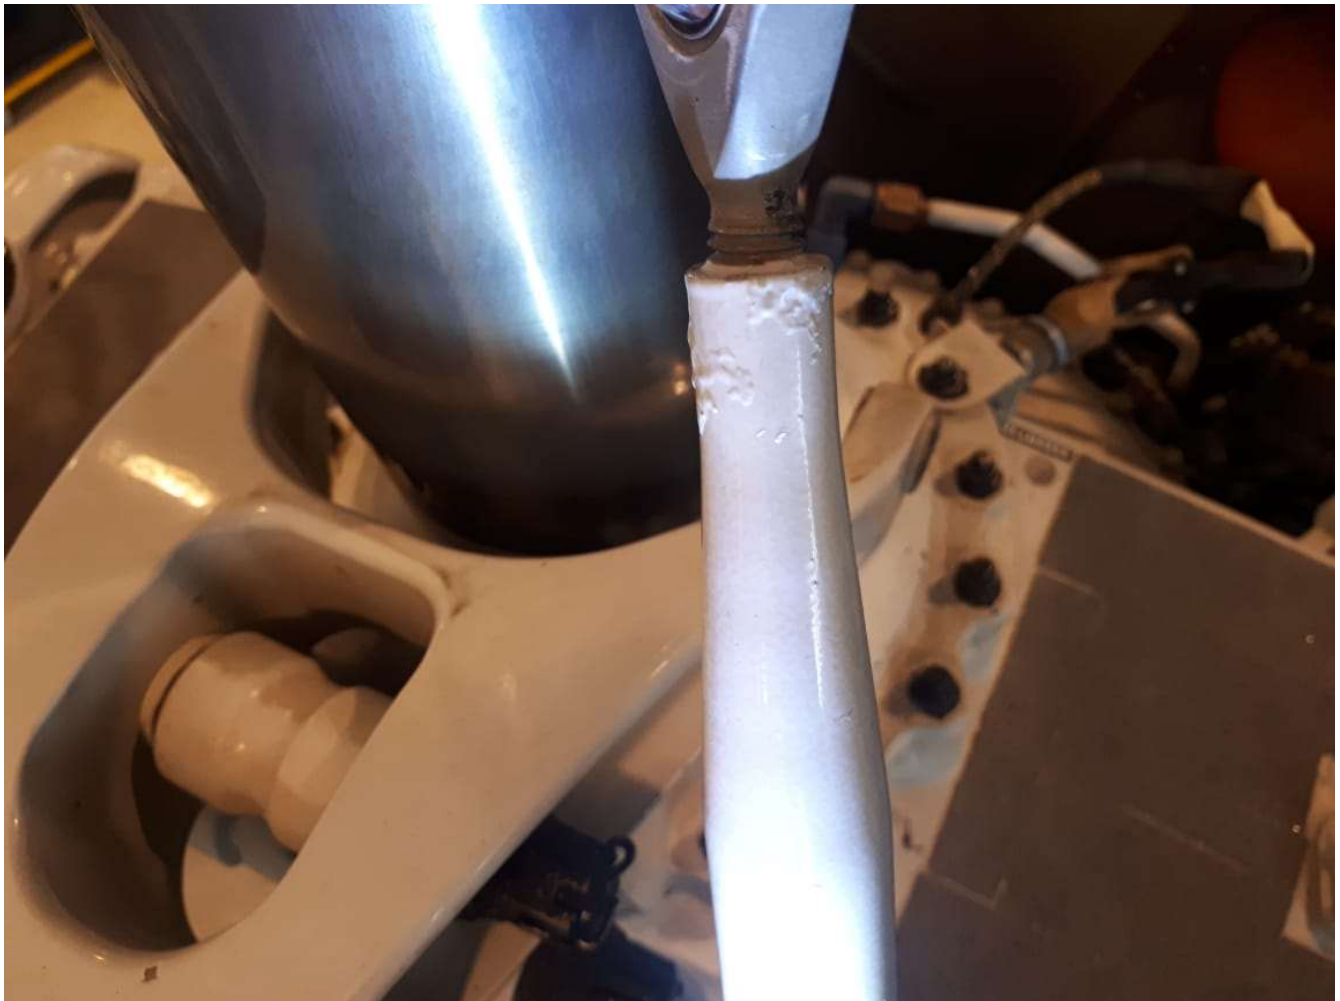
Bell has received a report of a swashplate cyclic input tube 429-001-020-101 exhibiting corrosion indications. Upon further investigation, it was discovered that stress corrosion cracking occurred in the swaged portion of the aluminum alloy tube near the rod end 407-001-404-105. This bulletin mandates an initial detailed inspection of the cyclic input tube assemblies and also requires a recurring 12 month inspection. Furthermore, Bell is adding a reporting requirement in this bulletin to gather data from the field. This data will be used to make an informed decision on an eventual terminating action for this bulletin. Applicability of this bulletin to any spare part shall be determined prior to its installation on an affected helicopter.

Figure 2 – Corrosion on Swashplate Cyclic Input Tube
