**No. AS350-05.01.03**

# ALERT SERVICE BULLETIN

Check for absence of rotation of the bearing spacer of the Tail-Rotor-Head (TRH) pitch-change-unit  
 ATA: 65

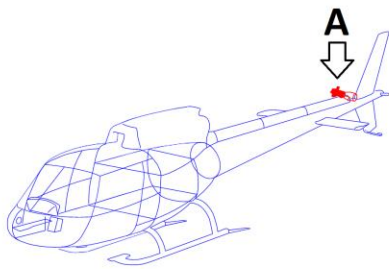
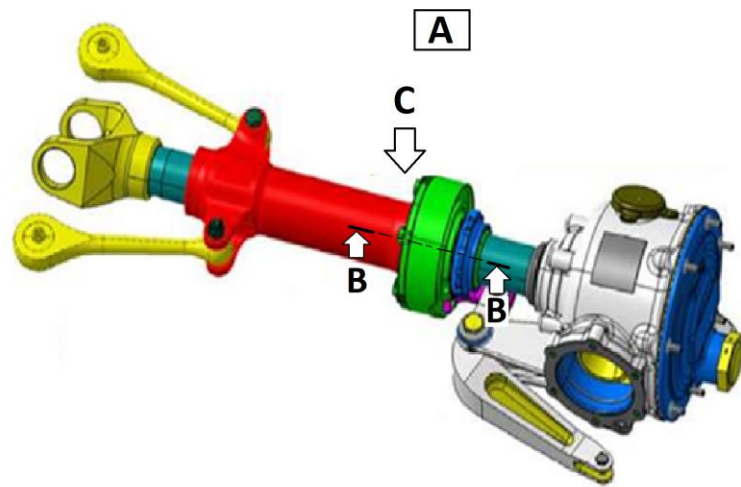
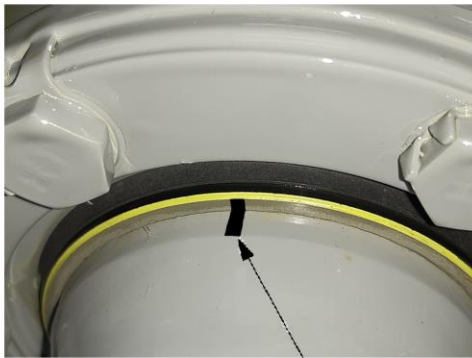
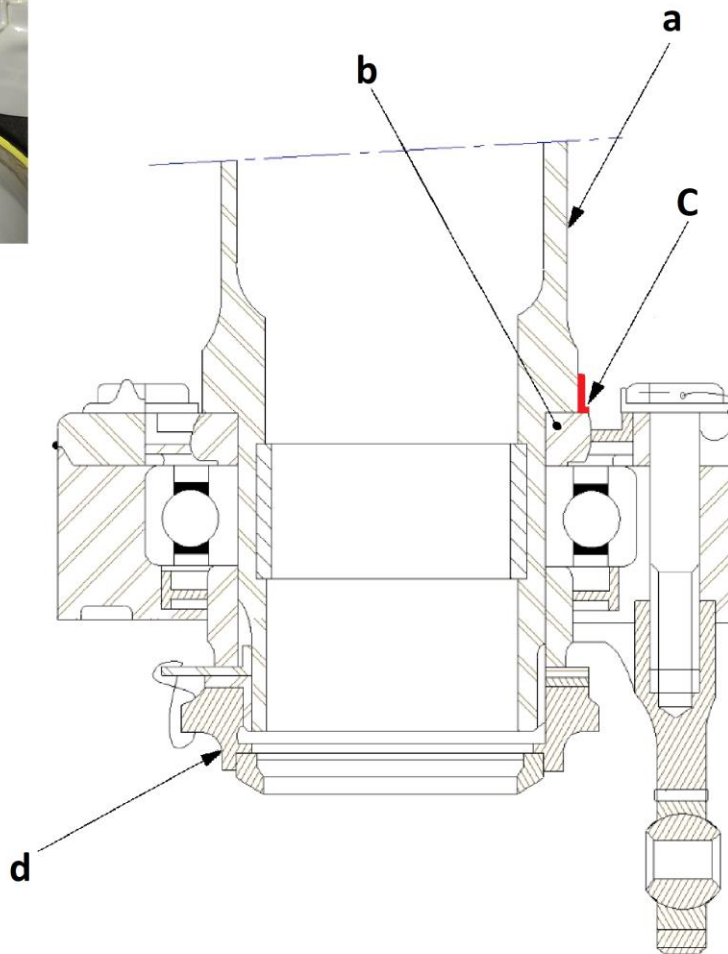
Figure 1

During a tail rotor pitch change spider inspection, the operator reported excessive play in the assembly and excessive wear on its parts due to unwanted rotating motion.

These significant damages on parts could lead to the loss of the helicopter yaw control.

Make sure that the nut (d) is not missing and well installed (not loose):

- If the nut is missing or loose:
  - . Inform the Airbus Helicopters Support Department about the results by a creation of a Technical Event (TE) on WebTEK: <https://airbusworld.helicopters.airbus.com>
  - . Comply with paragraph [3.B.2.c.](#)
- If the nut is not missing and not loose:
  - . Identify the position of the TRH pitch change unit (a) and of the bearing spacer (b) by means of a 2 to 5 mm wide black paint index mark (C) with the black paint (2) (not shown).  
Then:
    - . Record the MOD 0765002 in the Log Card (FM) of the TRH pitch change unit. Refer to paragraph [3.C.](#)

- Make sure that there is no damage on the rotating plate (not shown) and on the rotating plate threads with the magnifying lens (zz).
  - . If there is damage, replace the rotating plate (not shown).
  - . If there is no damage, install again the rotating plate (not shown).
- Comply with paragraph [3.B.2.a.](#)
