No. AS365-05.00.82

ALERT SERVICE BULLETIN

TIME LIMITS - MAINTENANCE CHECKS - Main Rotor
Inspection of the pitch rod upper links
ATA 62

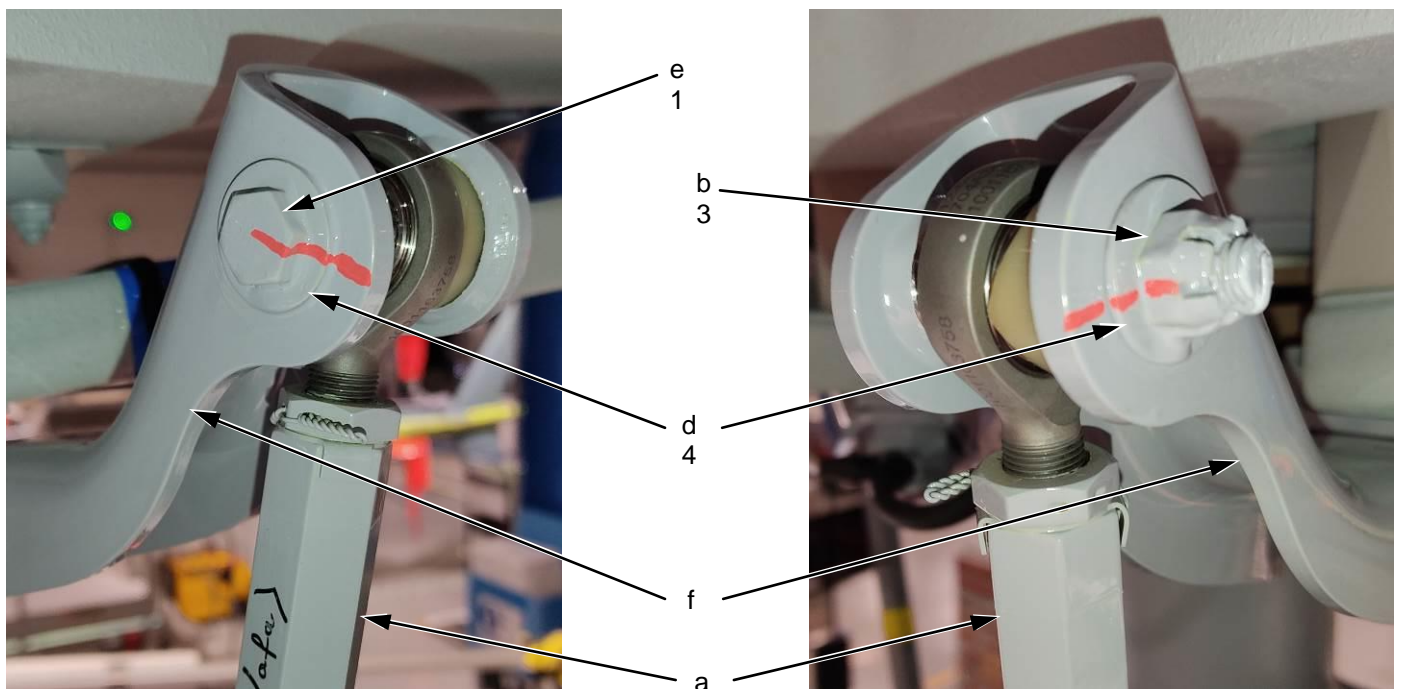
Figure 1

Airbus Helicopters has recently been informed of a case a total loss of tightening torque of a screw used for the connection of the pitch rod and the horn.

This loss was discovered after a flight with increasing vibration level, during the post-flight inspection. After detailed inspection of the parts, significant wear was also noticed on the shank of the screw.

- As per the principles of Work Card 20-02-05-404 (MTC), mark the tightening of the screw (e) or (1) and nut (b) or (3), ([Figure 1](#)) by applying a line of red paint (approximately 2 mm (.078 in.)) to:

- . the screw head (e) or (1), the washer (d) or (4) and the pitch horn (f),
- . the nut (b) or (3), the washer (d) or (4) and the pitch horn (f).

- Make sure that the two red lines of the pitch rod (a) upper link ([Figure 1](#)) are aligned.
- If the two red lines are aligned on both sides, comply with paragraph [3.B.3.](#)
- If at least one of the two red lines is not aligned, check the tightening torque of the pitch rod upper links as per paragraph 3.B.2.c.
