No. AS365-52.00.29

ALERT SERVICE BULLETIN

DOORS - Emergency exit
Emergency evacuation labels for helicopters
installed with fixed parts of FLIR system

Corresponds to modification MC90B73

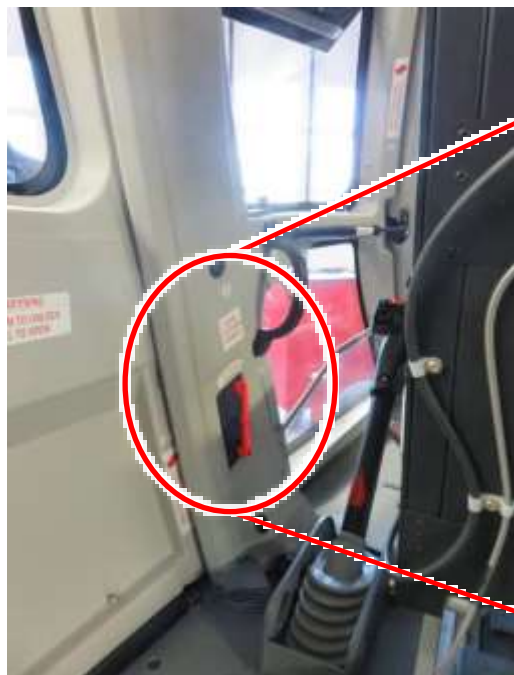
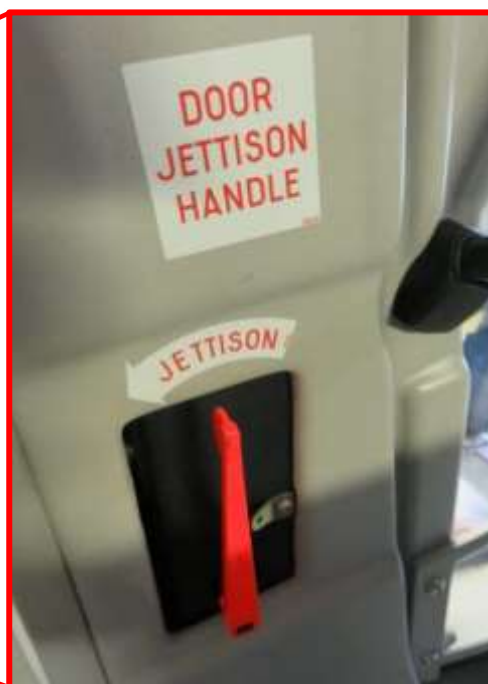
The front passenger door is an emergency exit. It must be possible for rescuers near the helicopter to open the door. When the helicopter is installed with the FLIR system, the upper strut of the FLIR external assembly does not let the front passenger door open. But a rescuer can continue to eject the door with the jettison handles which are installed in the cabin.

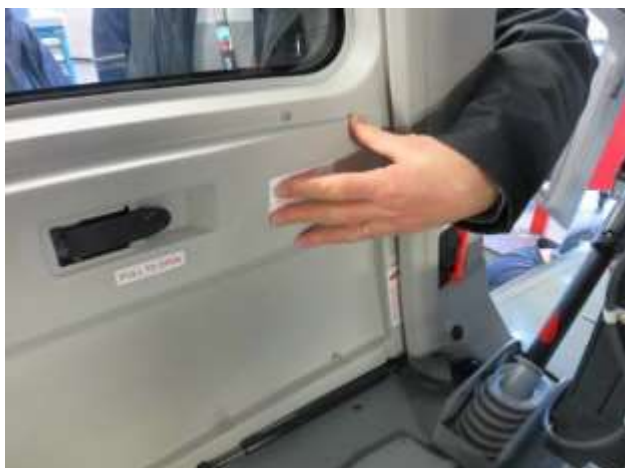
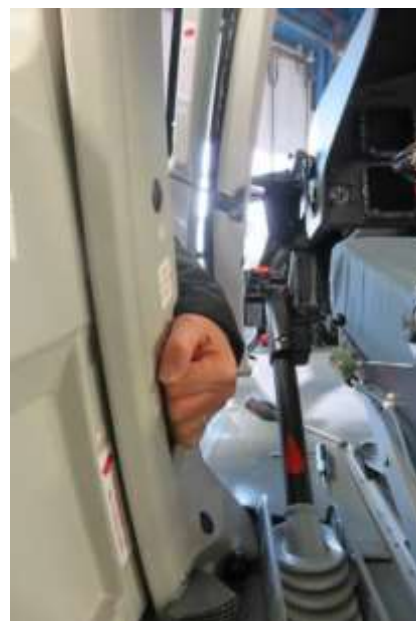
The rescuer can operate the jettison handle through the access at the cockpit door.

This ALERT SERVICE BULLETIN installs labels on the external LH and RH side of the helicopter to give instructions to the rescuers on how to operate the jettison handles.
