No. AS365-71.00.28

ALERT SERVICE BULLETIN

POWER PLANT - Firewall

Modification of the material of the firewall edging

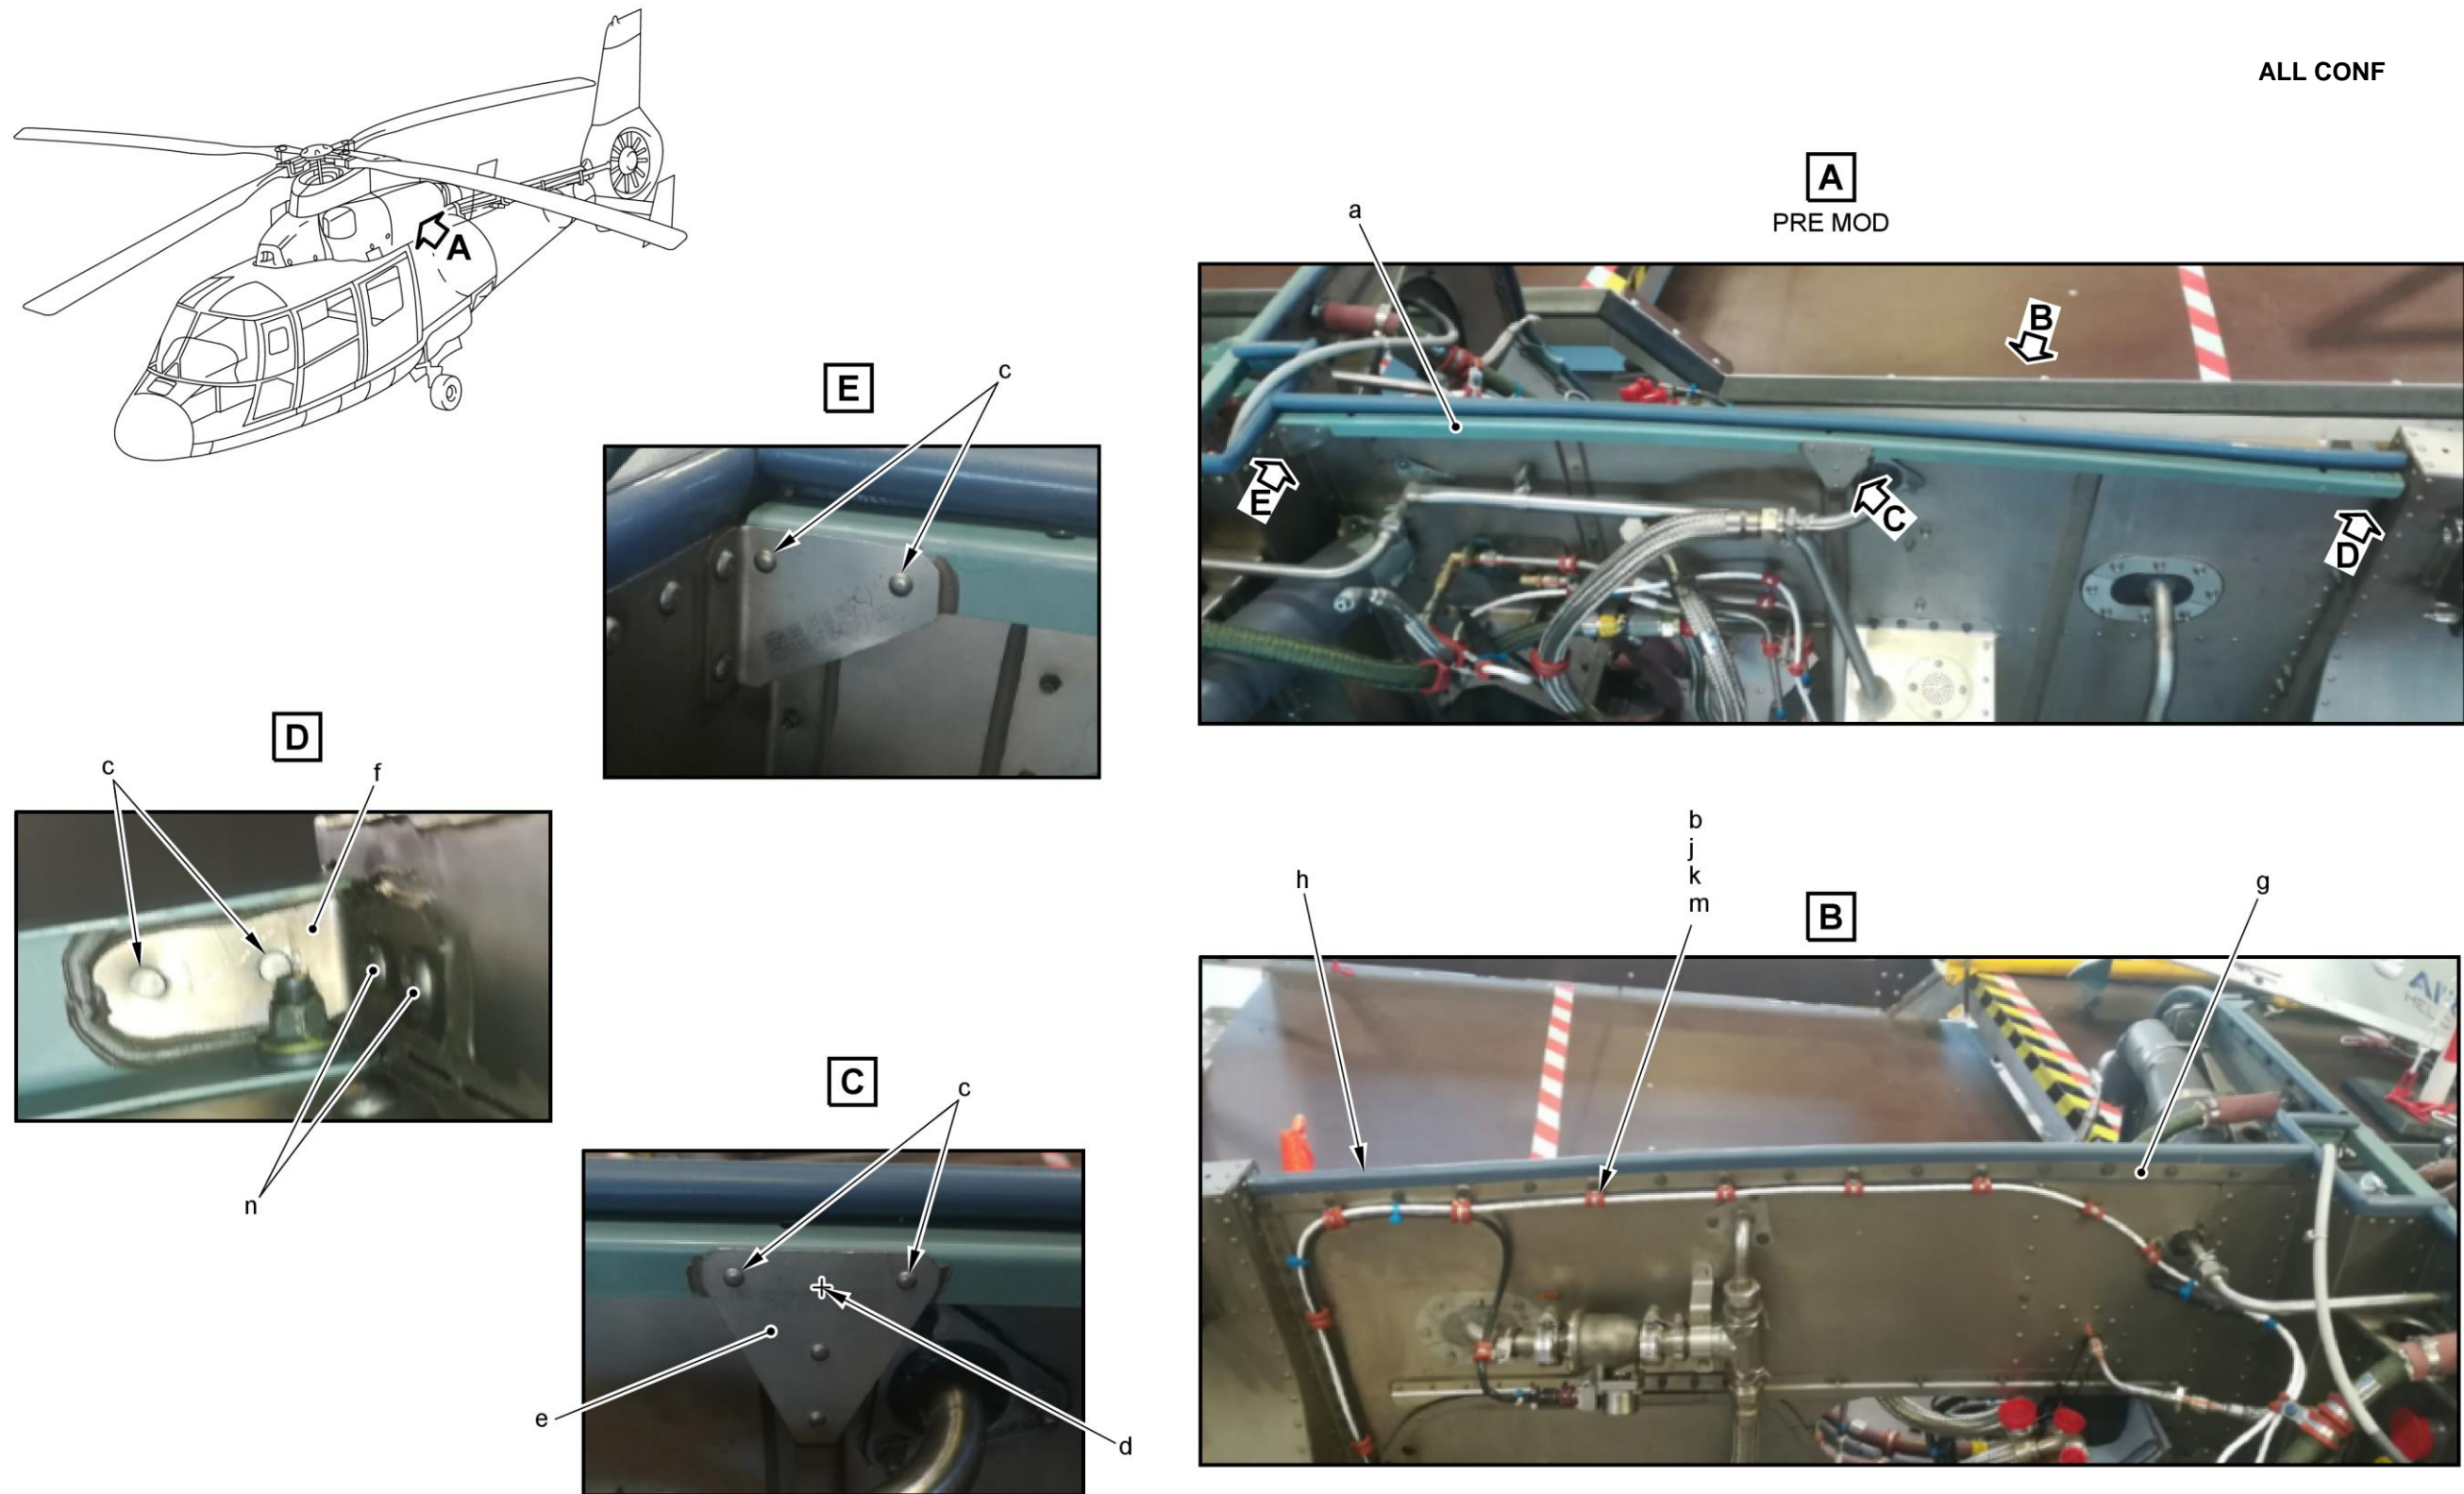
Figure 1

The investigation following a fire in a left engine compartment highlighted the failure of the upper stiffener of the central firewall. This part being in aluminum, it can lead to a distortion of the firewall and a loss of tightness of the central firewall seal if submitted to a fire.

- Remove the rivets (c) from the stiffener (a). Refer to Work Card 20-03-01-102 (MTC).
- If the center rivet (d) is installed on the gusset (e) (DETAIL C):
 - . Remove the rivet (d). Refer to Work Card 20-03-01-102 (MTC).
- Remove and discard (DETAIL B):
 - . The stiffener (a)
 - . The bolts (b)
 - . The washers (j)
 - . The nuts (k).
- Remove and keep (DETAIL A and DETAIL B):
 - . The cover strip (g)
 - . The fireproof seal (h)
 - . The clamps (m).
- If the bracket (f) is in unsatisfactory condition (DETAIL D):
 - . Remove the rivet (n)
 - . Remove and discard the bracket (f).
