No. EC120-05A019

ALERT SERVICE BULLETIN

TIME LIMITS - MAINTENANCE CHECKS - Main Rotor Hub Inspection of rotating and non-rotating scissors bolts

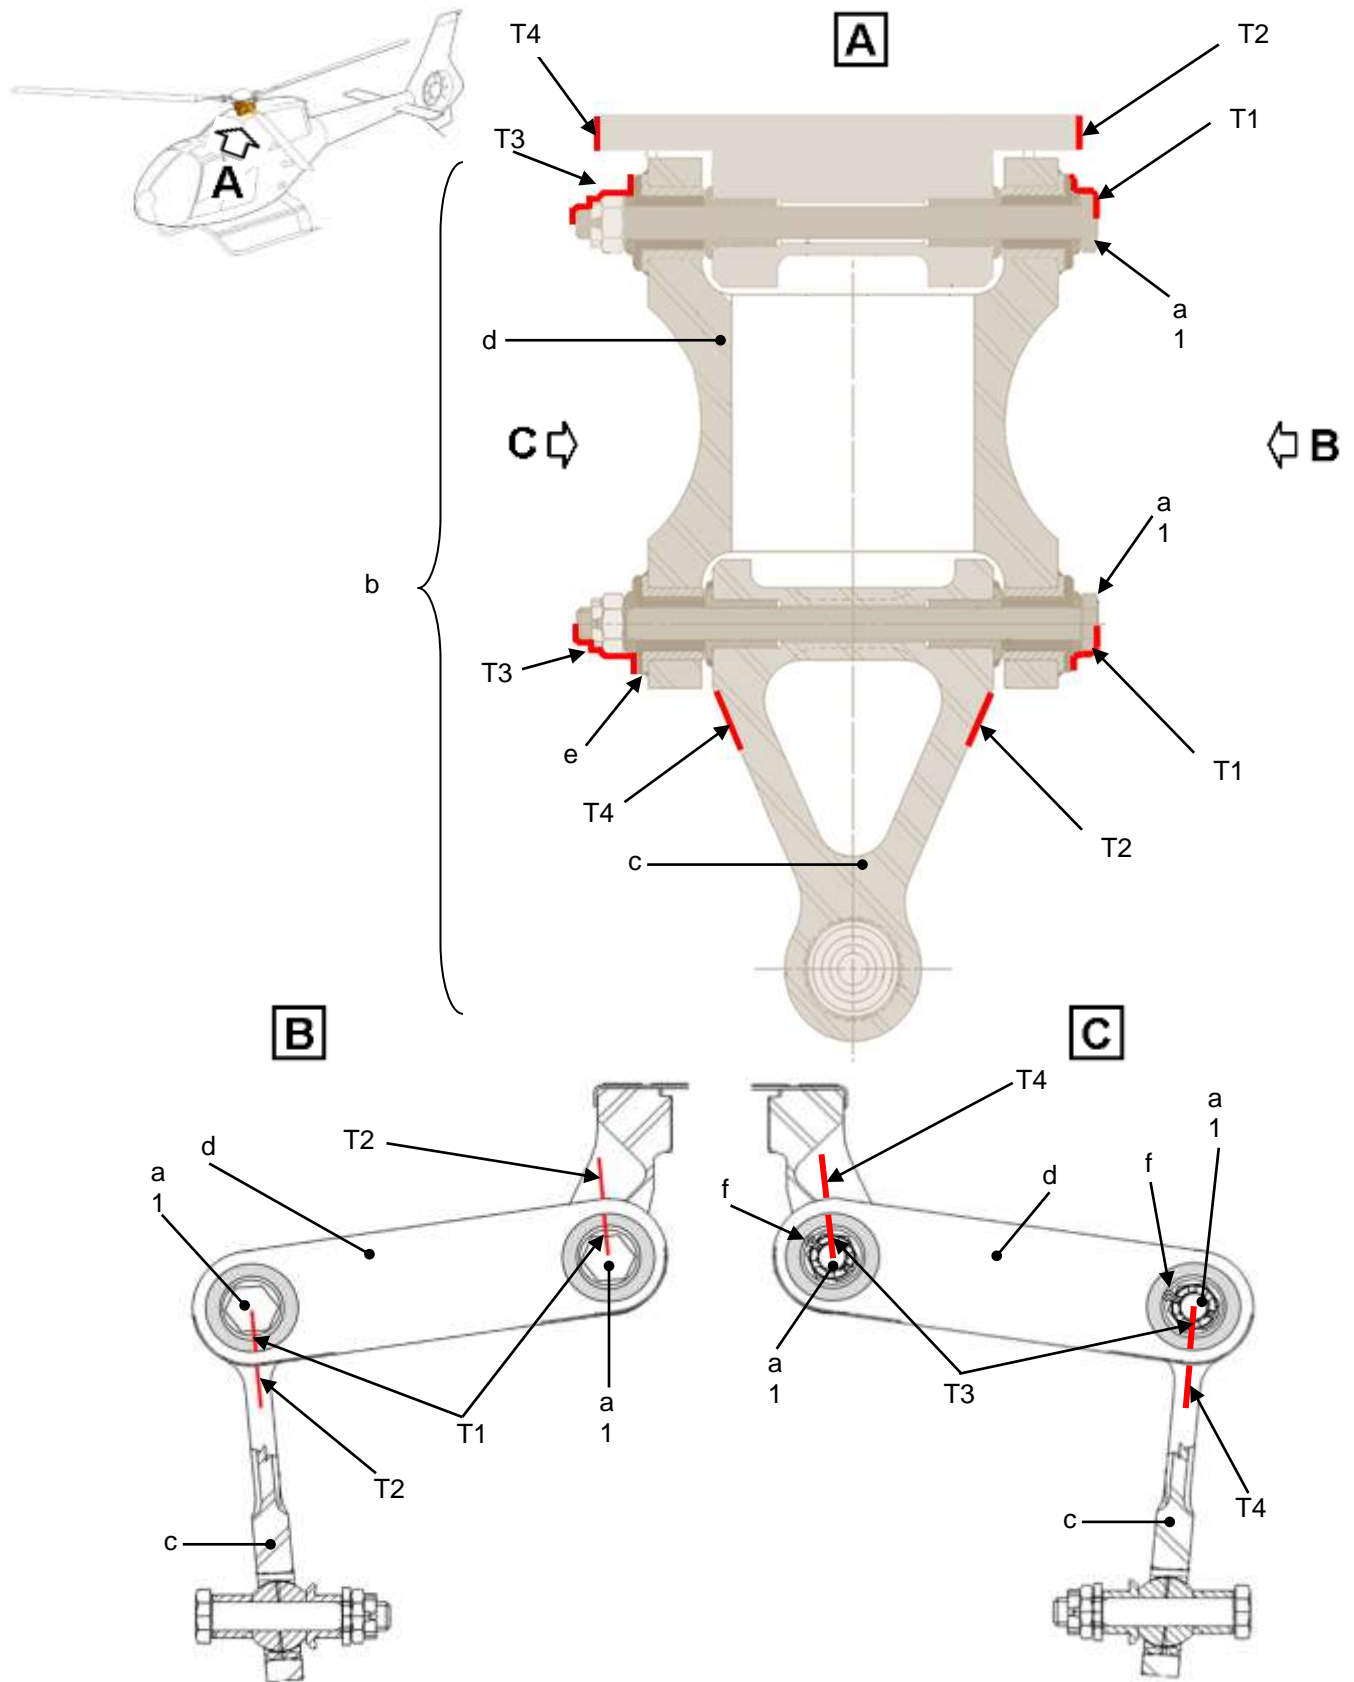
Figure 1

Draw the T1 and T2 lines with red paint on the scissors bolts as indicated in [Figure 1](#).

Draw the T3 and T4 lines with red paint on the scissors nuts as indicated in [Figure 1](#).

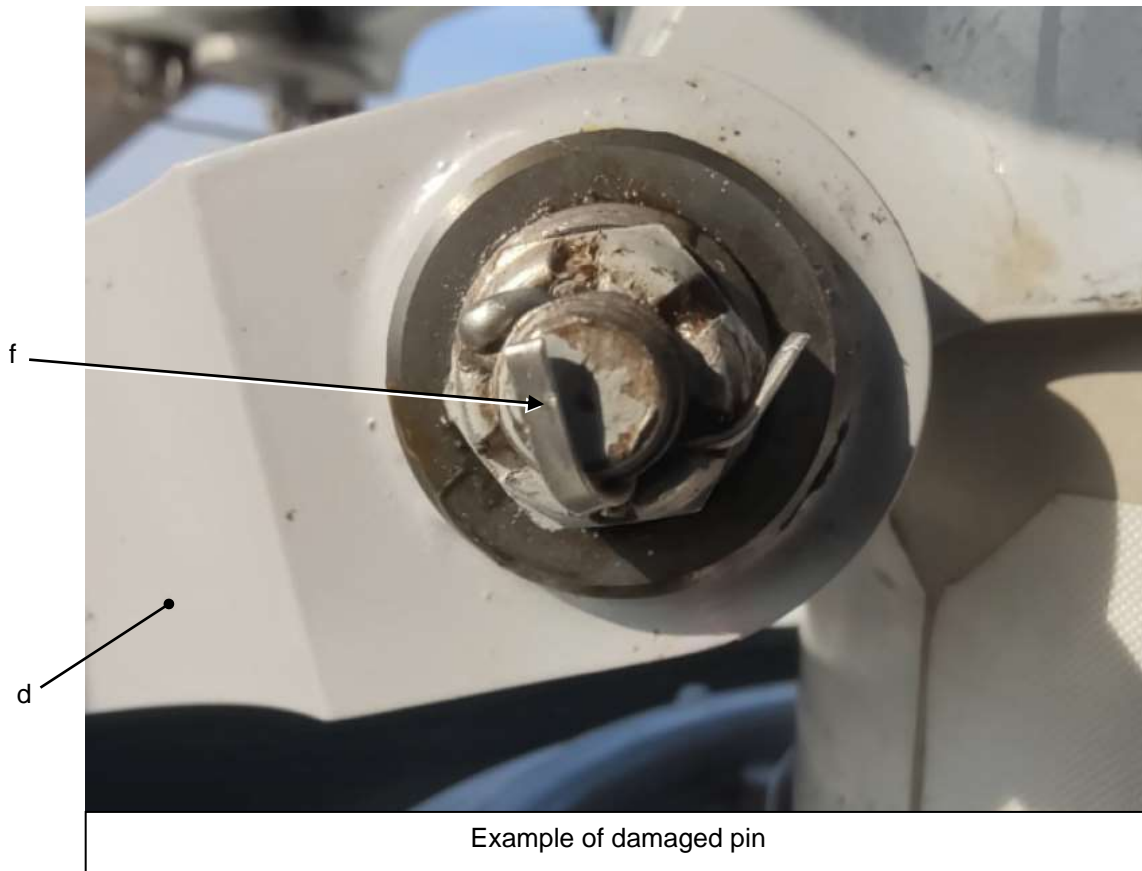
Figure 2

- If paragraph [3.B.2.b.](#) has not been complied with:
 - . Make sure that the lines T1 and T2 are aligned.
 - . Make sure that the pin (f) is in good condition (no twist, no shearing, no rupture), see example of damage on [Figure 2](#).
- If the lines T1 and T2 are aligned and the pin (f) is in good condition:
 - . Continue the flights.
- If the lines T1 and T2 are not aligned and/or the pin (f) is not in good condition:
 - . Perform a detailed inspection, on a workbench, of:
 - .. The delta-shaped scissors link (c) as per Task 62-32-00,6-1 (AMM).
 - .. The scissors link (d) as per Task 62-32-00,6-2 (AMM).
 - .. The bush (e) of the scissors link as per Task 62-32-00,6-3 (AMM).
 - . Replace the bolt(s) (a):

- . Make sure that the pin (f) is in good condition (no twist, no shearing, no rupture), see example of damage on [Figure 2](#).
 - . Make sure that the lines T3 and T4 are aligned.

- . Perform a detailed inspection, on a workbench, of:
 - .. The delta-shaped scissors link (c) as per Task 62-32-00,6-1 (AMM).
 - .. The scissors link (d) as per Task 62-32-00,6-2 (AMM).

- .. The bush (e) of the scissors link as per Task 62-32-00,6-3 (AMM).
 - . Replace the bolt(s) (a):

- .. Discard the bolt(s) (a).
- .. Install the scissors (b) using the bolt(s) (1) as per Task 62-32-00,4-1 (AMM).
- .. Check for hard points on the scissors link hinge (b) as per Task 62-32-00,6-7 (AMM).
- . Clean the existing T1 and T2 red lines.
- . Clean the existing T3 and T4 red lines.
- . Comply with paragraphs [3.B.2.a.](#) and [3.B.2.b.](#)
