No. EC120-32A014

ALERT SERVICE BULLETIN

LANDING GEAR - Landing gear
Inspection for corrosion on the landing gear

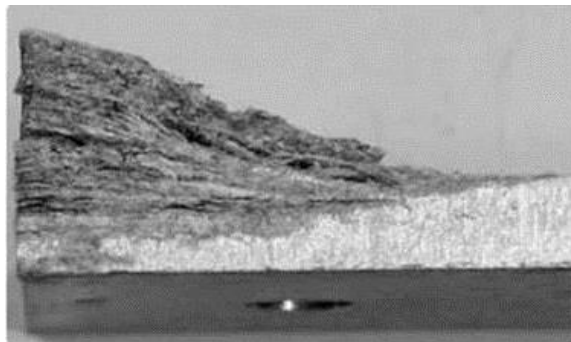
[Figure 1](#)

- If you do not find cracks and / or corrosion, or if the corrosion **is not more than** the criteria in [Table 3](#):
 - . Comply with paragraphs [3.B.3.](#) and [3.C.](#),
- If the corrosion **is more than** the criteria in [Table 3](#) or if you find cracks or leafing corrosion or exfoliant corrosion (Figures 1 and 2):
 - . Contact Airbus Helicopters at the address below to get a technical solution:
 - .. Airbus World: Technical Request Management <https://airbusworld.helicopters.airbus.com>
 - .. E-mail: support.technical-optionnal.ah@airbus.com
 - .. Fax: + 33 (0) 4 42 85 99 66

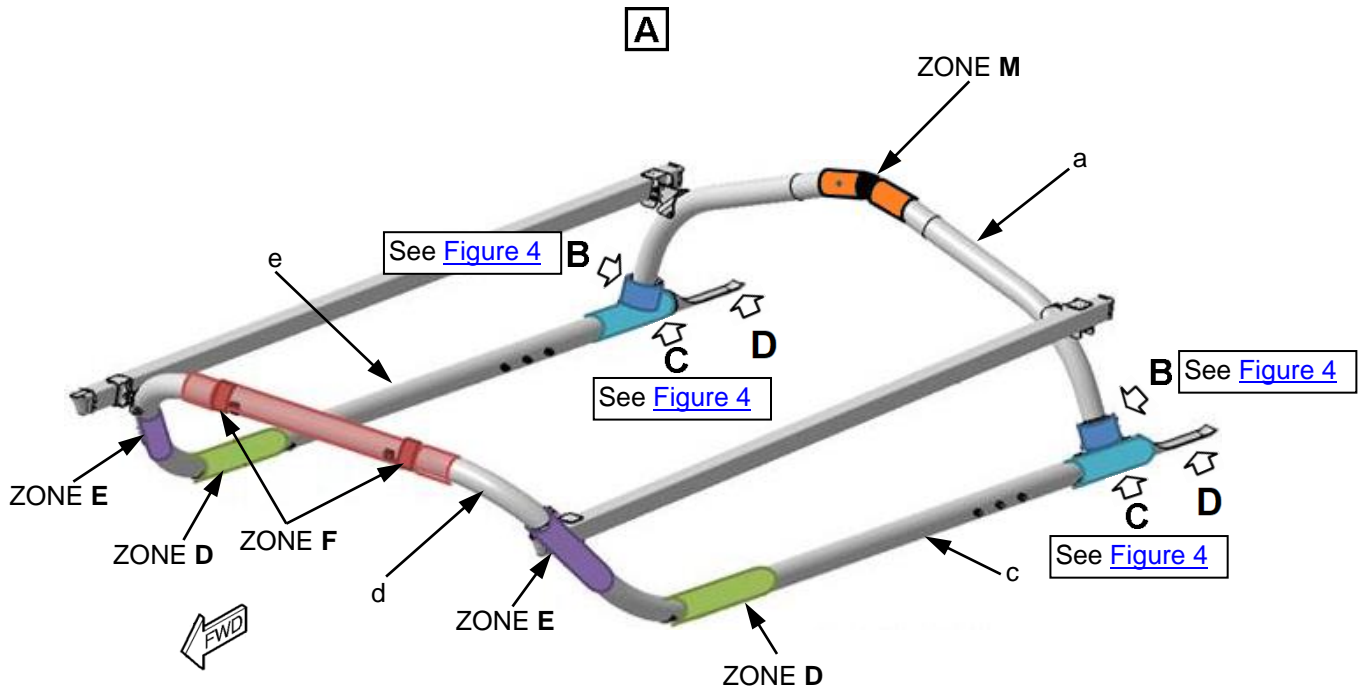
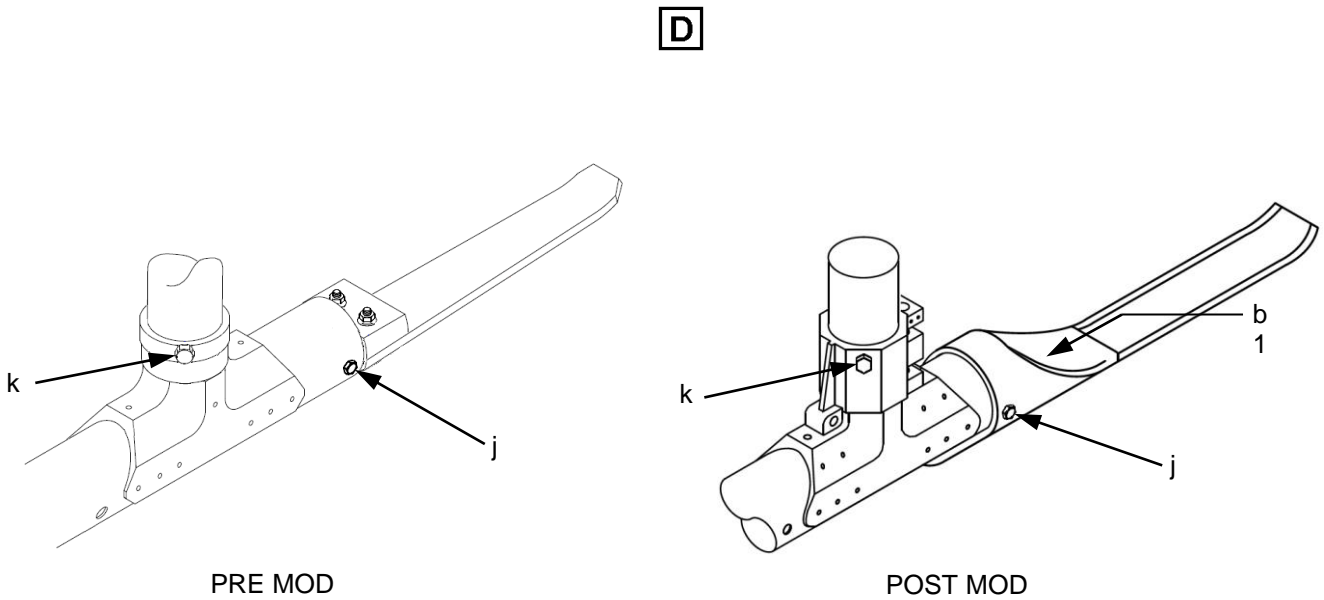
Figure 3

Zones B, C, D, E, F and M are included in the cleaning and the inspection of the landing gear tubes (a), (c), (d) and (e).

Table 3		
Zones	Location	Permitted criteria
M	Below the two half-bearings of the rear crossbeam (a).	Make sure that there is a minimum thickness of 7 mm (.275 in.).
	Over 100 mm (3.937 in.) inboard and 100 mm (3.937 in.) outboard of the clamp	
B1	On the LH/RH fitting, in the rear crossbeam (a) fitting zone, (Detail B, Figure 4).	Make sure that there is a minimum thickness of 3.4 mm (.133 in.).
B2	On the LH/RH rear crossbeam (a), in the fitting zone, (Detail B, Figure 4).	Make sure that there is a minimum thickness of 4 mm (.157 in.).
C1	On the LH/RH skid assemblies (c) and (e), (Detail C, Figure 4).	Make sure that there is a minimum thickness of 2.3 mm (.090 in.).
C2	On the fitting, in the junction zone of the LH/RH skid assemblies (c) and (e), (Detail C, Figure 4).	Make sure that there is a minimum thickness of 2.3 mm (.090 in.).
D	Zone of the LH/RH front footstep.	Make sure that there is a minimum thickness of 2.4 mm (.094 in.).

E	On the front crossbeam (d).	Make sure that there is a minimum thickness of 2.3 mm (.090 in.).
	On the LH/RH skid assembly (c).	Make sure that there is a minimum thickness of 1.9 mm (.075 in.).
F	Below the half-bearings of the front crossbeam (d).	Make sure that there is a minimum thickness of 2.9 mm (.114 in.).
	From 100 mm (3.937 in.) outboard of the LH clamp to 100 mm (3.937 in.) outboard of the RH clamp.

- Remove the landing gear fairing (not shown) from the rear crossbeam (a). Refer to Task 32-12-00, 4-1 (AMM).
- Clean the outer side of the landing gear tubes (a), (c), (d) and (e) (Detail A, [Figure 3](#)). Refer to Work Card 20-04-01-102 (MTC) and Work Card 20-04-01-402 (MTC).

- Do an external visual inspection of the landing gear tubes (a), (c), (d) and (e) to make sure that there are no cracks and no corrosion.
 - . If you find one crack:
 - .. Contact Airbus Helicopters at the address that follows to get a technical solution:
 - ... Airbus World: Technical Request Management <https://airbusworld.helicopters.airbus.com>
 - ... E-mail: support.technical-optional.ah@airbus.com
 - ... Fax: + 33 (0) 4 42 85 99 66

- . If you find any corrosion within zones C or E:
 - .. Disassemble the landing gear. Refer to Task 32-12-00, 4-2 (AMM).
 - .. Remove the corrosion from all the zones. Refer to Work Card 20-90-04-101 (MTC).
 - .. Comply with paragraph [3.B.2.b.](#)
- . If you find corrosion only within zones B, D, F or M:
 - .. Remove the corrosion from all the zones. Refer to Work Card 20-90-04-101 (MTC).
 - .. Comply with paragraph [3.B.2.b.](#)
- . If you do not find cracks or corrosion:
 - .. Comply with paragraph [3.B.2.d.](#)

- Below the collar in zones M and F ([Figure 3](#)) and in the reworked zones, apply:
 - . Chemical conversion coating (Alodine 1200) (2). Refer to Work Card 20-90-05-401 (MTC).
 - . A double layer of chromate Primer P05 (3) and Primer P20 (4). Refer to Work Card 20-04-05-101 (MTC).
- If the landing gear has not been disassembled and if rivets are loose and/or missing and if there is no corrosion evidence, replace all the missing or loose rivets. Refer to Task 32-12-00, 8-2 (AMM).
