No. EC120-32A014

ALERT SERVICE BULLETIN

LANDING GEAR - Landing gear Inspection for corrosion on the landing gear

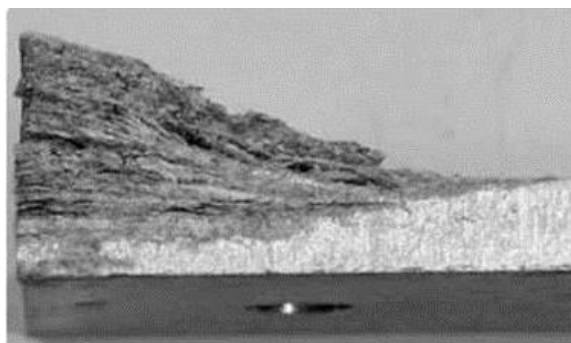
[Figure 1](#)

- On the rear crossbeam, at the clamp position
- On the rear junction fitting between the skid and the rear crossbeam
- In the splicing area between the front crossbeam and the skid.

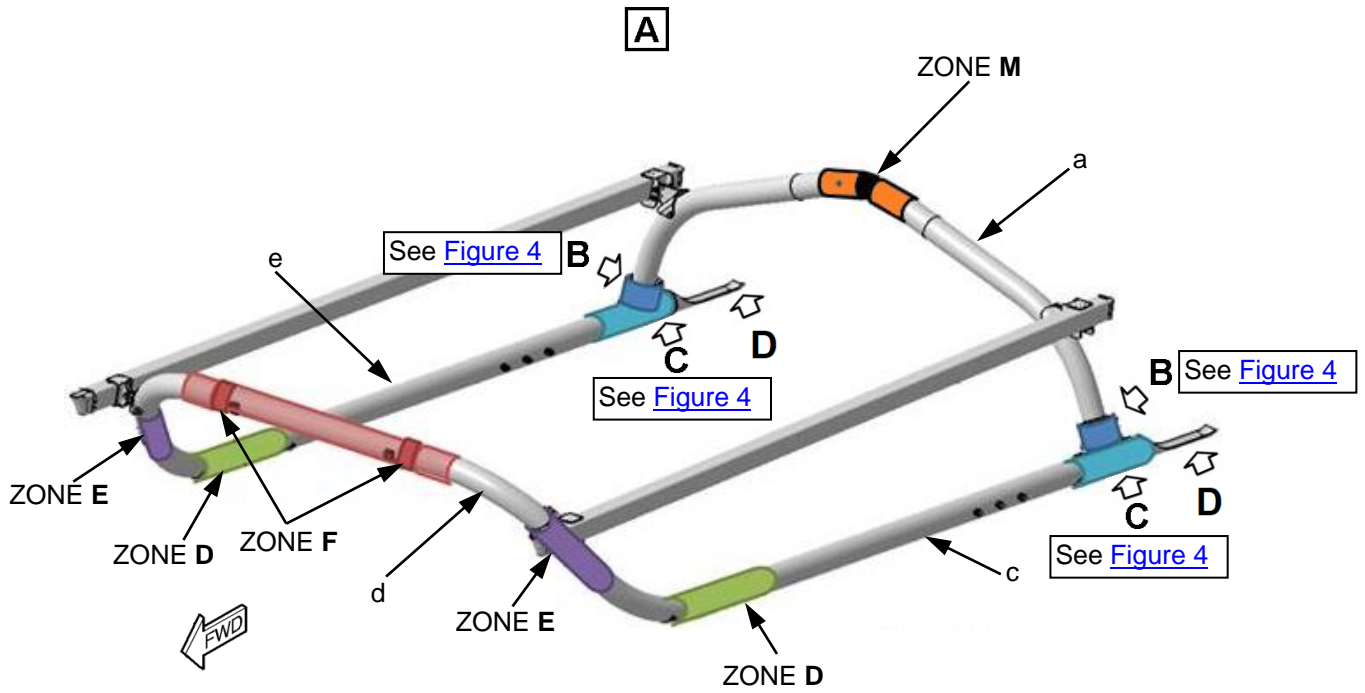
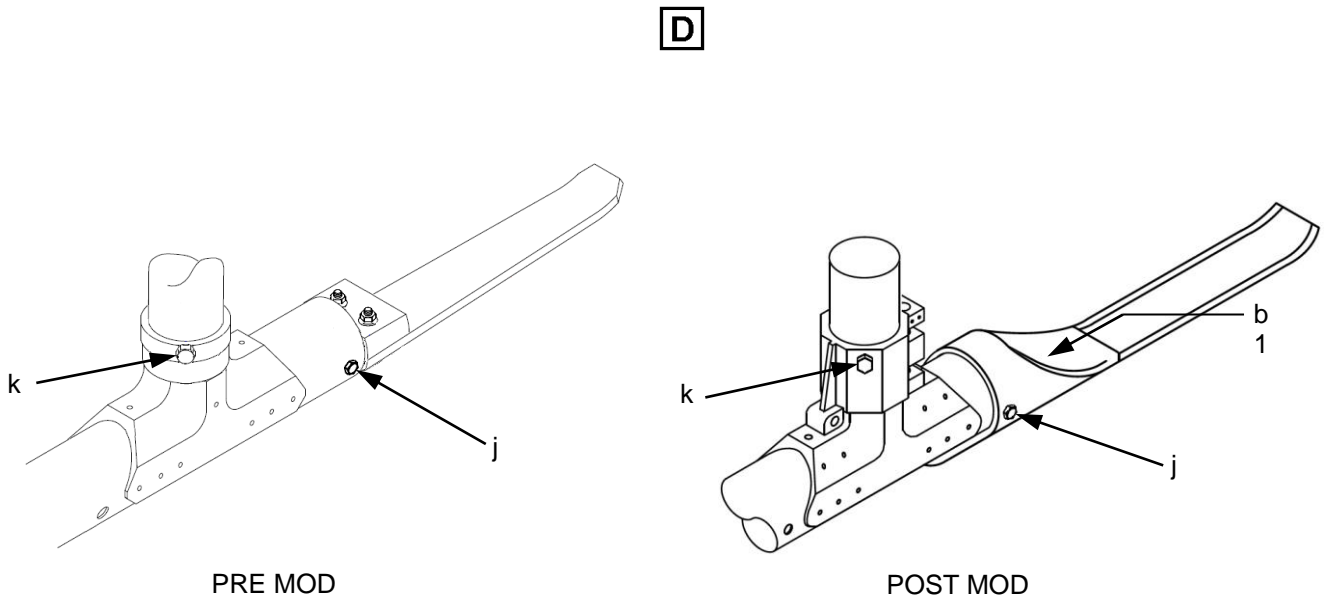
Figure 3

Zones B, C, D, E, F and M are included in the cleaning and the inspection of the landing gear tubes (a), (c), (d) and (e).

- With the borescope (zz), examine the inner side of the landing gear tubes (a), (c), (d) and (e) for corrosion and cracks. Refer to Detail A, [Figure 3](#), and the criteria of [Table 3](#).

- . If you find any corrosion within zones C or E:
 - .. Disassemble the landing gear. Refer to Task 32-12-00, 4-2 (AMM).
 - .. Remove the corrosion from all the zones. Refer to Work Card 20-90-04-101 (MTC).
- . If you find corrosion only within zones B, D, F or M:
 - .. Remove the corrosion from all the zones. Refer to Work Card 20-90-04-101 (MTC).
- . Then, in all cases, comply with paragraph 3.B.2.b.

- . If you find any corrosion within zones C or E:
 - .. Disassemble the landing gear. Refer to Task 32-12-00, 4-2 (AMM).
 - .. Remove the corrosion from all the zones. Refer to Work Card 20-90-04-101 (MTC).
 - .. Comply with paragraph [3.B.2.c](#).
- . If you find corrosion only within zones B, D, F or M:
 - .. Remove the corrosion from all the zones. Refer to Work Card 20-90-04-101 (MTC).
 - .. Comply with paragraph [3.B.2.c](#).
- . If you do not find external nor internal corrosion nor cracks:
 - .. Install the screws (j) or the blanking cap assembly (b) or (1) and the screw (k). Refer to Task 32-12-00, 4-2 (AMM) (Detail D, [Figure 3](#)).
 - .. Comply with paragraph [3.B.2.d](#).

- Below the collar in zones M and F ([Figure 3](#)) and in the reworked zones, apply:
 - . Chemical conversion coating (Alodine 1200) (2). Refer to Work Card 20-90-05-401 (MTC).

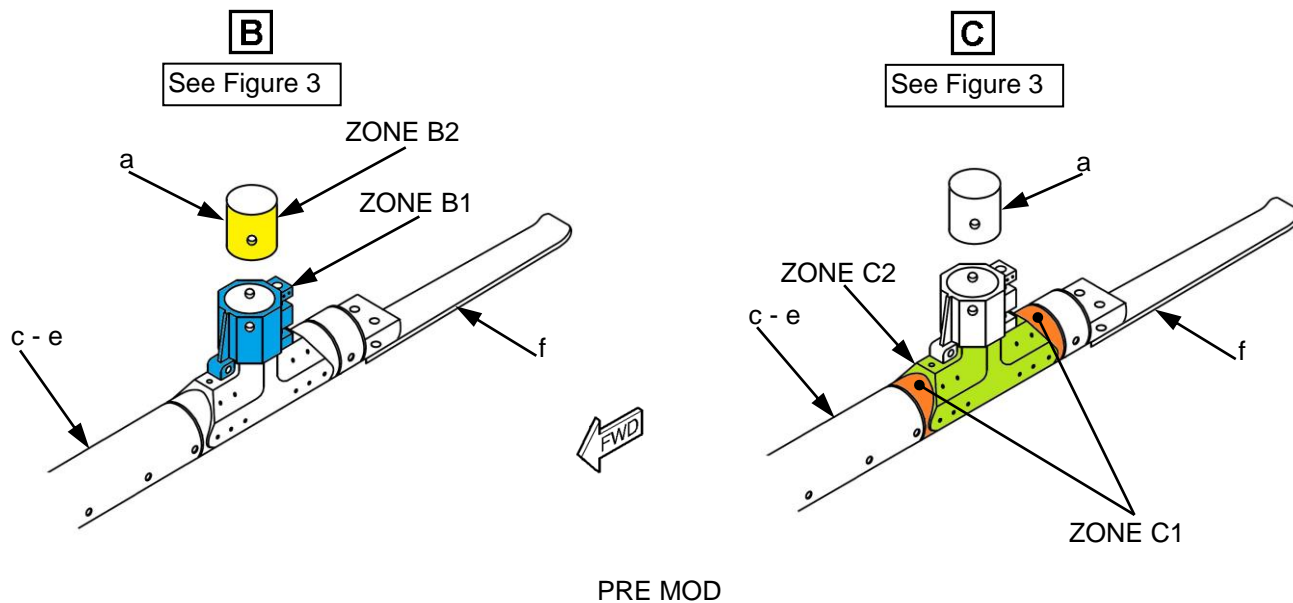
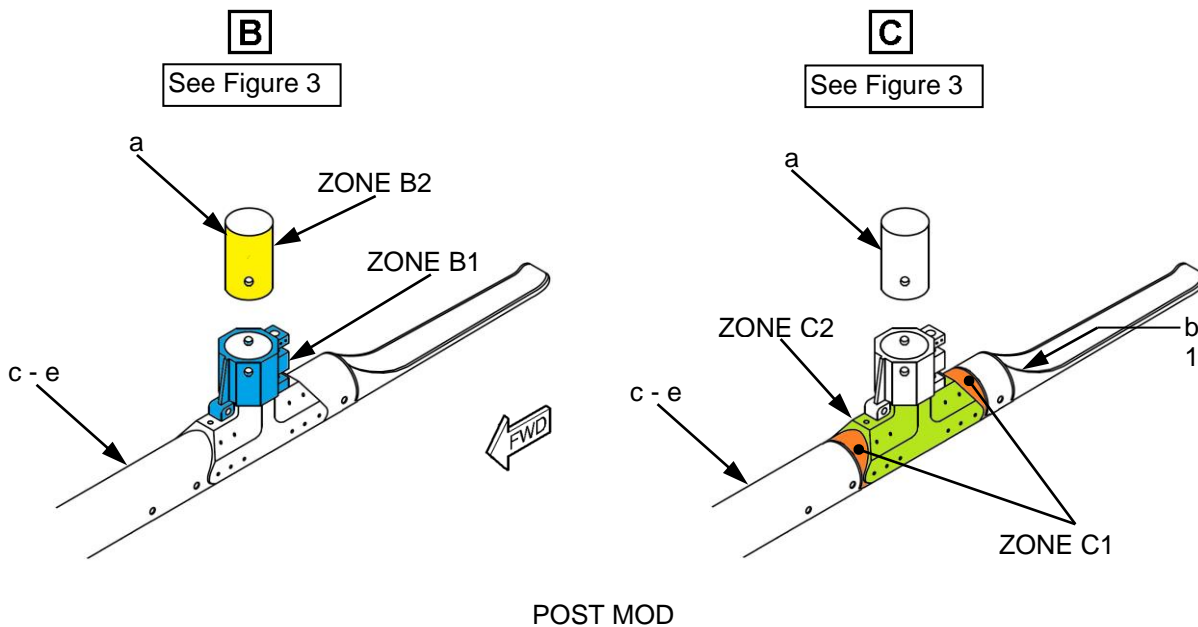
Figure 4

Table 3		
Zones	Location	Permitted criteria
M	Below the two half-bearings of the rear crossbeam (a).	Make sure that there is a minimum thickness of 7 mm (.275 in.).
	Over 100 mm (3.937 in.) inboard and 100 mm (3.937 in.) outboard of the clamp	
B1	On the LH/RH fitting, in the rear crossbeam (a) fitting zone, (Detail B, Figure 4).	Make sure that there is a minimum thickness of 3.4 mm (.133 in.).
B2	On the LH/RH rear crossbeam (a), in the fitting zone, (Detail B, Figure 4).	Make sure that there is a minimum thickness of 4 mm (.157 in.).
C1	On the LH/RH skid assemblies (c) and (e), (Detail C, Figure 4).	Make sure that there is a minimum thickness of 2.3 mm (.090 in.).
C2	On the fitting, in the junction zone of the LH/RH skid assemblies (c) and (e), (Detail C, Figure 4).	Make sure that there is a minimum thickness of 2.3 mm (.090 in.).
D	Zone of the LH/RH front footstep.	Make sure that there is a minimum thickness of 2.4 mm (.094 in.).

E	On the front crossbeam (d).	Make sure that there is a minimum thickness of 2.3 mm (.090 in.).
	On the LH/RH skid assembly (c).	Make sure that there is a minimum thickness of 1.9 mm (.075 in.).
F	Below the half-bearings of the front crossbeam (d).	Make sure that there is a minimum thickness of 2.9 mm (.114 in.).
	From 100 mm (3.937 in.) outboard of the LH clamp to 100 mm (3.937 in.) outboard of the RH clamp.

- If the corrosion **is not more than** the criteria in [Table 3](#):
 - . Comply with paragraph [3.B.2.d](#).
- If the corrosion **is more than** the criteria in [Table 3](#):
 - . Contact Airbus Helicopters at the address below to get a technical solution:
 - .. Airbus World: Technical Request Management <https://airbusworld.helicopters.airbus.com>
 - .. E-mail: support.technical-optionnal.ah@airbus.com
 - .. Fax: + 33 (0) 4 42 85 99 66
