**No. EC120-53A015**

# ALERT SERVICE BULLETIN

### FUSELAGE - TAIL BOOM

#### Corrosion on the tail boom

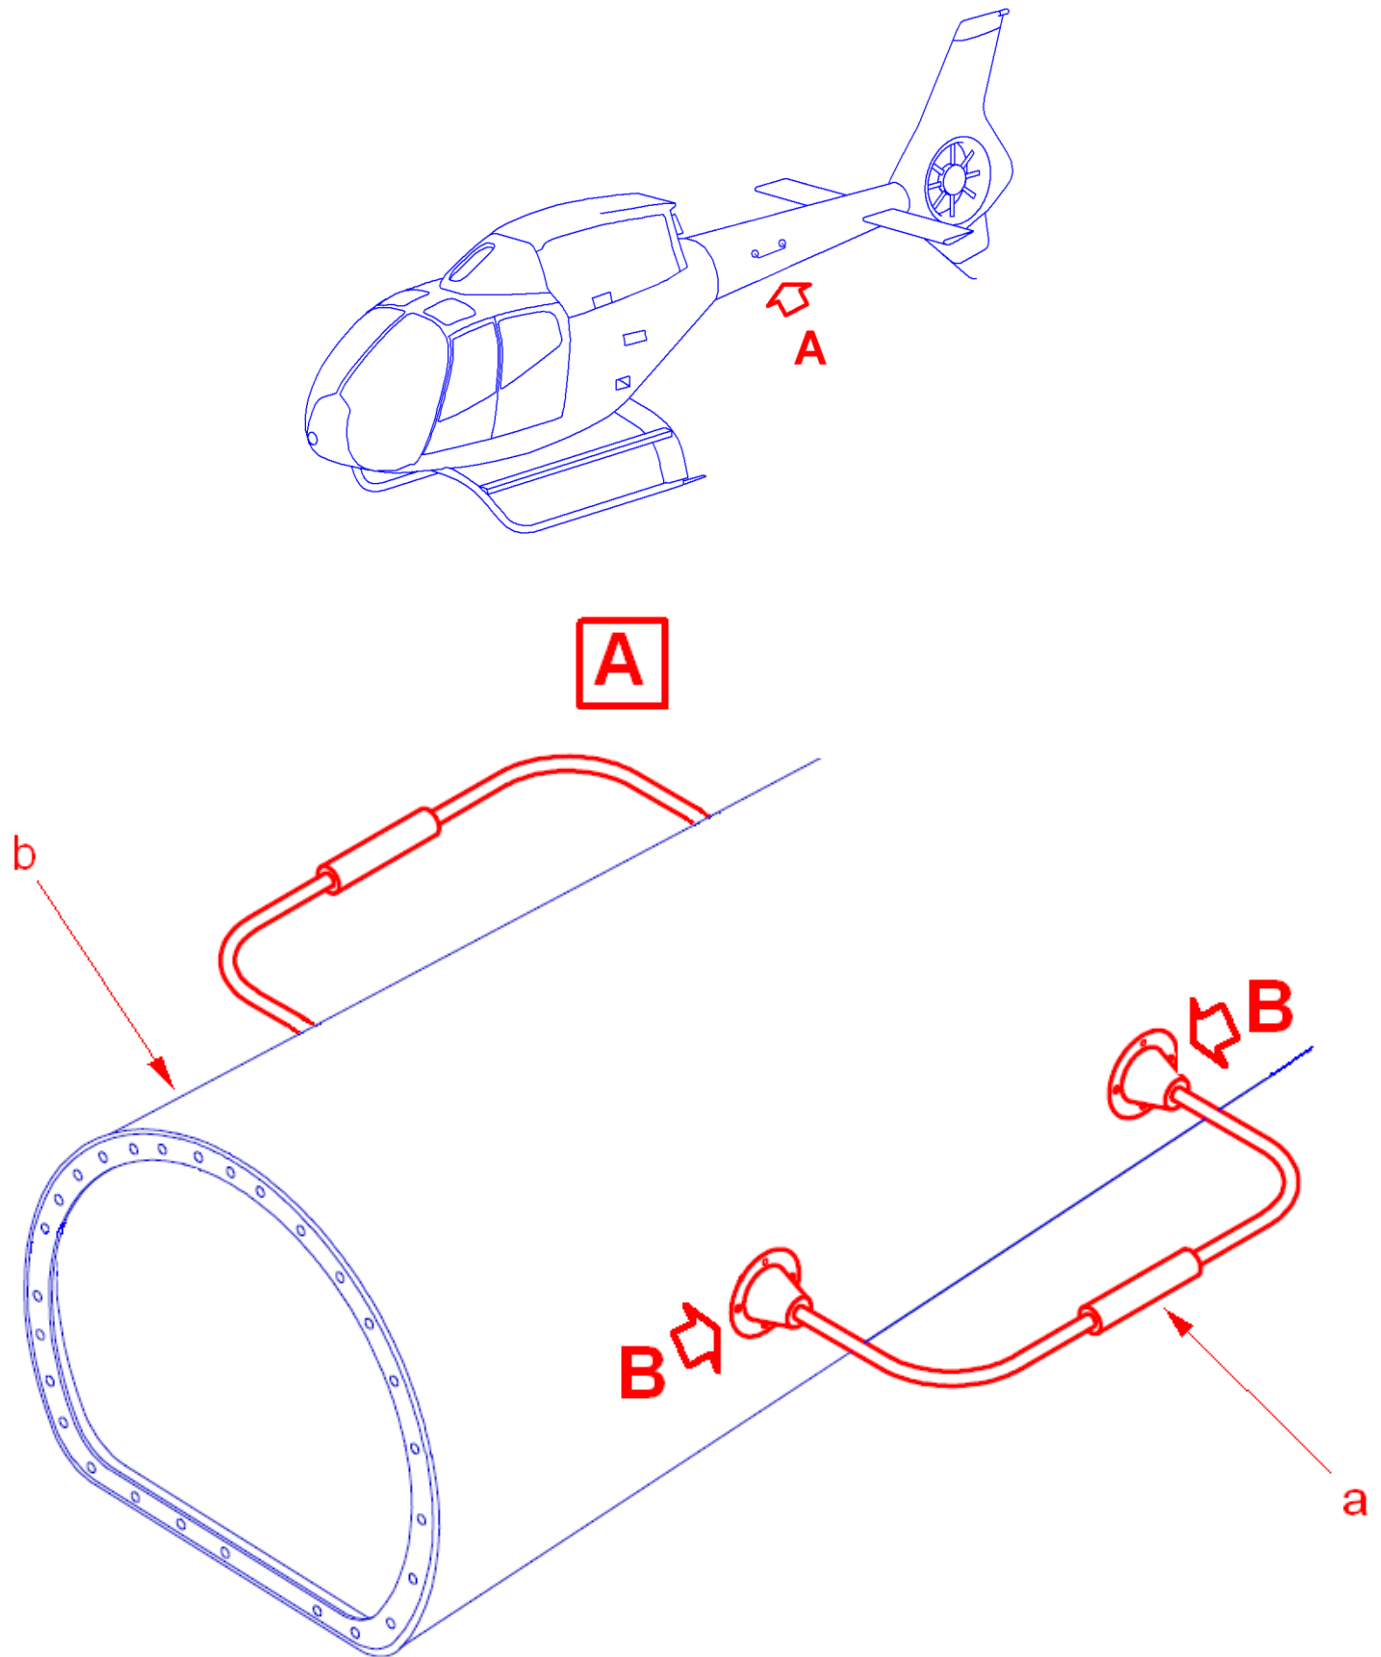
Figure 1

##### 3.B.2.a. Check for corrosion and cracks under the LH VOR antenna mounting bases or blanks (Figure 1)

- Remove the antennas (a), if installed, or the blanks installed in place of the VOR antennas, as per AMM Task 34-55-02, 4-1 (Figure 1).
- Clean the areas (b).
- Make sure that:
  - . there is no aluminum oxide (white powder) on the VOR antenna attachment screws (c), on the skin and at the screw holes (d).
  - . that there are no cracks on the skin at the VOR antenna attachment screw holes (d). If in doubt, carry out a dye-penetrant inspection as per AMM Task 20-10-00, 3-19.

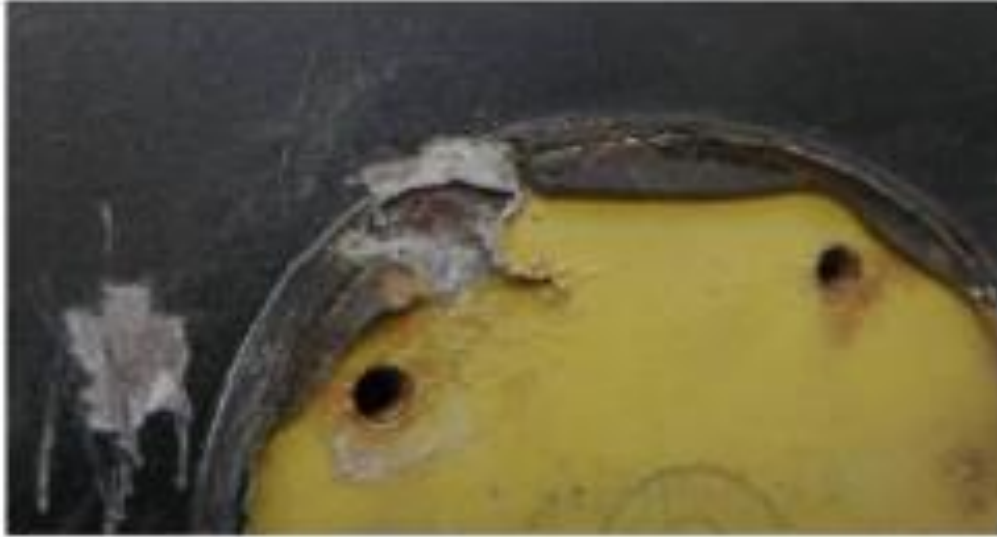
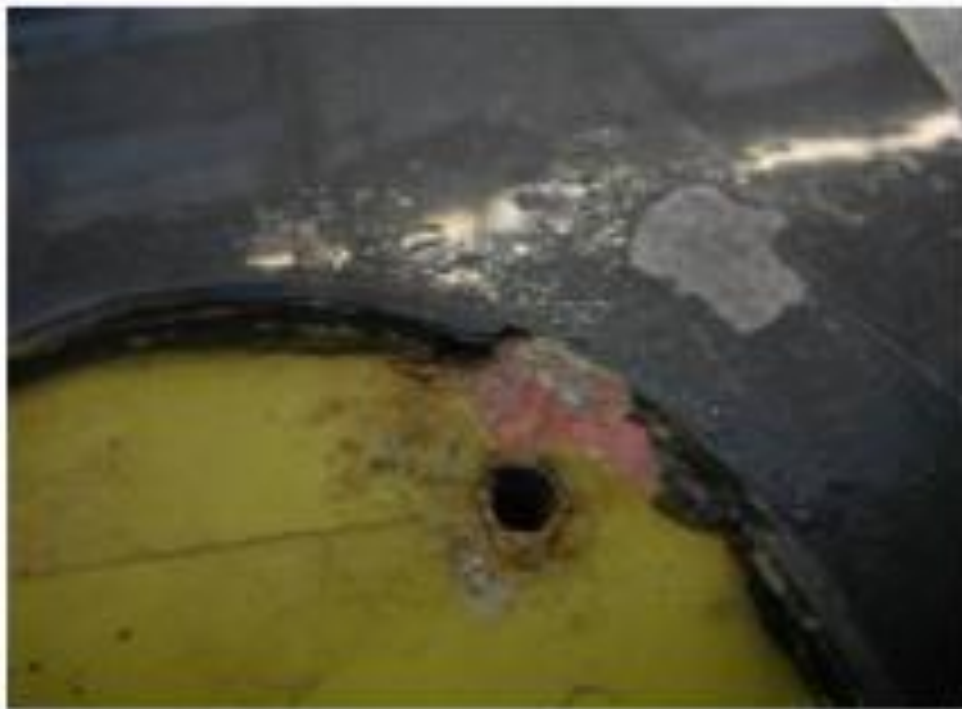
Figure 3 (Examples of corrosion)

Corrosion and cracks were found on the external tail boom skin, at the attachments of the LH and RH VOR antennas (Figures 3 and 4).

This galvanic type corrosion is due to:

- contact between the aluminum skin and the stainless steel antenna attachment inserts,
- a lack of protection.

If this corrosion is not detected, the tail boom can be subject to buckling in certain flight configurations.

##### 3.B.2.a.1. Presence of corrosion and/or cracks (Figures 3 and 4)

- Contact Airbus Helicopters at the following address:
  - Tel.: + 33 (0)4.42.85.97.89
  - Fax: + 33 (0)4.42.85.99.66
  - E-mail: [Airframe.Technical-Support@airbus.com](mailto:Airframe.Technical-Support@airbus.com)

And comply with Service Bulletin No. 53-016.
