No. EC120-53A017

ALERT SERVICE BULLETIN

FUSELAGE - Rear Fuselage Corrosion on the tail boom

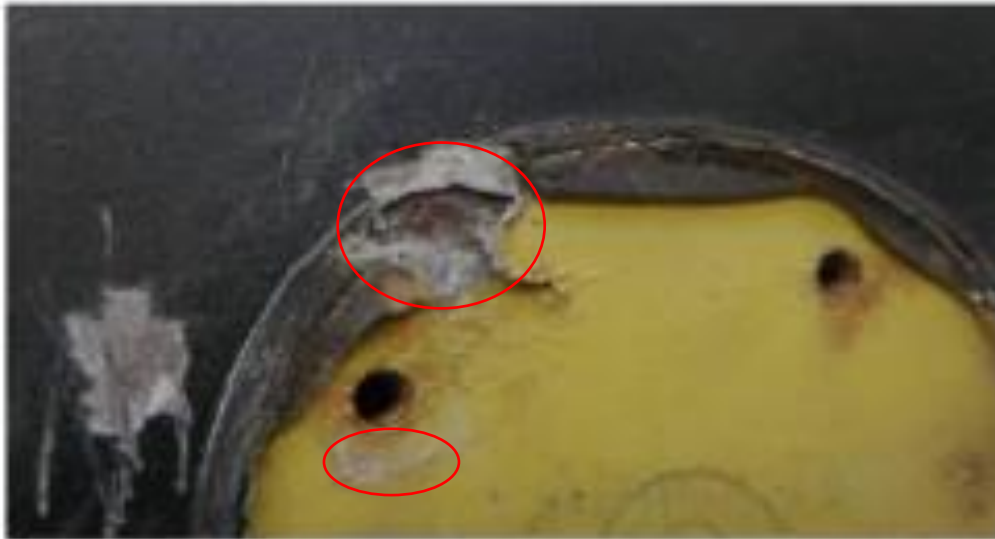
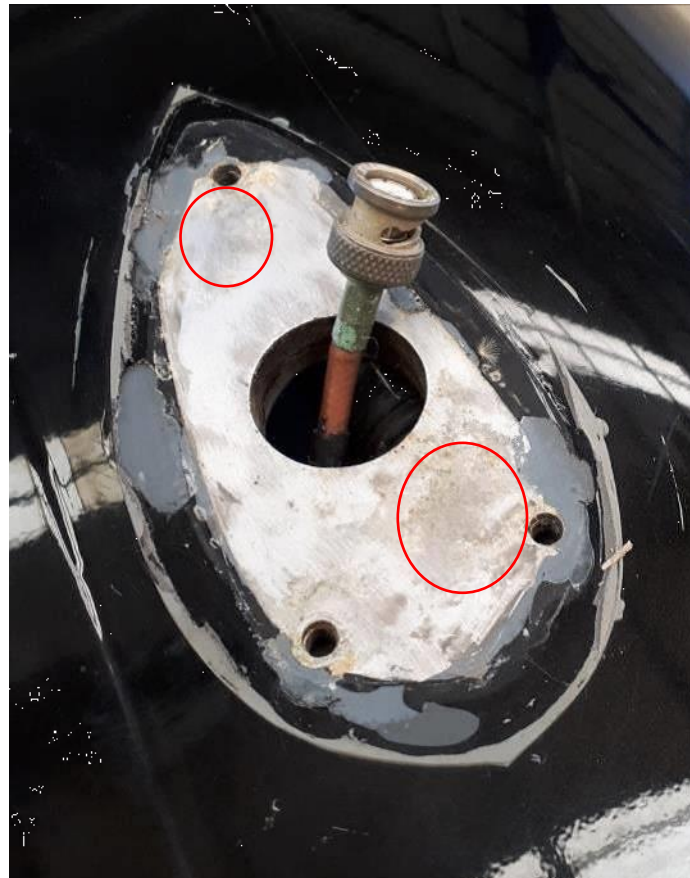
Figure 1

Corrosion was found on the external tail boom skin, under the VHF antenna ([Figure 1](#)).

This galvanic type corrosion is due to:

- a contact between the aluminium skin and the stainless steel antenna attachment inserts,
- the protection which is not sufficient.

Corrosion propagation cannot be detected without removing the VHF antenna and requires thorough inspection.

If this corrosion is not detected, the tail boom can undergo to buckling during severe landing.

Example of corrosion and aluminium oxide
