# ALERT SERVICE BULLETIN

**TITLE:** Rotor Head - Addition of paint lines to each side of the tail rotor hub body and splined flange assembly for visual inspection of tightening torque

| Model: | EC120 |

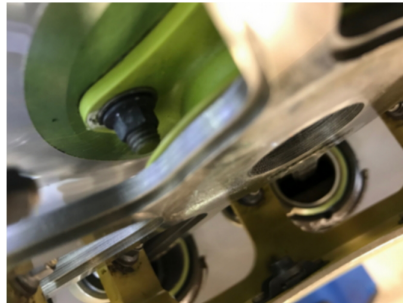
BEFORE MODIFICATION

Following the loss of tightening torque of the links between the hub and the splined flange of the tail rotor, EASB EC120-05A020 was issued requesting an inspection of the hub every 15 FH. This ALERT SERVICE BULLETIN adds a line of red paint on each bolt and each nut of the link between tail hub and splined flange. This will allow the visual detection during maintenance of any tightening torque loss. Compliance with this ALERT SERVICE BULLETIN is the starting point of the new inspection interval in accordance with the latest ALS and thus cancels the instructions introduced in EASB EC120-05A020 for helicopters with installed equipment or parts.

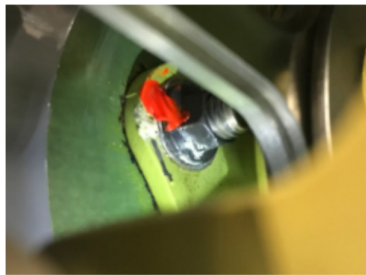
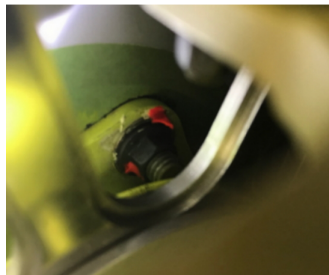
AFTER MODIFICATION

The objective of this ALERT SERVICE BULLETIN is to add red paint marks on both sides of the link between the tail rotor hub and the splined flange, on each bolt and each nut after application of the tightening torque. This will enable the detection of any loss of tightening torque during visual inspections.
