No. EC155-04A014

ALERT SERVICE BULLETIN

LIMITATIONS - Control rod double bearing Tail Gearbox (TGB)

ATA: 65

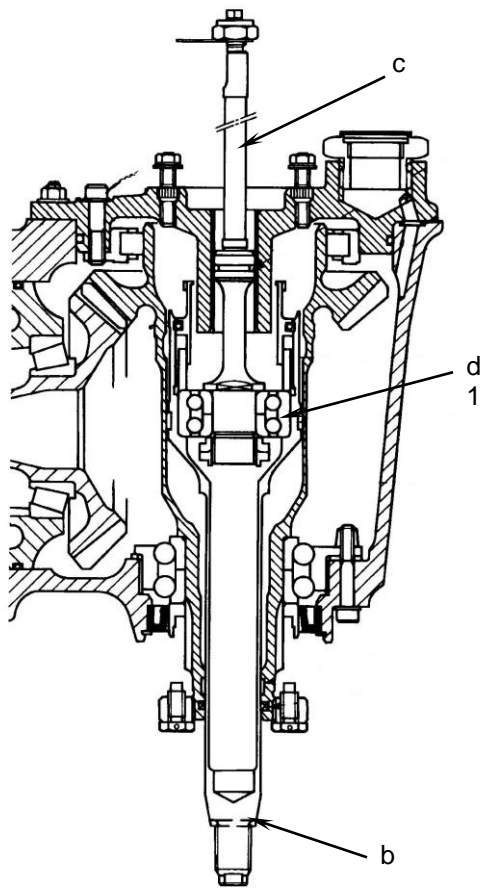
DETAIL B

- Clean the control shaft/rod assembly using WHITE SPIRIT (2) as per Work Card 20-04-01-102 (MTC):
 - 1) Inject WHITE SPIRIT (2) under pressure (for example using a can) into hole (a) of control shaft (b). (**See [DETAIL B Figure 2](#)**).

- . Hold shaft (b) in the vertical position pointing upwards.
 - . Manually turn control rod (c) several times to rinse double bearing (d) by draining the WHITE SPIRIT (2) through the bearing. (**See [Detail B Figure 2](#)**).

. If there are magnetic particles or magnetic abrasion dust:

- . Replace double bearing (d) with a double bearing (1) as per AMM Task 65-20-01-961.
- . Install the control shaft/rod assembly as per paragraph [3.B.4.b.](#)
- . **Inform the Airbus Helicopters Customer Service Technical Support Department in accordance with paragraph [2.B.](#)**
- . **Comply with paragraph [2.D.](#)**

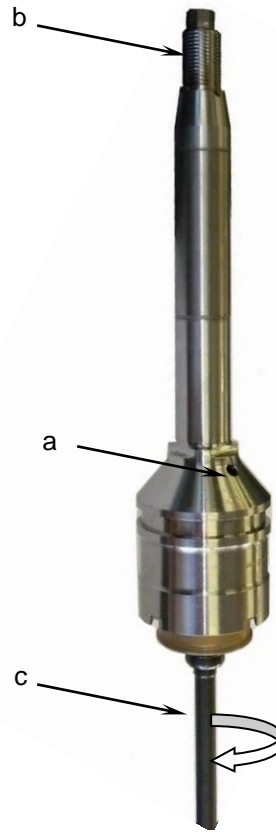
DETAIL A

- Remove the control shaft/rod assembly as per paragraph 3.B.4.a.
- Carry out a tactile check to ensure that there is no axial play in double bearing (d) (Figure 1):
 - . Apply an alternating manual axial load to control rod (c) whilst turning control shaft (b) (**See [DETAIL A Figure 2](#)**).

3.B.3.b. If play is felt:

- Replace double bearing (d) (Figure 2) with a double bearing (1) as per AMM Task 65-20-01-961.
- Install the control shaft/rod assembly as per paragraph 3.B.4.b.:
- . **Inform the Airbus Helicopters Customer Service Technical Support Department in accordance with paragraph 2.B.**
- . **Comply with paragraph 2.D.**
