No. EC155-04A014

ALERT SERVICE BULLETIN

LIMITATIONS - Control rod double bearing Tail Gearbox (TGB)

ATA: 65

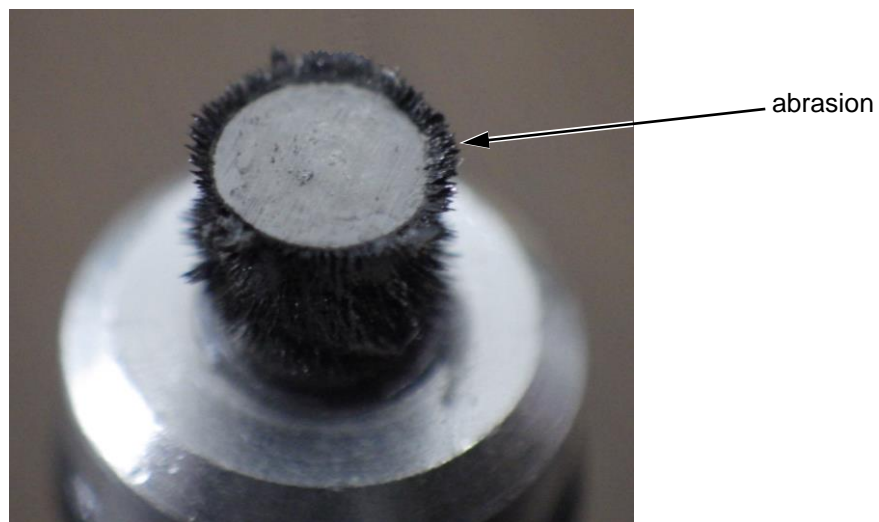
IN THE FLOW CHART, THE ABRASION PARTICLES (CLASS g AS PER MTC) MUST BE TAKEN INTO ACCOUNT IN ADDITION TO THE PARTICLE TYPES USUALLY TAKEN INTO ACCOUNT.

Figure 1: Example of abrasion on the magnetic plug

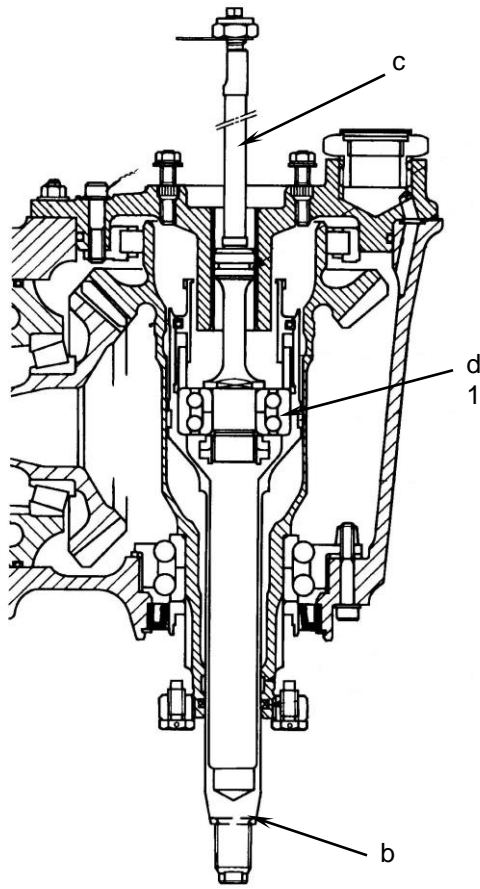
DETAIL B

- Clean the control shaft/rod assembly using WHITE SPIRIT (2) as per Work Card 20-04-01-102 (MTC):
 - 1) Inject WHITE SPIRIT (2) under pressure (for example using a can) into hole (a) of control shaft (b). (**See [DETAIL B Figure 2](#)**).

- . Hold shaft (b) in the vertical position pointing upwards.
 - . Manually turn control rod (c) several times to rinse double bearing (d) by draining the WHITE SPIRIT (2) through the bearing. (**See [Detail B Figure 2](#)**).

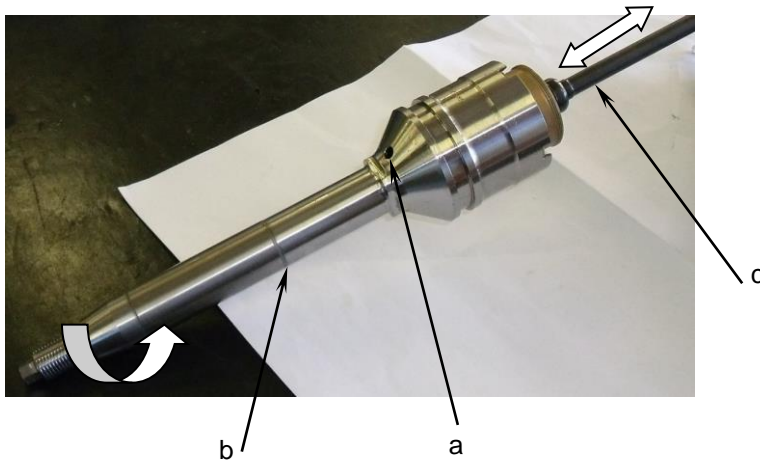
DETAIL C

- 2) Insert WHITE SPIRIT (2) (for example using a can) in the area of the control shaft (b) that must be cleaned. (**See [DETAIL C Figure 2](#)**).
 - . Manually turn the control rod (c) several times to wash the double bearing (d) by draining the WHITE SPIRIT (2).

Make sure that the area pointed out in [DETAIL C Figure 2](#) is clean.
