No. EC155-04A014

Civil version(s): B, B1

ALERT SERVICE BULLETIN

LIMITATIONS - Control rod double bearing Tail Gearbox (TGB)

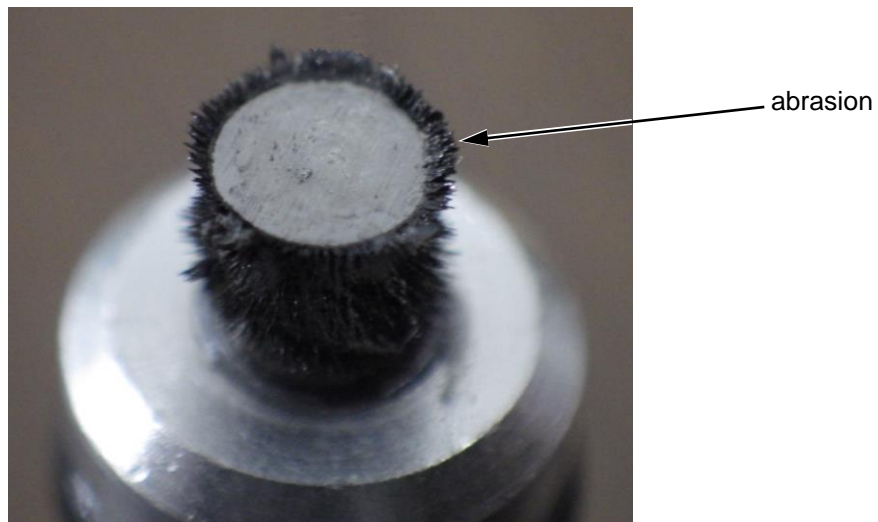
Figure 1: Example of abrasion on the magnetic plug

IN THE FLOW CHART, THE ABRASION PARTICLES (CLASS g AS PER MTC) MUST BE TAKEN INTO ACCOUNT IN ADDITION TO THE PARTICLE TYPES USUALLY TAKEN INTO ACCOUNT.

In this special case, abrasion-type particles (class g as per MTC) must be taken into account.

Are there **abrasion** (as per example in Figure 1)/scale/chip/splinter type particles or particles different from cotter pins, lockwire, swarf, various non-metallic debris ?**

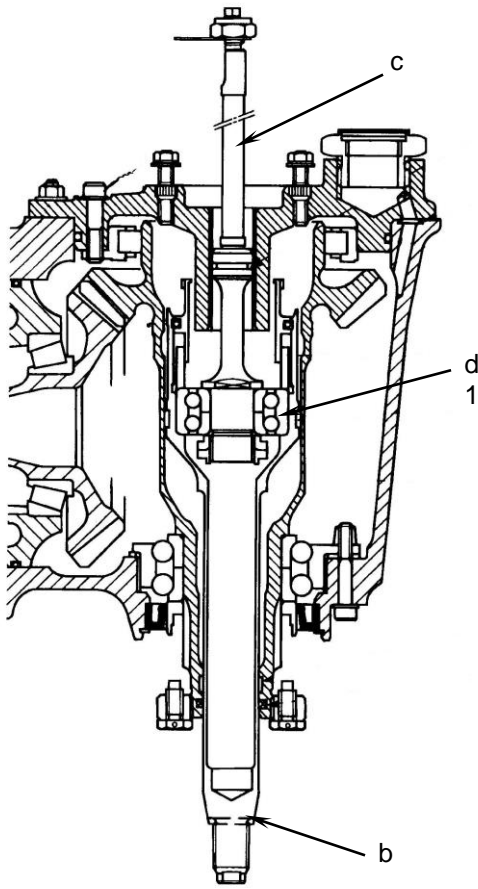
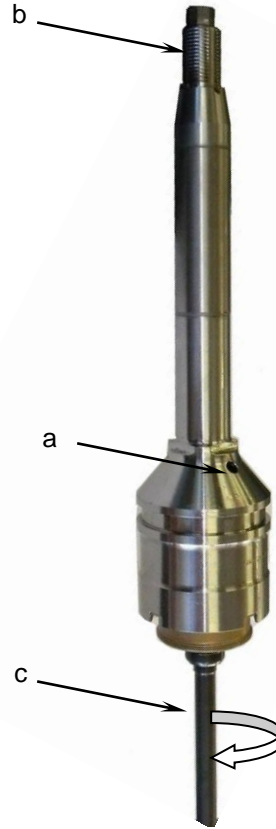
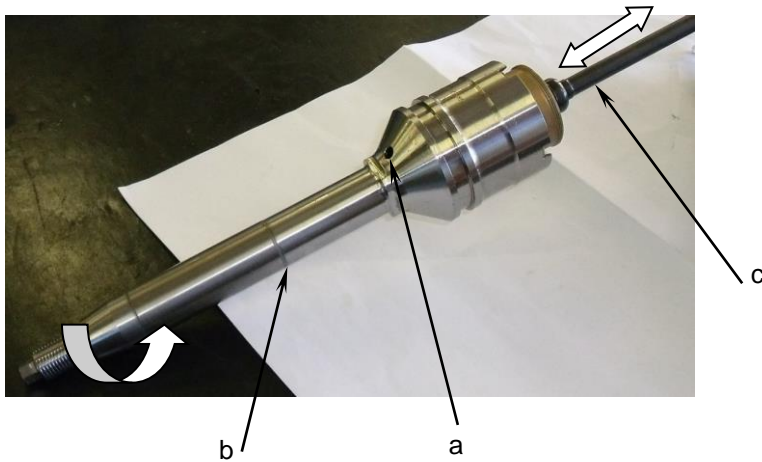
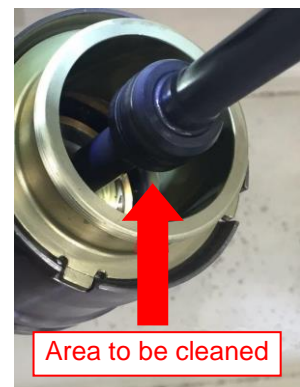
Figure 2

3.B.3. Checking the play in the double bearing of the TGB control shaft/rod assembly ([Figure 2](#))

- Replace double bearing (d) (Figure 2) with a double bearing (1) as per AMM Task 65-20-01-961.
- Install the control shaft/rod assembly as per paragraph 3.B.4.b.:
- . **Inform the Airbus Helicopters Customer Service Technical Support Department in accordance with paragraph 2.B.**
- . **Comply with paragraph 2.D.**
