No. EC155-04A014

ALERT SERVICE BULLETIN

LIMITATIONS - Control rod double bearing Tail Gearbox (TGB)

ATA: 65

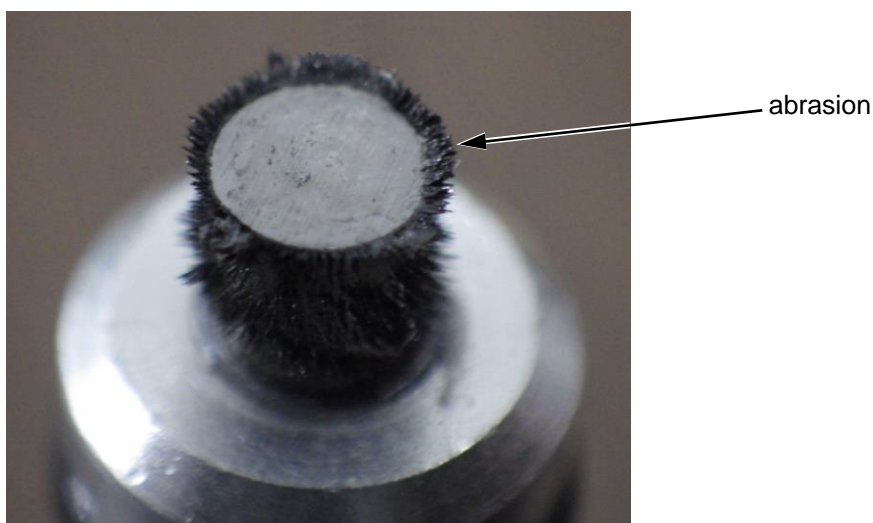
Figure 1: Example of abrasion on the magnetic plug

IN THE FLOW CHART, THE ABRASION PARTICLES (CLASS g AS PER MTC) MUST BE TAKEN INTO ACCOUNT IN ADDITION TO THE PARTICLE TYPES USUALLY TAKEN INTO ACCOUNT.

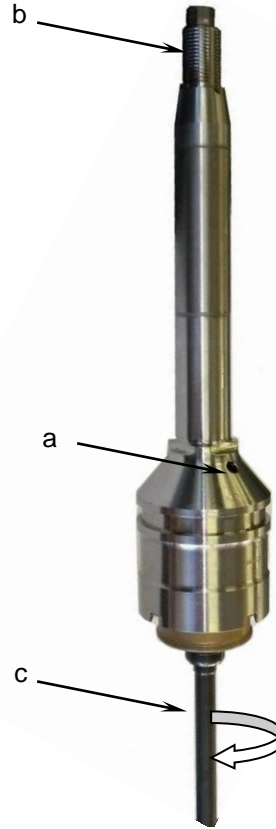
DETAIL A

- Remove the control shaft/rod assembly as per paragraph 3.B.4.a.
- Carry out a tactile check to ensure that there is no axial play in double bearing (d) (Figure 1):
 - . Apply an alternating manual axial load to control rod (c) whilst turning control shaft (b) (**See [DETAIL A Figure 2](#)**).

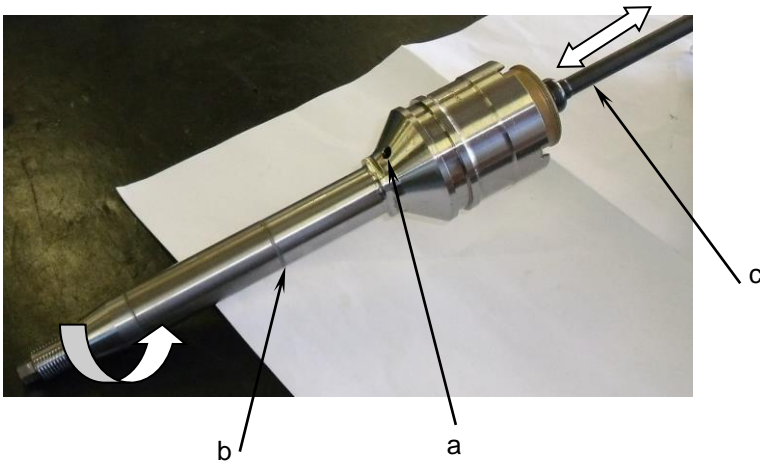
DETAIL C

Make sure that the area pointed out in [DETAIL C Figure 2](#) is clean.

- 2) Insert WHITE SPIRIT (2) (for example using a can) in the area of the control shaft (b) that must be cleaned. (**See [DETAIL C Figure 2](#)**).
 - . Manually turn the control rod (c) several times to wash the double bearing (d) by draining the WHITE SPIRIT (2).
