No. EC155-25A157

ALERT SERVICE BULLETIN

EQUIPMENT AND FURNISHING - Electrical Hoist Complementary maintenance of the electrical hoist

This ALERT SERVICE BULLETIN provides complements to 2nd level maintenance operations to prevent damage to the winding screw and guide pin due to pollution for the hoist P/N 76378-XXX.

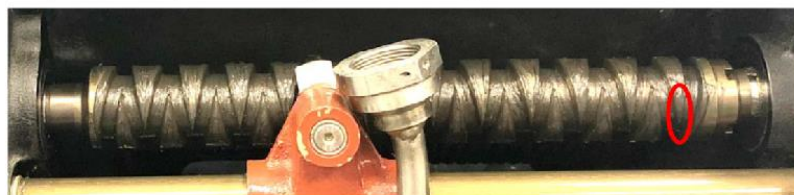
Figure 1

A 76368-240-D hoist jam occurred due to premature wear of the winding screw caused by the presence of sand in the lubricating grease. Wear on the threads of the screw weakened the tips at the intersection of the left and right threads and, as a result, one of the tips bent - see figure 1.

Localization of tips at the intersection of the left and right threads
of a winding screw

This Service Bulletin is edited to provide a spot check of the correct condition of the winding screw.

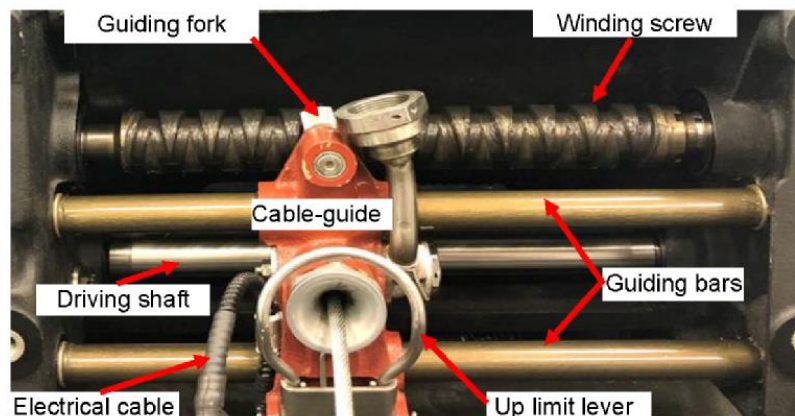
Figure 2

Cable-guide area including winding screw and guiding fork

- A. Cleaning the winding screw of the cable guide system - see figures 2 and 3
- Clean the winding screw and guide fork with a non-metallic brush and / or with a lint-free cloth using Starnet or Isopropyl Alcohol.

- Move the cable-guide, reeling out up to 5 m (16.4 ft) of cable in order to completely clean the winding screw.
- Make sure there is no more grease, sand or dust deposit.
- In particular, ensure the complete cleaning of guiding fork inversion areas on the winding screw – see figure 3.

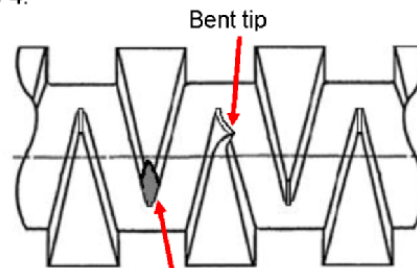
- (1) Check for damaged (bent or broken) tips on the winding screw – see figure 4.

Example of a winding screw with damaged tips
Figure 4

- By checking in particular the area where the guiding fork is located in the hook assembly stowage position - moving the cable guide by reeling out about 5 m (16.4 ft) of cable.
- (2) If there is one or several bent or broken tips on the winding screw, the hoist must be sent for repair to Goodrich Actuation Systems, Hoist & Winch, requesting first a RMA (*) at Desk-customer.Stouen@collins.com.
(*) It is reminded that RMA is a standard Return Material Authorization request in order to assure that identification of the material, a clear reason for return as well as logistic information are given.
 - (3) If the winding screw does not have a damaged tip, lubricate in accordance with paragraph 3.C. of this Service Bulletin.

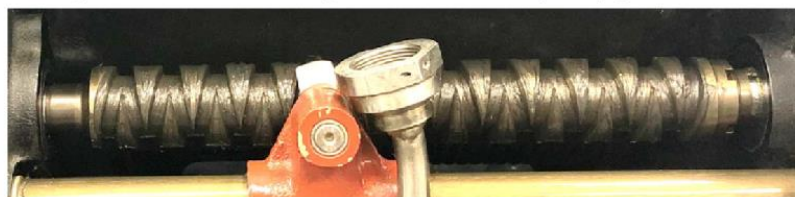
Figure 6

Correct application of grease to the winding screw

- (1) Lubricate the winding screw with grease AIR 4217 (NATO G-353).

The amount of grease to use is approximately 1 cm³ (0.06 in³) and the grease is to be distributed evenly on the surface of the thread of the winding screw with a brush – see figure 6. Wind a few meters of cable to move the cable guide so that the winding screw can be completely greased.
