No. EC155-53A040

ALERT SERVICE BULLETIN

FUSELAGE - Engine cowlings
Inspection of the engine upper fixed cowling

Revision No.	Date of issue
Revision 0	2021-10-27

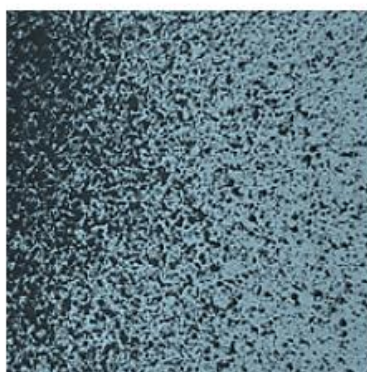
Acceptable: P20 primer exposed across the whole surface

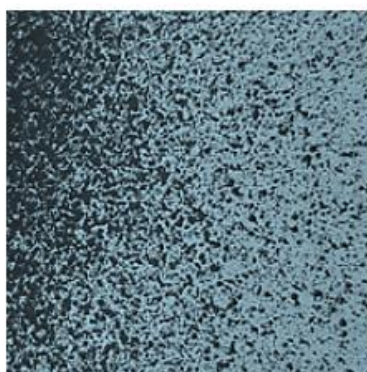
Acceptable: P20 primer exposed across the whole surface

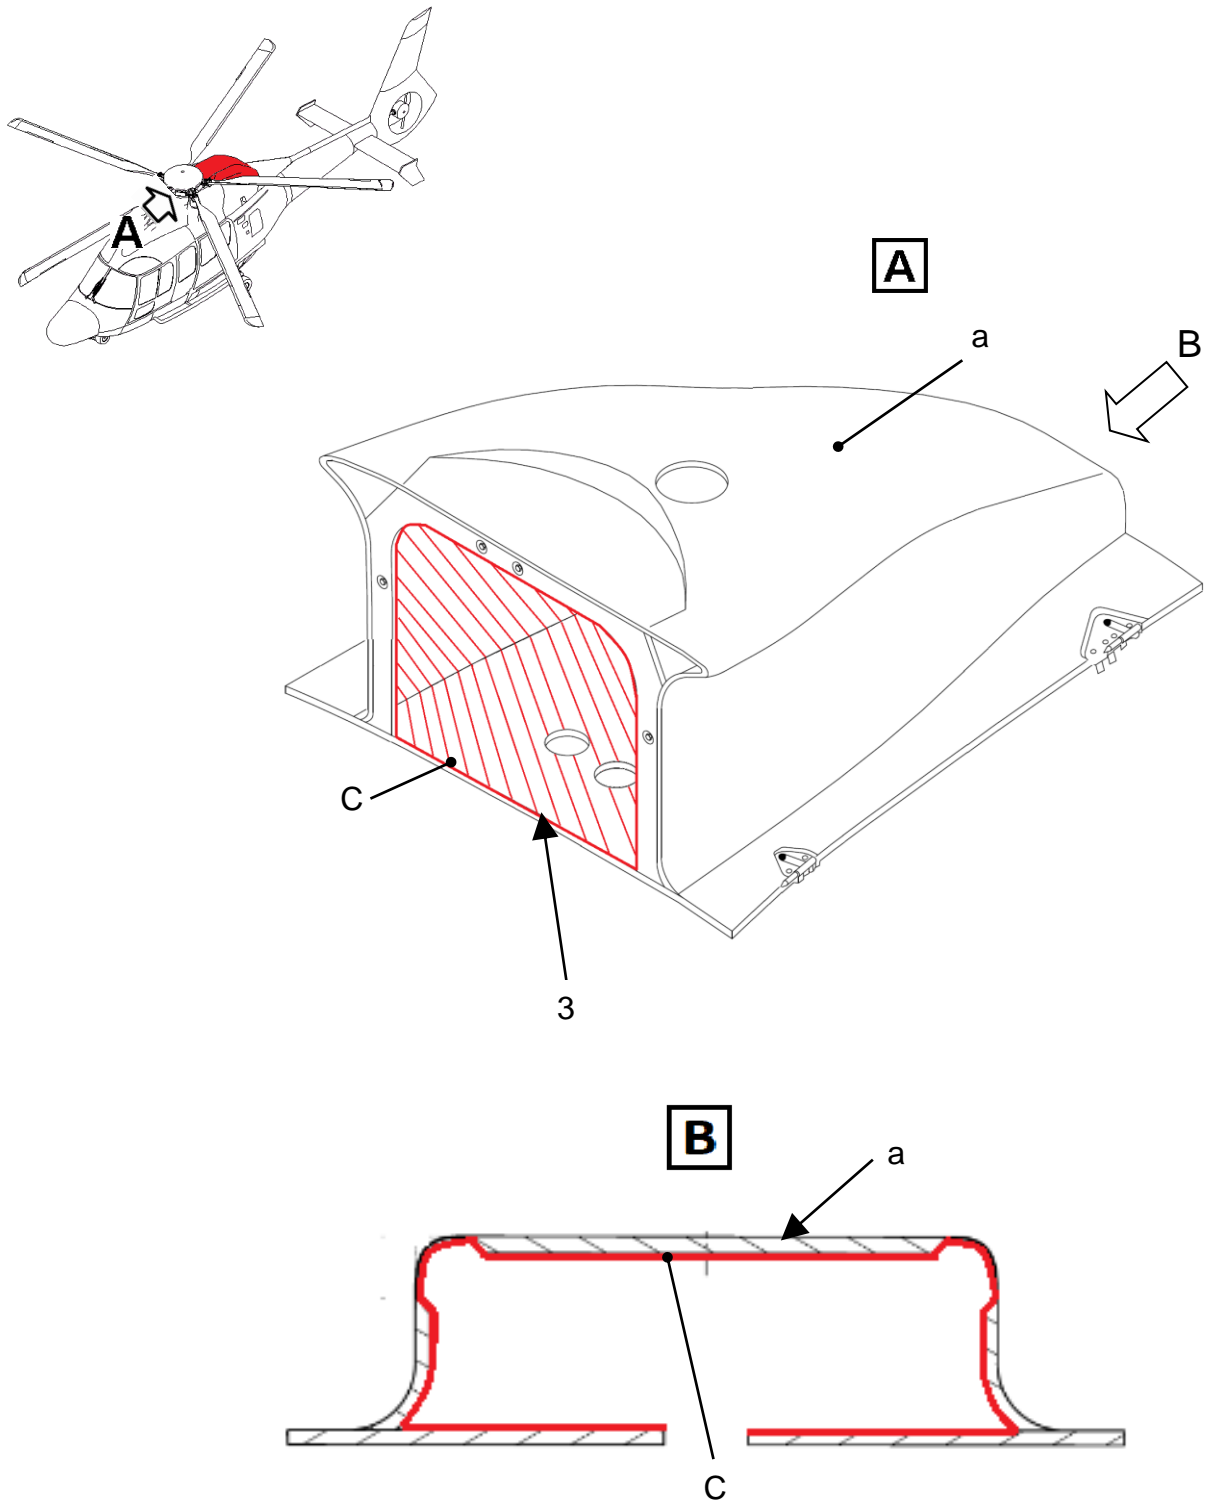
Figure 3

From Airbus Helicopters fire test results, the presence of polyurethane finish paint on non-ventilated surfaces may support fire propagation in case of a fire event adjacent to this area.

3.B.2.a. Visual check of the inside of the duct of the engine upper fixed cowling (Figure 1, [Figure 3](#))

- Do a visual check to make sure that there is no finish paint inside the duct of the engine upper fixed cowling (a) in the hatched zone C (Figure 1 and [Figure 3](#), Details A and B):
 - . The last layer must be the P20 primer layer.
 - . A light spray of paint through which the primer color is still visible is considered acceptable and does not need to be stripped.

- Remove the engine upper fixed cowling (a), refer to the Task 53-54-00-061 (AMM).
- Remove the finish paint inside of the duct of the engine upper fixed cowling (a) with sand paper (1) or (2) (not shown) until the primer layer appears.
- Apply the protection on the stripped zone with epoxy primer P20 (3) refer to Figure 1 and Work Card 20-04-05-402 (MTC).
- Identify again the engine upper fixed cowling (a), refer to paragraph [3.C.](#)
- Install the engine upper fixed cowling (a), refer to the Task 53-54-00-061 (AMM).
