**No. EC155-63A014**

## ALERT SERVICE BULLETIN

#### MAIN ROTOR DRIVE - Change of pressure switch of the dual pump MGB oil pressure

Corresponds to modification 0779B39

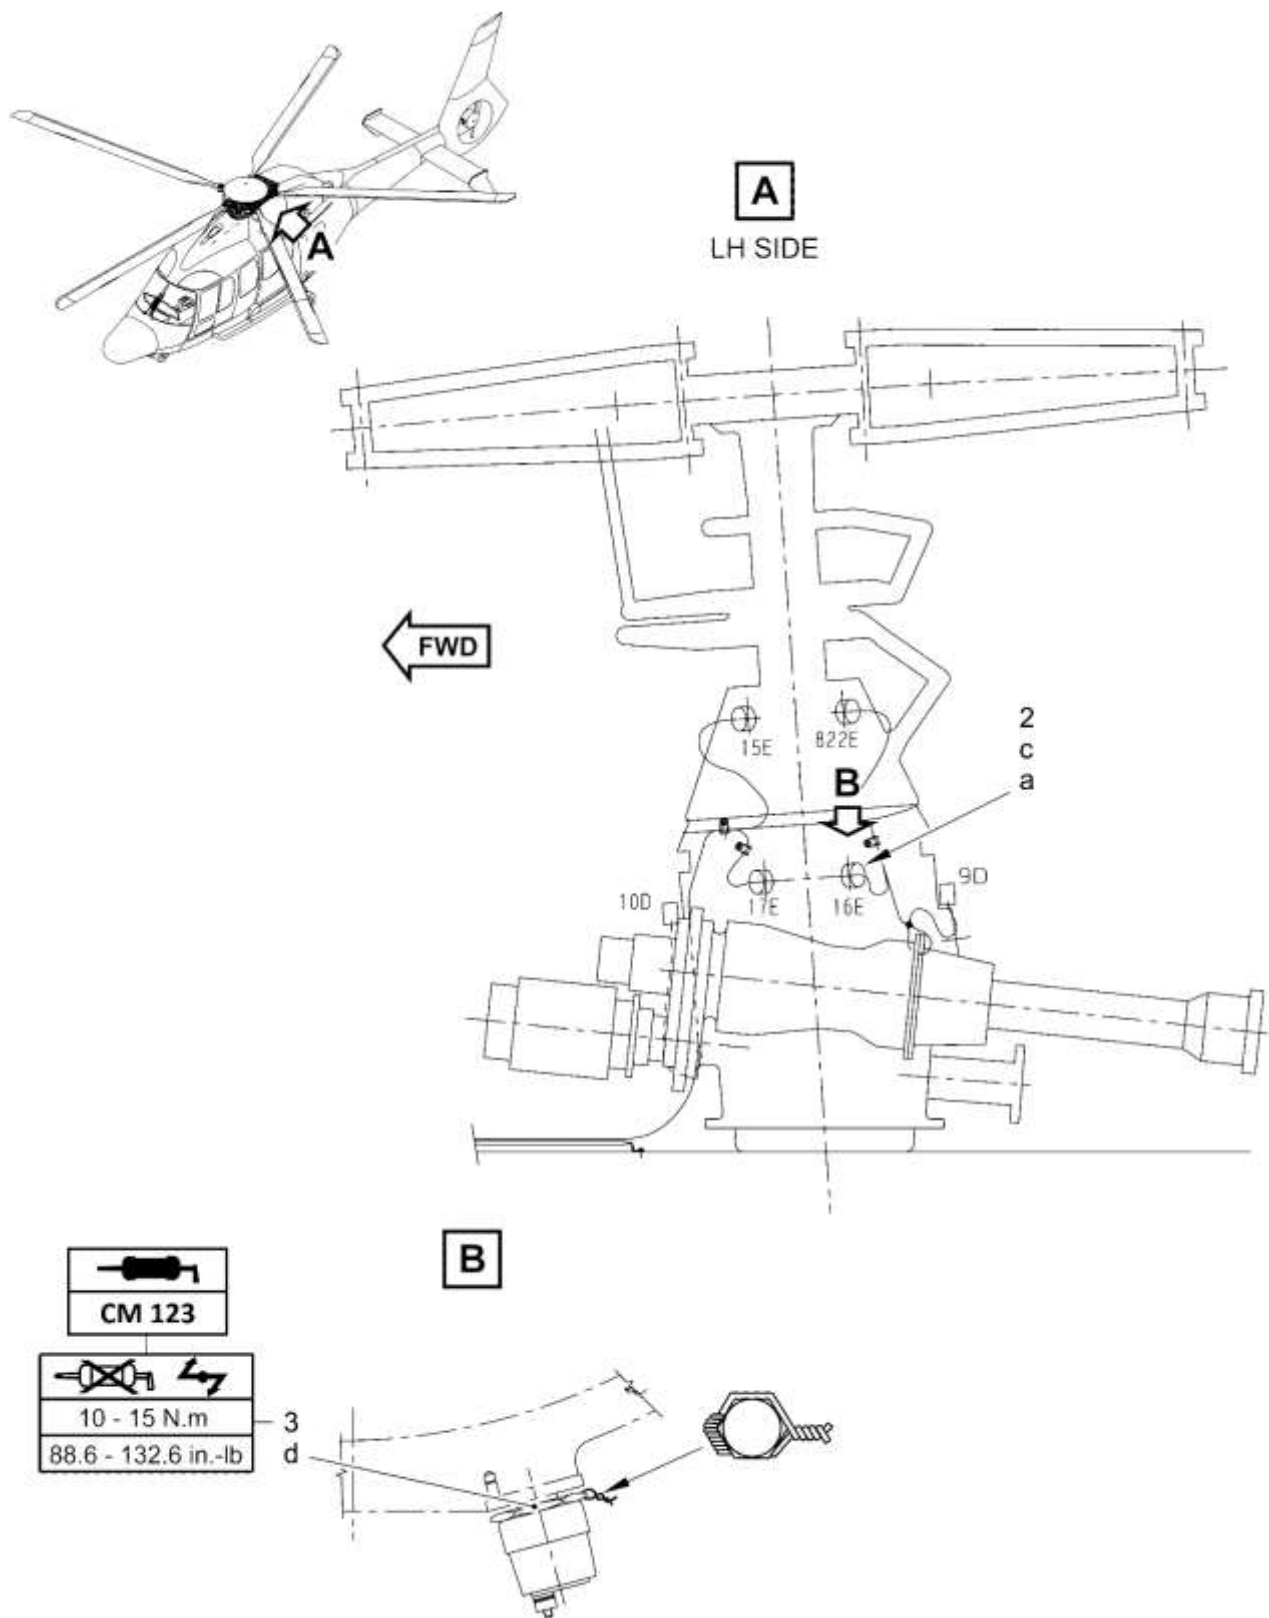
Figure 1 - Replacement of pressure switches "16E", "65E" and "66E"

The purpose of this ALERT SERVICE BULLETIN is to replace the existing pressure switch "16E" which has a detection threshold at 0.8 bar with new pressure switch which has a detection threshold at 0.6 bar, to avoid a false alarm "loss of lubrication".

The analysis revealed that the minimum threshold of 0.6 bar had not been reached and the crew could have completed their mission. This being due to the performances of the pressure switch detection threshold P/N S 1130 019 087 (704A37721087).

- Disconnect the connector (a) "16E" (Detail A).
- Remove and discard the lockwires (Detail B).
- Remove and store the pressure switch (c) (Detail A).
- Discard the sealing bushes (d) (Detail B).

- Secure lockwire (1) to the pressure switch (2) (Detail A and B).

- Lubricate the sealing bushes (3) with oil (4).
- Install the pressure switch (2) with the sealing bush (3) (Details A and B).

- Tighten to the indicated torque (Detail B).
- Safety the pressure switch (2) to the sealing bush (3) using lockwire (1) (previously secured to the pressure switch (2)).
- Connect the connector (a) "16E" again (Details A and B).
