No. EC155-63A014

ALERT SERVICE BULLETIN

MAIN ROTOR DRIVE - Change of pressure switch of the dual pump MGB oil pressure

Corresponds to modification 0779B39

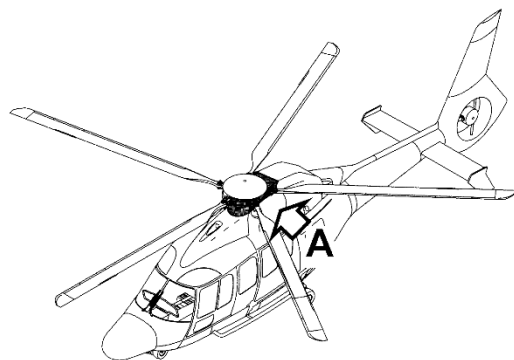
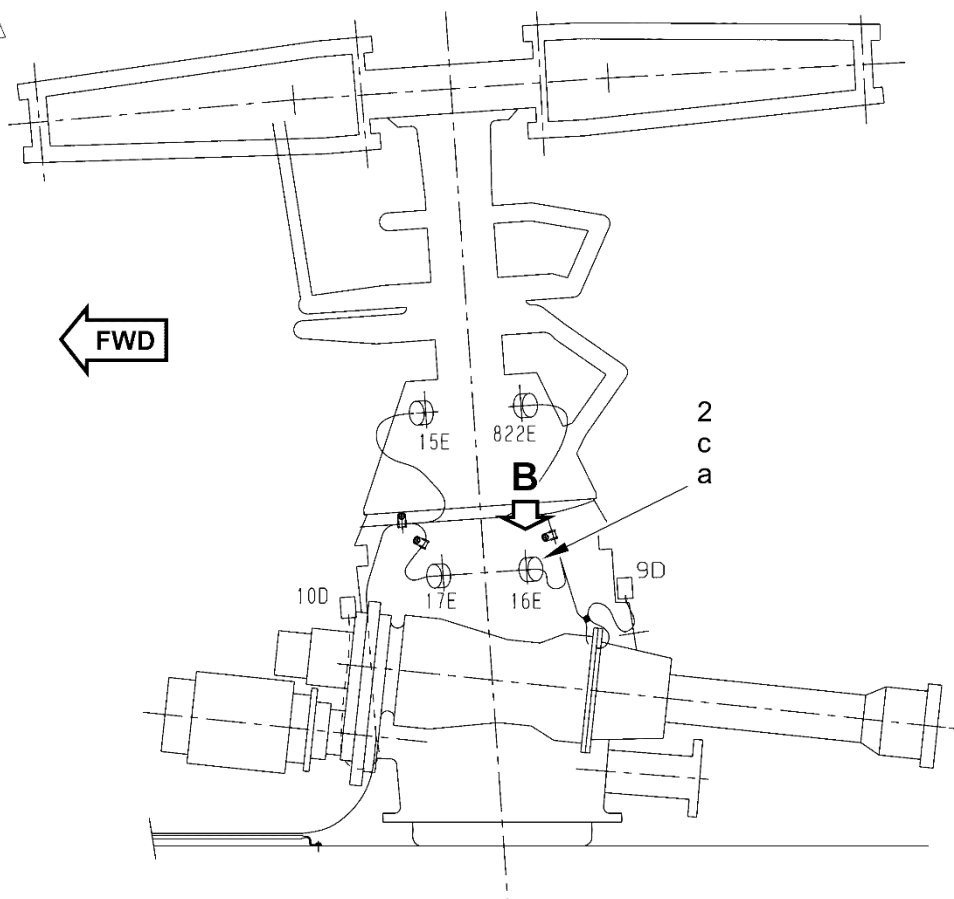
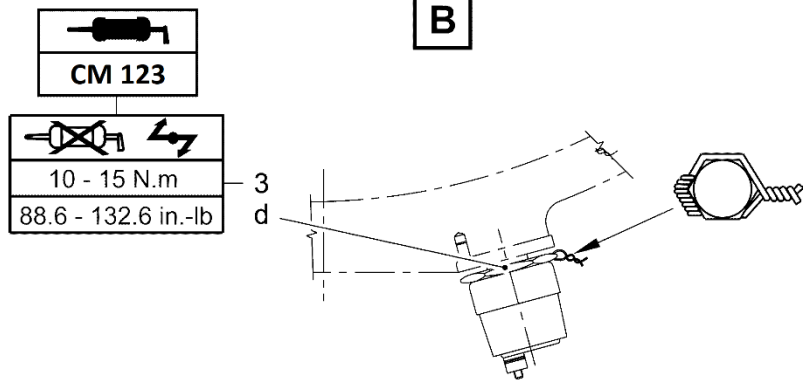
Figure 1 - Replacement of pressure switch "16E"

One customer reported the following event: during a flight, the amber oil pressure alarms, then red "MGB P" were triggered, forcing the crew to apply emergency procedures to land.

The analysis revealed that the minimum threshold of 0.6 bar had not been reached and the crew could have completed their mission. This being due to the performances of the pressure switch detection threshold P/N S 1130 019 087 (704A37721087).

- Disconnect the connector (a) "16E" (Detail A).
- Remove and discard the lockwires (Detail B).
- Remove and store the pressure switch (c) (Detail A).
- Discard the sealing bushes (d) (Detail B).

- Secure lockwire (1) to the pressure switch (2) (Details A and B).

- Lubricate the sealing bushes (3) with oil (4).
- Install the pressure switch (2) with the sealing bush (3) (Details A and B).

- Tighten to the indicated torque (Detail B).
- Safety the pressure switch (2) to the sealing bush (3) using lockwire (1) (previously secured to the pressure switch (2)).
- Connect the connector (a) "16E" again (Details A and B).
