ALERT SERVICE BULLETIN

TITLE: Servo-control system - Check of the connection between the upper ball bearing end and the main rotor servo-control

Model:	EC155
Helicopters affected:	B , B1
Component affected:	SC8037 and SC8037-1

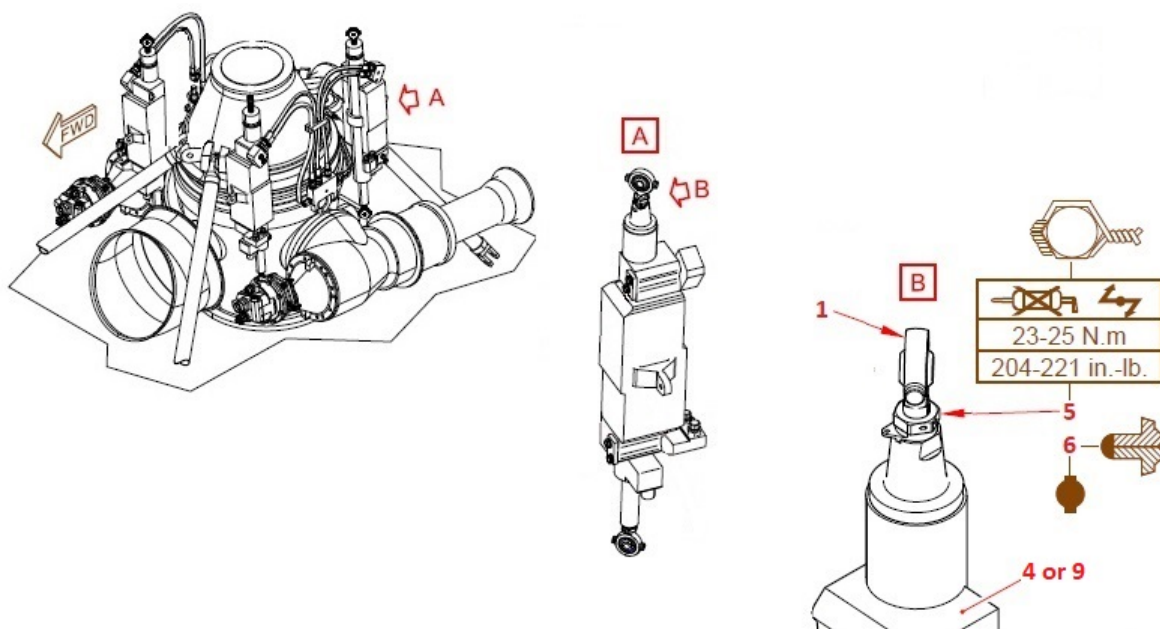
Figure 1

- 4.1. Only the procedure for the left rear main rotor servo-control is given. Do the same procedure for the left front main rotor servo-control and the right front main rotor servo-control, unless differently specified.
- 4.2. Do a check of the nut (5) tightening torque of the Ball bearing end 1211351P (1) of the Main rotor servo-control SC8037-1 (4) or Main rotor servo-control SC8037 (9) (Figure 1). Refer to Work Card Assembly by screws and nuts - Joining [MTC 20-02-05-404](#).

4.2.1. If you get to the minimum torque 2.3 daN.m (204 lbf.in) value before the marks align:

4.2.2. If the tightening torque value is more than or equal to 2 daN.m (177 lbf.in) and less than 2.3 daN.m (204 lbf.in) when you get to the alignment of the marks (corresponds to a loss of tightening torque less than 15% of the minimum torque value):

4.2.3. If the tightening torque value is less than 2 daN.m (177 lbf.in) when you get to the alignment of the marks (corresponds to a loss of tightening torque more than 15% of the minimum torque value):

- Torque until the marks align but do not torque to more than the max torque value given in figure 1
- Use Lock-wire CM 776 to safety the nut (5) with the nut retainer (6).
- Apply a bead of Sealing compound CM 6068 to:
 - The upper end of the Main rotor servo-control SC8037-1 (4) or Main rotor servo-control SC8037 (9)
 - The nut (5)
 - The nut retainer (6)
 - The Lock-wire CM776.
- Comply with paragraph 4.5.

- Torque the nut (5) to the nominal values given in Figure 1.
- Use Lock-wire CM 776 to safety the nut (5) with the nut retainer (6).
- Apply a bead of Sealing compound CM 6068 to:
 - The upper end of the Main rotor servo-control SC8037-1 (4) or Main rotor servo-control SC8037 (9)
 - The nut (5)
 - The nut retainer (6)
 - The Lock-wire CM776.
- Comply with paragraph 4.5.

- Comply with paragraph 4.3.

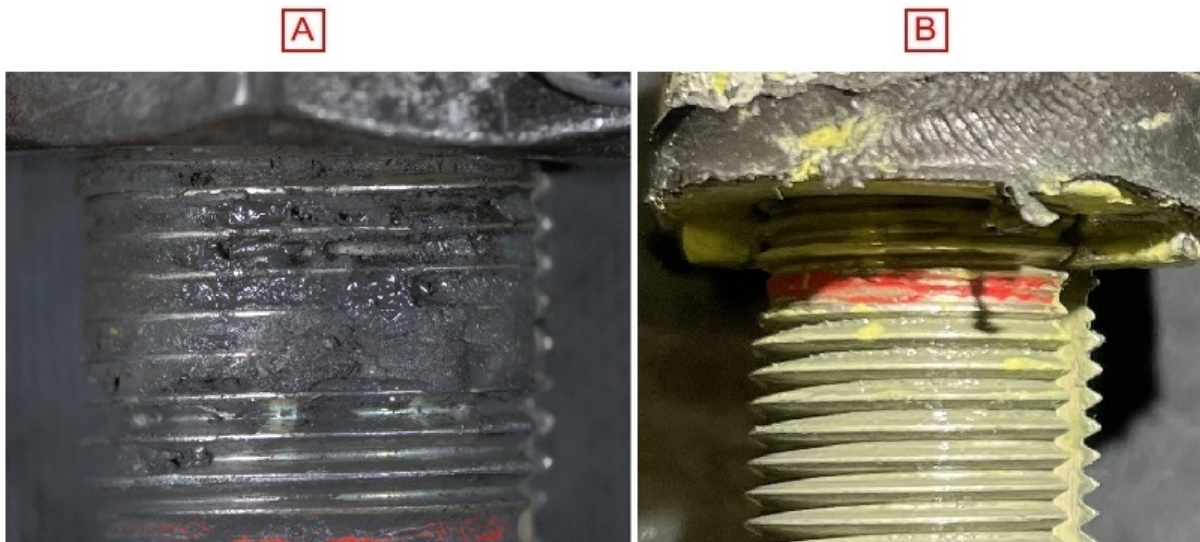
Figure 2

4.3.3. Do a detailed visual inspection of threads of the Ball bearing end 1211351P (1) (Figure 2).

4.3.3.1. If there is no dirt, no corrosion and no damaged threads (Figure 2, Detail B):

4.3.3.2. If there is dirt (Figure 2, Detail A), corrosion or damaged threads:

- Clean the Ball bearing end 1211351P (1) with Cleaning agent CM 208. Refer to Work Card Use of cleaning products on individual parts and on helicopters - Cleaning [MTC 20-04-01-102](#) Cleaning agent
- Keep the removed Ball bearing end 1211351P (1).

- Do photos of the threads
- Discard the Ball bearing end 1211351P (1).

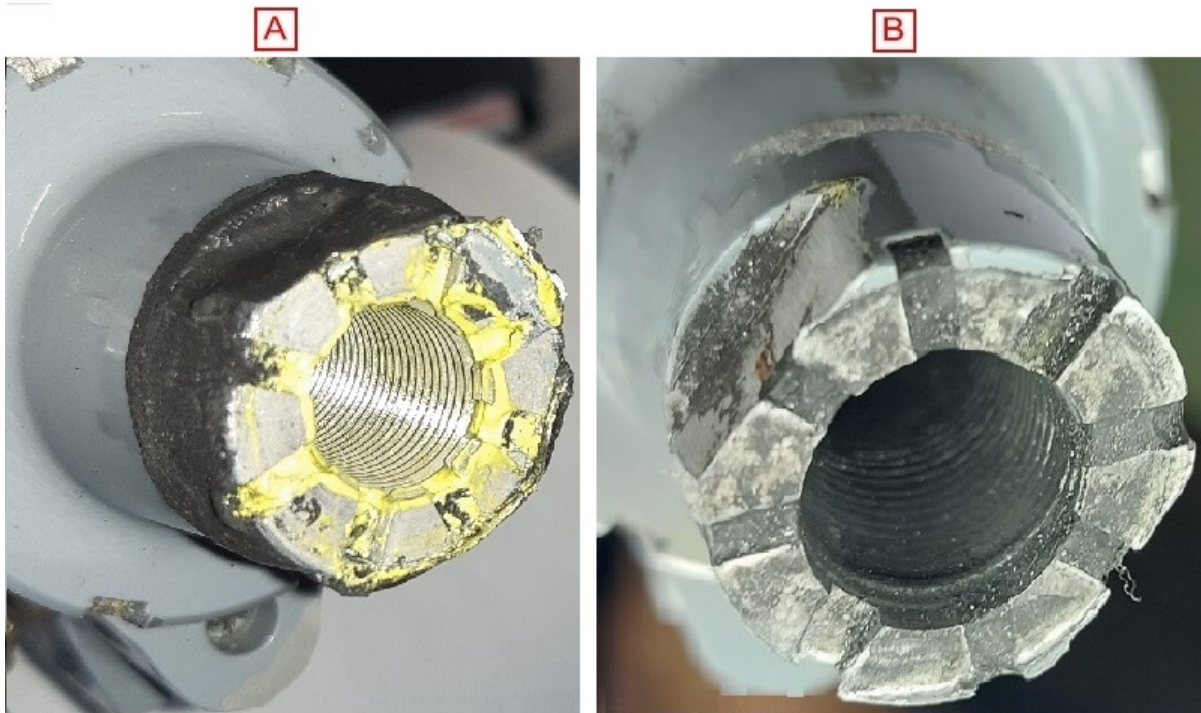
Figure 3

- 4.3.4. Do a detailed visual inspection of the threads on the inner surface of the upper end fitting of the Main rotor servo-control SC8037-1 (4) or Main rotor servo-control SC8037 (9) with the Flashlight (7) (not shown) and the Articulated mirror (8) (not shown):
- Do photos of the threads
 - Clean the threads on the inner surface of the upper end fitting of the Main rotor servo-control SC8037-1 (4) or Main rotor servo-control SC8037 (9) with Cleaning agent CM 208. Refer to Work Card Use of cleaning products on individual parts and on helicopters - Cleaning [MTC 20-04-01-102](#)
 - Do photos of the threads after cleaning.
- 4.3.4.1. If there is oxidation, corrosion or damaged threads (Figure 3, Detail B), comply with paragraph 4.4.
- 4.3.4.2. If there is no oxidation, no corrosion and no damaged threads (Figure 3, Detail A), comply with paragraph 4.3.5.

- 4.3.5. Turn a serviceable (new one or removed one if the threads were clean) Ball bearing end 1211351P (1) until its threads are almost fully in the upper end fitting of the Main rotor servo-control SC8037-1 (4) or Main rotor servo-control SC8037 (9):

- If there is a hard point, comply with paragraph 4.4.
 - If there is no hard point, comply with paragraph 4.3.6.
- 4.3.6. Install a serviceable Ball bearing end 1211351P (1) on the Main rotor servo-control SC8037-1 (4) or Main rotor servo-control SC8037 (9). Refer to Task Removal / Installation - Main rotor actuator - MGB POST 0763C88 [AMM 67-30-01-061A](#) or Removal / Installation - Main rotor actuator [AMM 67-30-01-061B](#)
