ALERT SERVICE BULLETIN

TITLE: Servo-control system - Check of the connection between the upper ball bearing end and the main rotor servo-control

Model:	EC155
Helicopters affected:	B , B1
Component affected:	SC8037 and SC8037-1

ASB EC155-67-30-0001

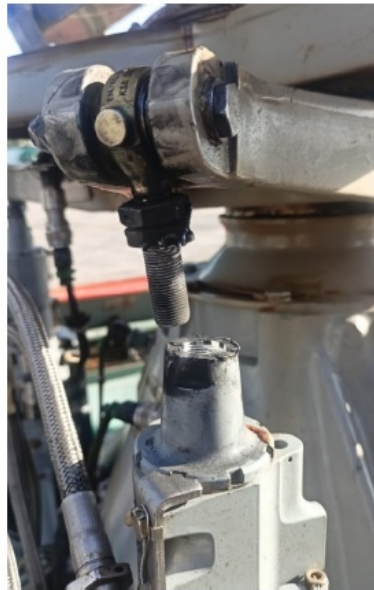
Airbus Helicopters was informed of two cases of loss of tightening torque between an upper ball bearing end and a main rotor servo-control. One case led to the disconnection of these two parts. In this case, the crew detected a vibration and hardening of the collective pitch lever on the ground when the collective pitch was increased.

After investigation, it turns out that there is no requirement to monitor the tightening torque of the upper ball bearing end in service.

Consequently, the purpose of this ALERT SERVICE BULLETIN is to check the nut tightening torque of the upper ball bearing end of the main rotor servo-controls and to collect information regarding the fleet status.

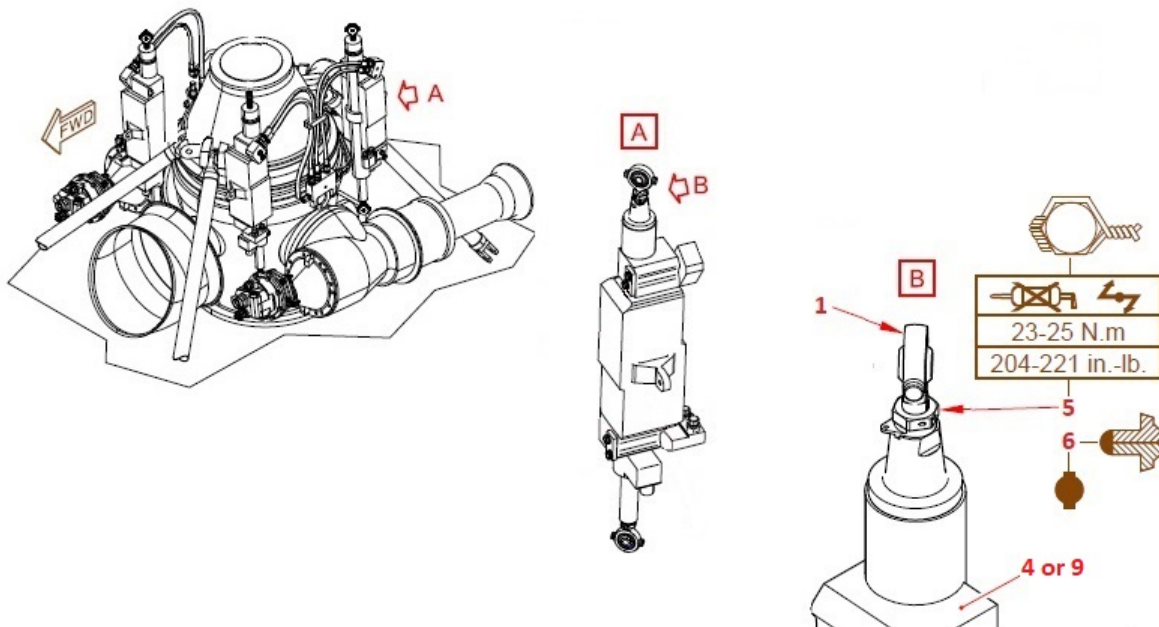
Figure 1

- 4.1. Only the procedure for the left rear main rotor servo-control is given. Do the same procedure for the left front main rotor servo-control and the right front main rotor servo-control, unless differently specified.
- 4.2. Do a check of the nut (5) tightening torque of the Ball bearing end 1211351P (1) of the Main rotor servo-control SC8037-1 (4) or Main rotor servo-control SC8037 (9) (Figure 1). Refer to Work Card Assembly by screws and nuts - Joining [MTC 20-02-05-404](#).

4.2.1. If you get to the minimum torque 2.3 daN.m (204 lbf.in) value before the marks align:

4.2.2. If the tightening torque value is more than or equal to 2 daN.m (177 lbf.in) and less than 2.3 daN.m (204 lbf.in) when you get to the alignment of the marks (corresponds to a loss of tightening torque less than 15% of the minimum torque value):

4.2.3. If the tightening torque value is less than 2 daN.m (177 lbf.in) when you get to the alignment of the marks (corresponds to a loss of tightening torque more than 15% of the minimum torque value):

- Torque until the marks align but do not torque to more than the max torque value given in figure 1
- Use Lock-wire CM 776 to safety the nut (5) with the nut retainer (6).
- Apply a bead of Sealing compound CM 6068 to:
 - The upper end of the Main rotor servo-control SC8037-1 (4) or Main rotor servo-control SC8037 (9)
 - The nut (5)
 - The nut retainer (6)
 - The Lock-wire CM776.
- Comply with paragraph 4.5.

- Torque the nut (5) to the nominal values given in Figure 1.
- Use Lock-wire CM 776 to safety the nut (5) with the nut retainer (6).
- Apply a bead of Sealing compound CM 6068 to:
 - The upper end of the Main rotor servo-control SC8037-1 (4) or Main rotor servo-control SC8037 (9)
 - The nut (5)
 - The nut retainer (6)
 - The Lock-wire CM776.
- Comply with paragraph 4.5.

- Comply with paragraph 4.3.

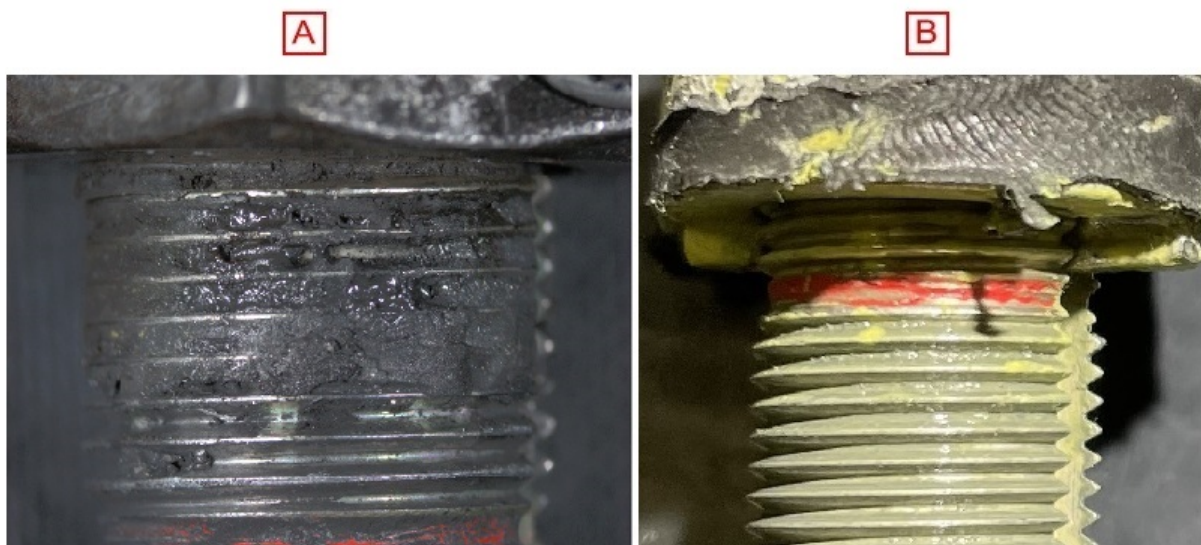
Figure 2

4.3.3. Do a detailed visual inspection of threads of the Ball bearing end 1211351P (1) (Figure 2).

4.3.3.1. If there is no dirt, no corrosion and no damaged threads (Figure 2, Detail B):

4.3.3.2. If there is dirt (Figure 2, Detail A), corrosion or damaged threads:

- Clean the Ball bearing end 1211351P (1) with Cleaning agent CM 208. Refer to Work Card Use of cleaning products on individual parts and on helicopters - Cleaning [MTC 20-04-01-102](#) Cleaning agent
- Keep the removed Ball bearing end 1211351P (1).

- Do photos of the threads
- Discard the Ball bearing end 1211351P (1).
