**No. EC155-71A015**

# ALERT SERVICE BULLETIN

### POWER PLANT - Firewall

#### Modification of the material of the firewall edging

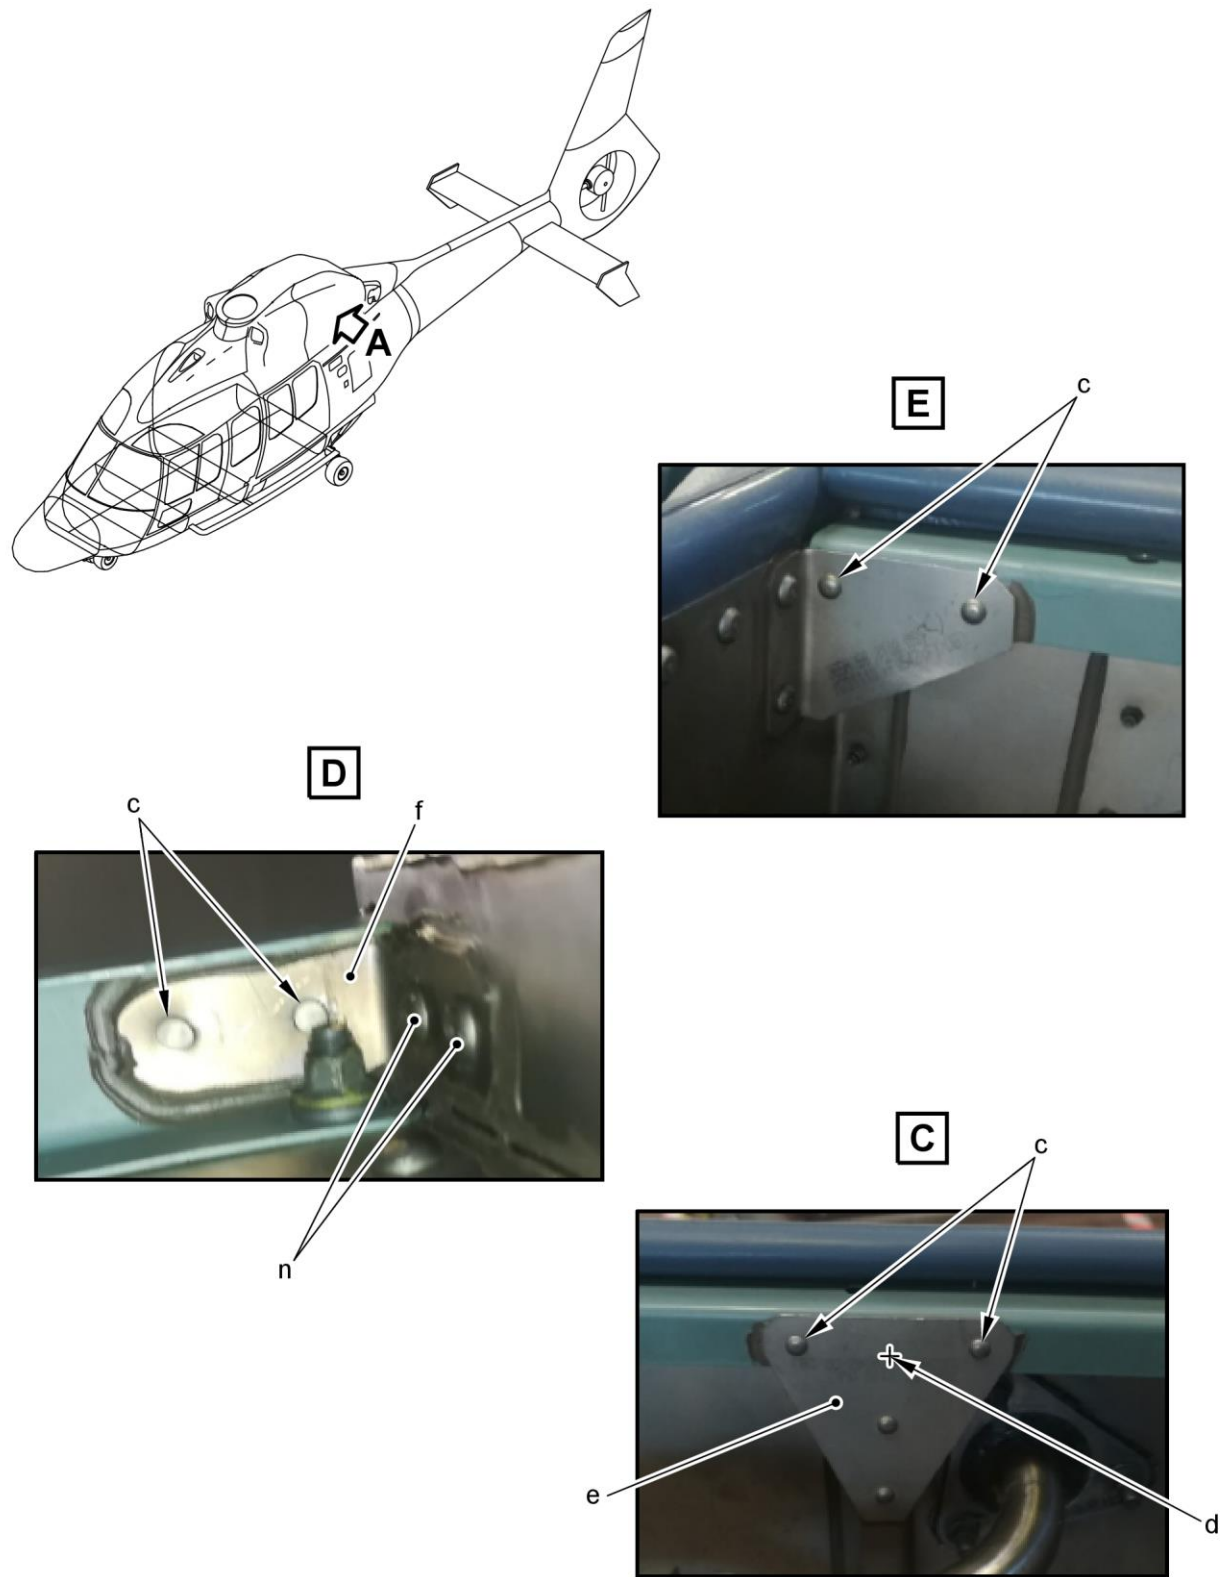
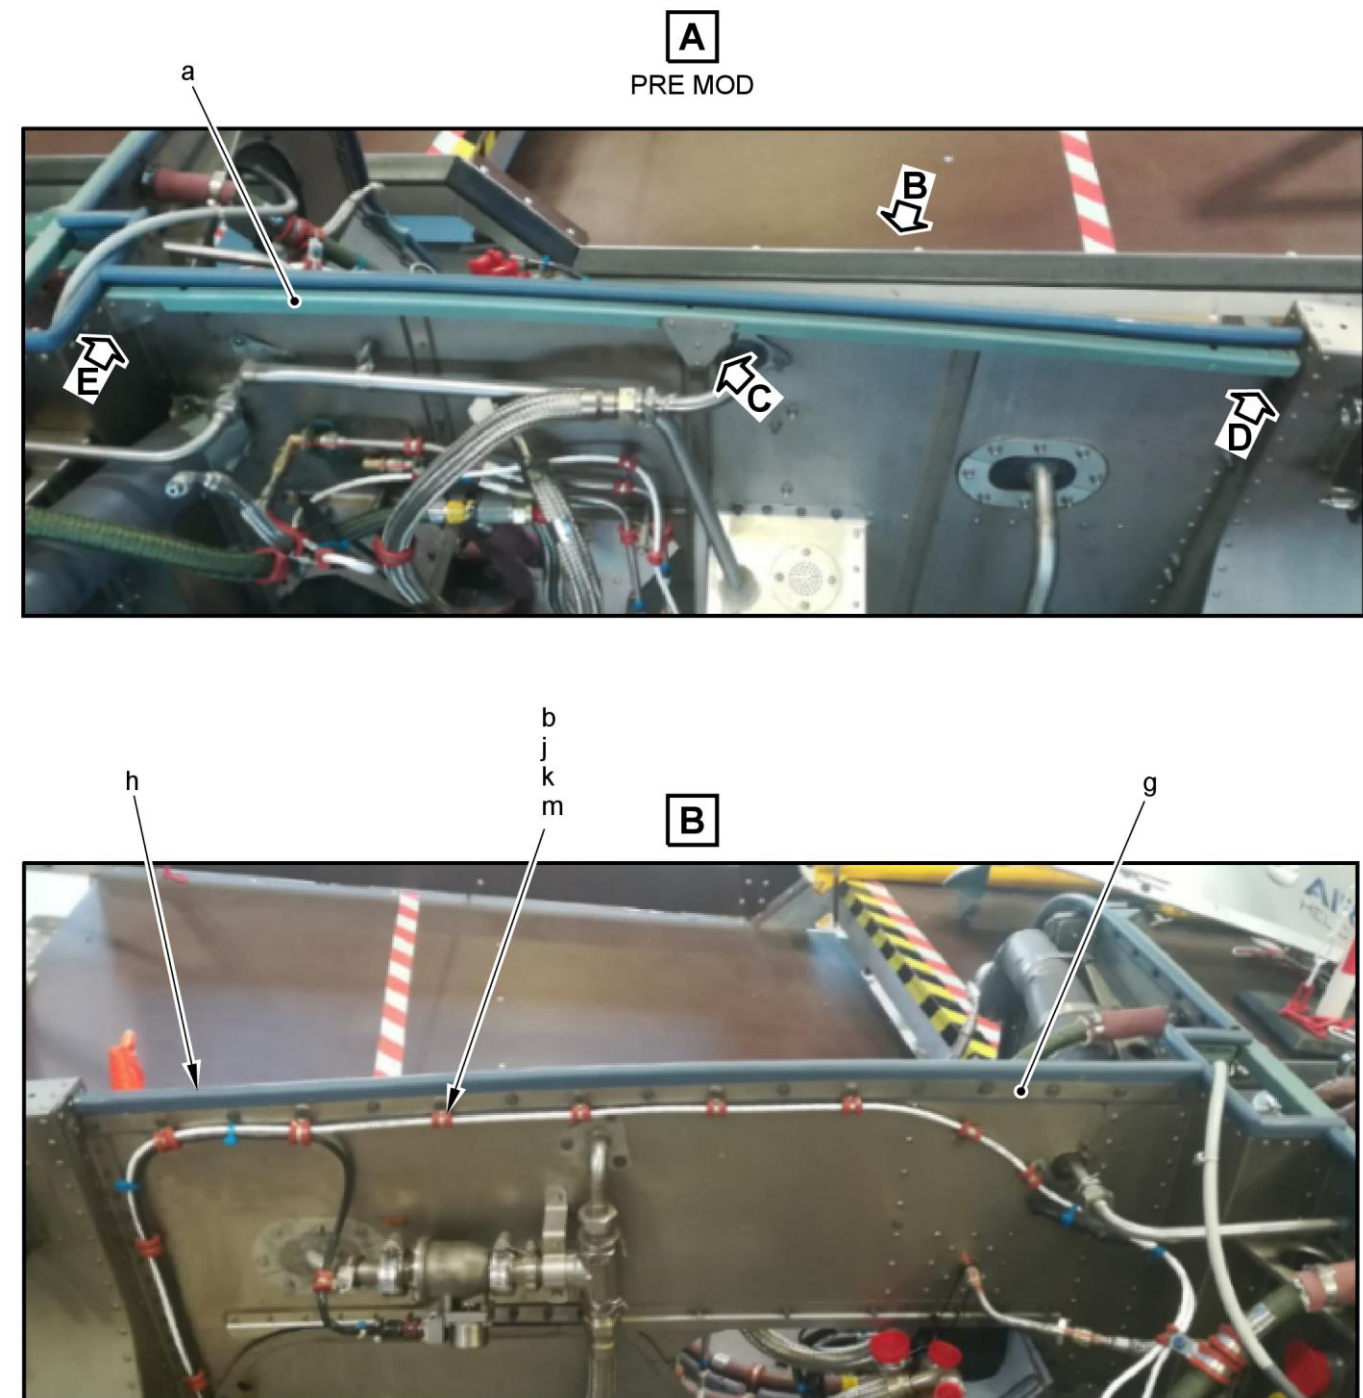
Figure 1

The investigation following a fire in a left engine compartment highlighted the failure of the upper stiffener of the central firewall. This part being in aluminum, it can lead to a distortion of the firewall and a loss of tightness of the central firewall seal if submitted to a fire.

#### 3.B.2.a. Removal of the aluminum stiffener from the firewall ([Figure 1](#))

Refer to DETAIL A, DETAIL C, DETAIL D and DETAIL E:

- Remove the rivets (c) from the stiffener (a). Refer to Work Card 20-03-01-102 (MTC).
- If the center rivet (d) is installed on the gusset (e) (DETAIL C):
  - . Remove the rivet (d). Refer to Work Card 20-03-01-102 (MTC).
- Remove and discard (DETAIL B):
  - . The stiffener (a)
  - . The bolts (b)
  - . The washers (j)
  - . The nuts (k).
- Remove and keep (DETAIL A, DETAIL B):
  - . The cover strip (g)
  - . The fireproof seal (h)
  - . The clamps (m).
- If the bracket (f) is in unsatisfactory condition (DETAIL D):
  - . Remove the rivet (n)
  - . Remove and discard the bracket (f).
