No. EC155-71A015

ALERT SERVICE BULLETIN

POWER PLANT - Firewall

Modification of the material of the firewall edging

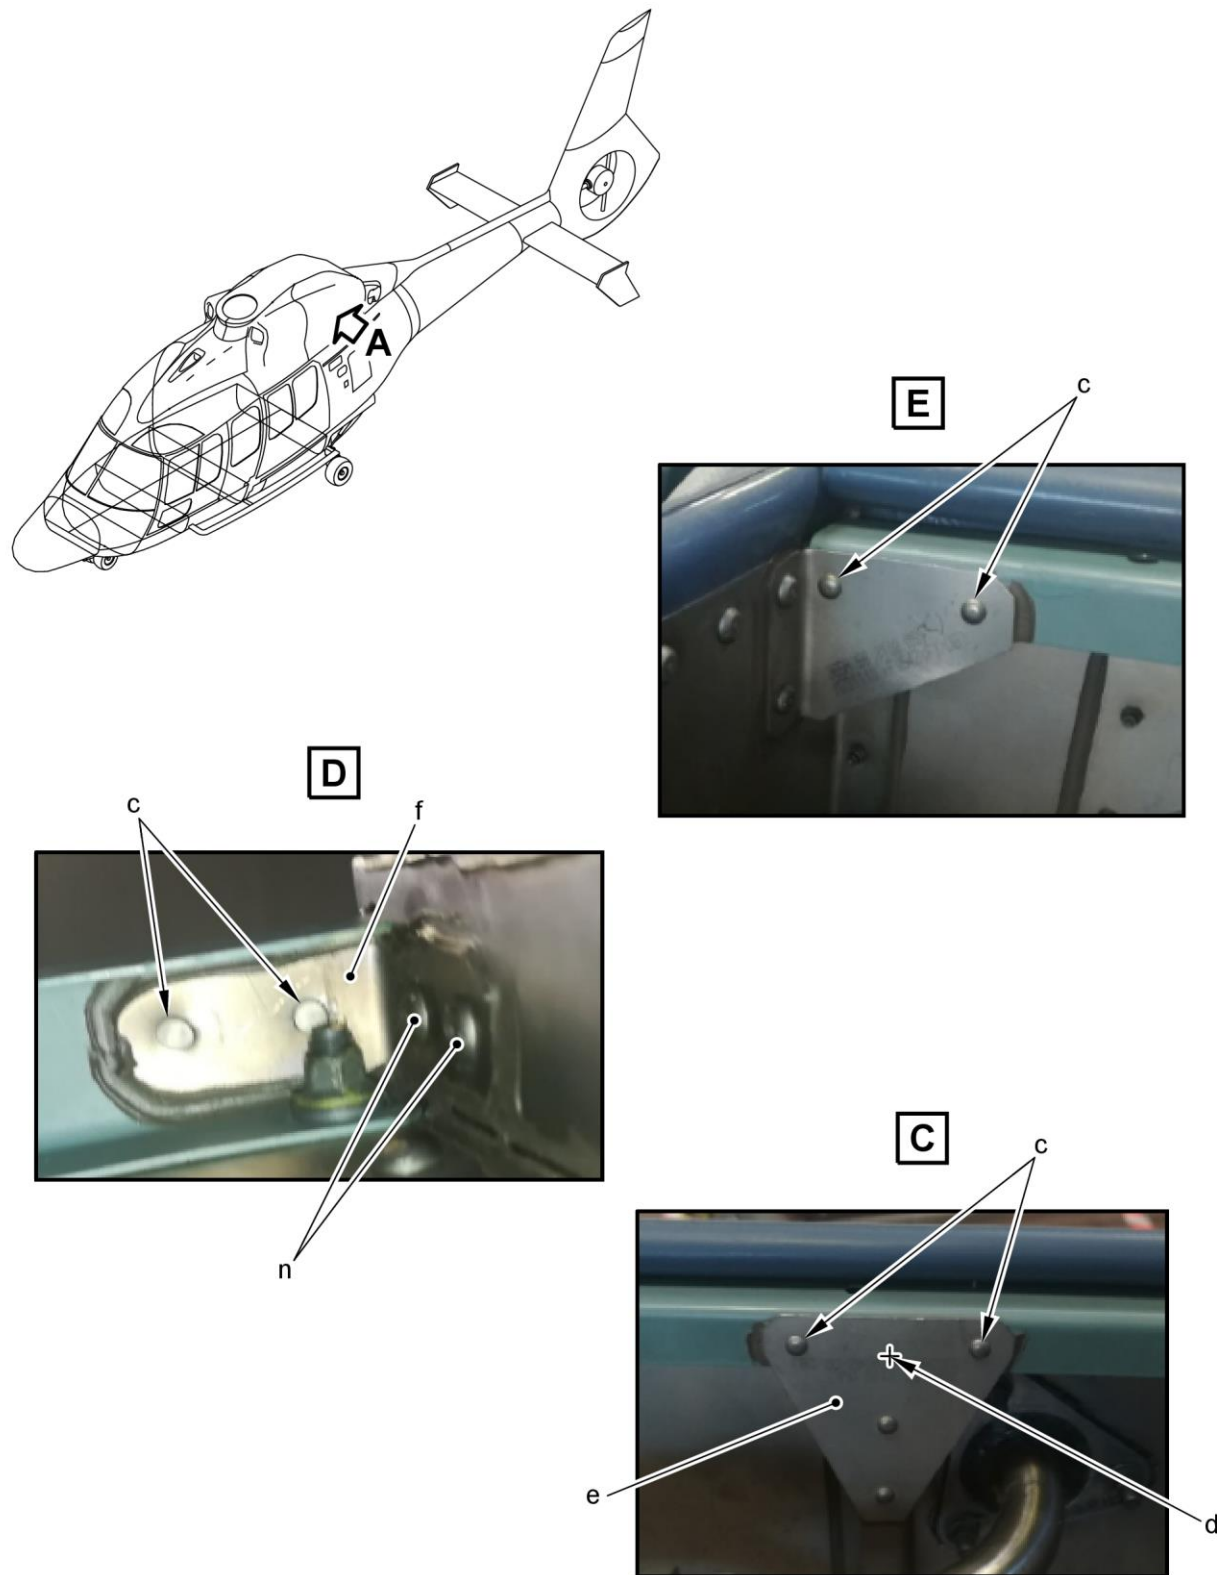
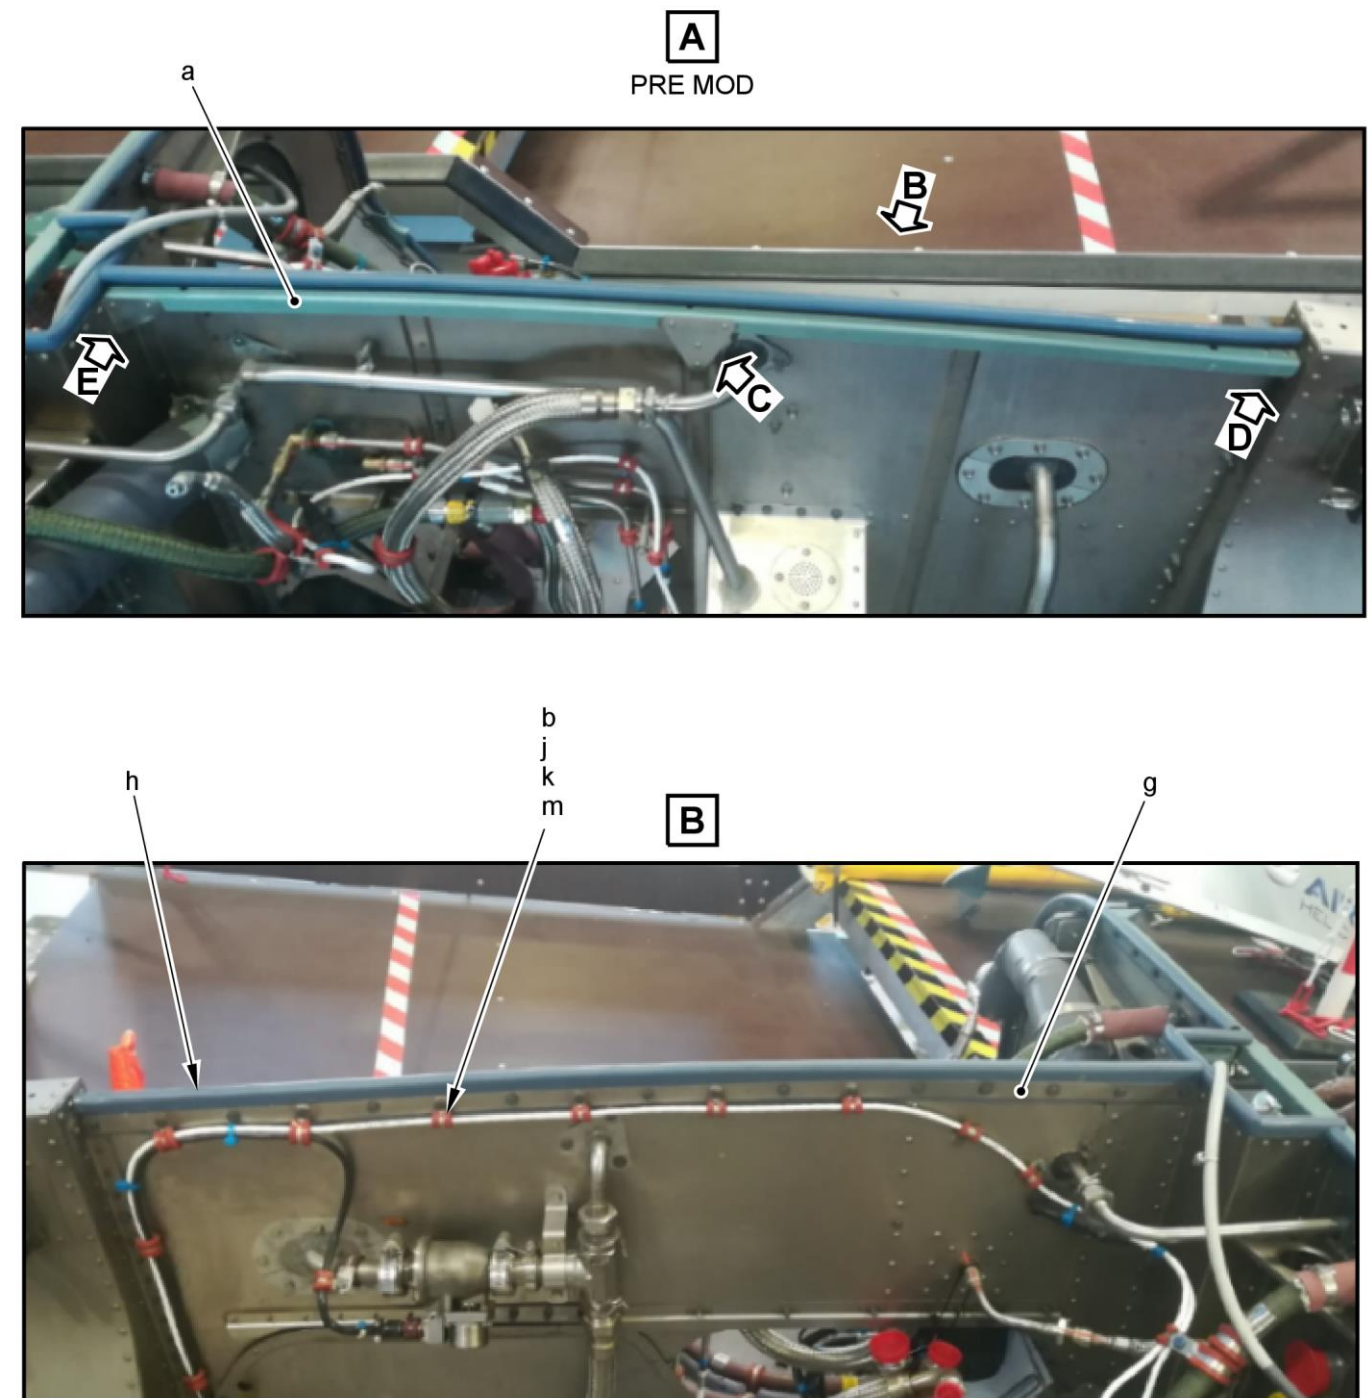
Figure 1

The investigation following a fire in a left engine compartment highlighted the failure of the upper stiffener of the central firewall. This part being in aluminum, it can lead to a distortion of the firewall and a loss of tightness of the central firewall seal if submitted to a fire.

3.B.2.a. Removal of the aluminum stiffener from the firewall ([Figure 1](#))

- Remove the rivets (c) from the stiffener (a). Refer to Work Card 20-03-01-102 (MTC).
- If the center rivet (d) is installed on the gusset (e) (DETAIL C):
 - . Remove the rivet (d). Refer to Work Card 20-03-01-102 (MTC).
- Remove and discard (DETAIL B):
 - . The stiffener (a)
 - . The bolts (b)
 - . The washers (j)
 - . The nuts (k).
- Remove and keep (DETAIL A, DETAIL B):
 - . The cover strip (g)
 - . The fireproof seal (h)
 - . The clamps (m).
- If the bracket (f) is in unsatisfactory condition (DETAIL D):
 - . Remove the rivet (n)
 - . Remove and discard the bracket (f).
