ALERT SERVICE BULLETIN

429-21-54

MODEL AFFECTED: 429

SUBJECT: MAIN ROTOR TRANSMISSION DEBRIS PAN ASSEMBLY 429-040-407-101, ONE TIME INSPECTION OF.

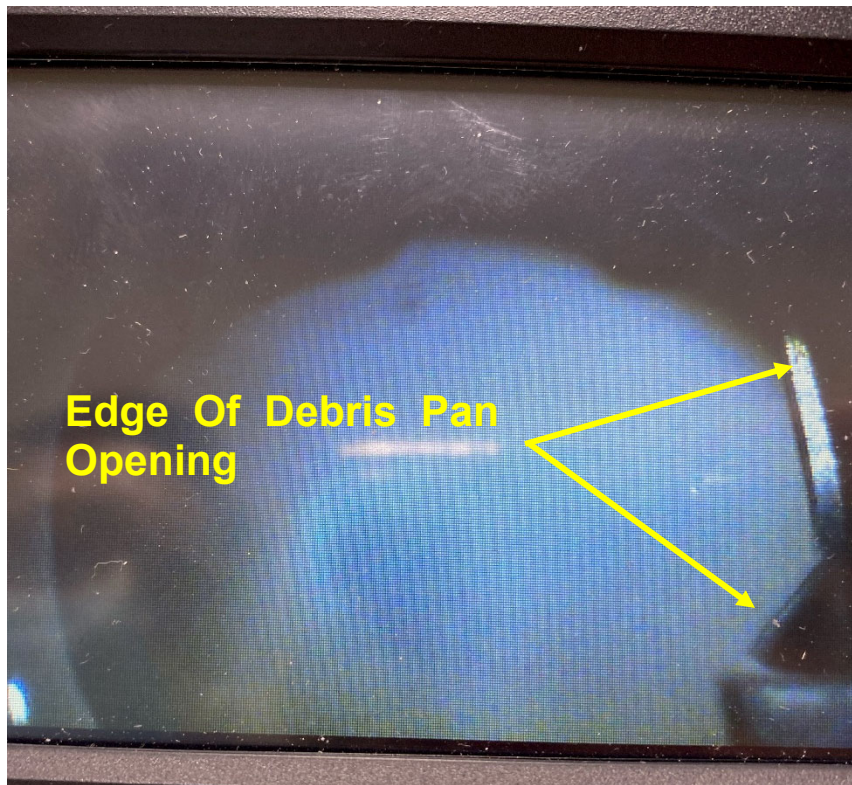
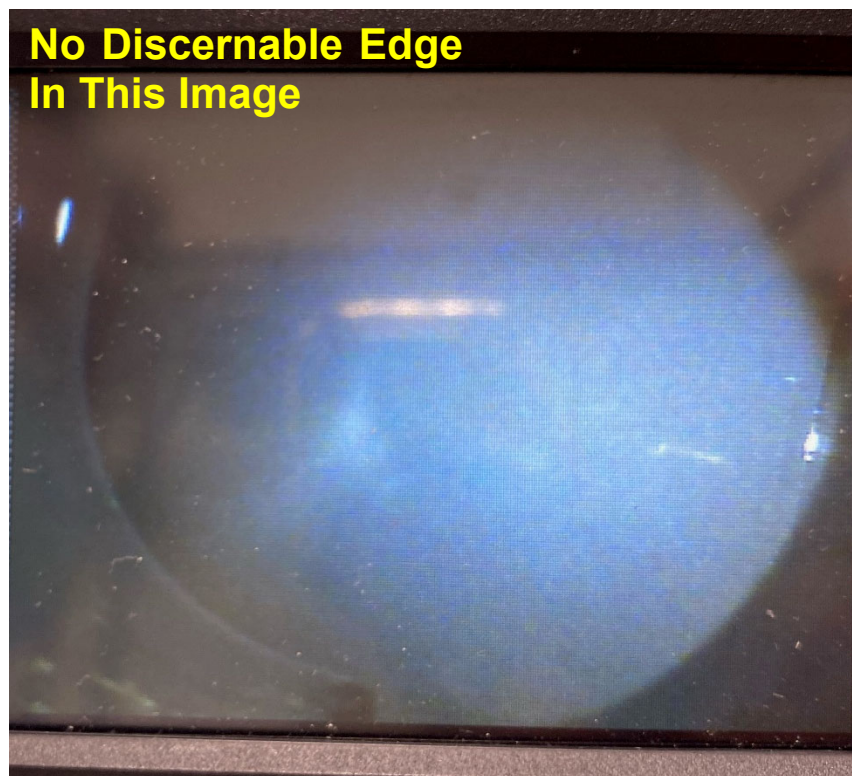
Figure 1 – Borescope Inspection Of The Debris Pan Assembly

Bell has been informed of the possibility of incorrectly installing the debris pan 429-040-407-101. The cause is due to a mistake in Figure 1 of DMC-429-A-63-10-00-00A-720A-A, which shows the debris pan as being installed 180° from its correct position. This can result in lubricating oil not being supplied to the mast chip detector and to the mast spline from the #13 oil jet. Bell is introducing this bulletin which requires a one time inspection of the debris pan to verify that it is installed in the correct position. A Maintenance Manual revision is in work to correct the mistake in Figure 1. Applicability of this bulletin to any spare part shall be determined prior to its installation on an affected helicopter.

4. Remove mast chip detector (DMC-429-A-63-20-00-16A-520A-A).
5. Using a borescope, inspect the debris pan assembly (1, Figure 1) for the presence of the opening for the lubricating oil as shown in Figure 1.

- a. If the edge of the debris pan opening is visible proceed to step 14.
 - b. If the edge of the debris pan opening is not visible, proceed to next step.

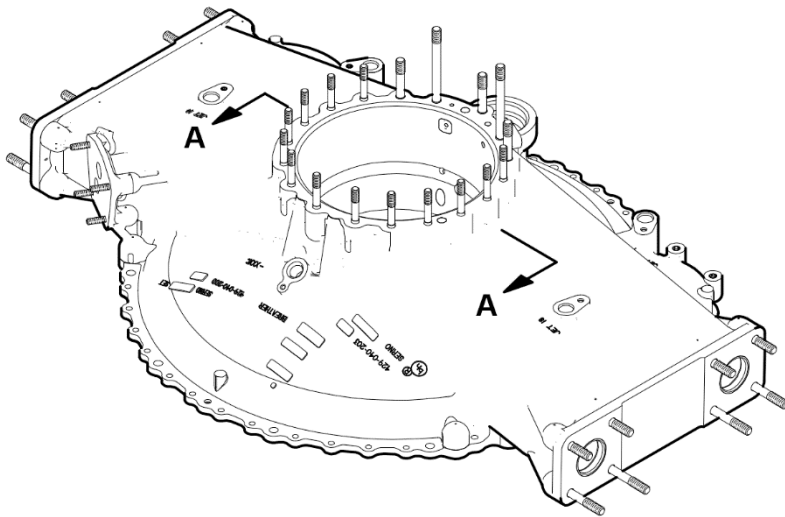
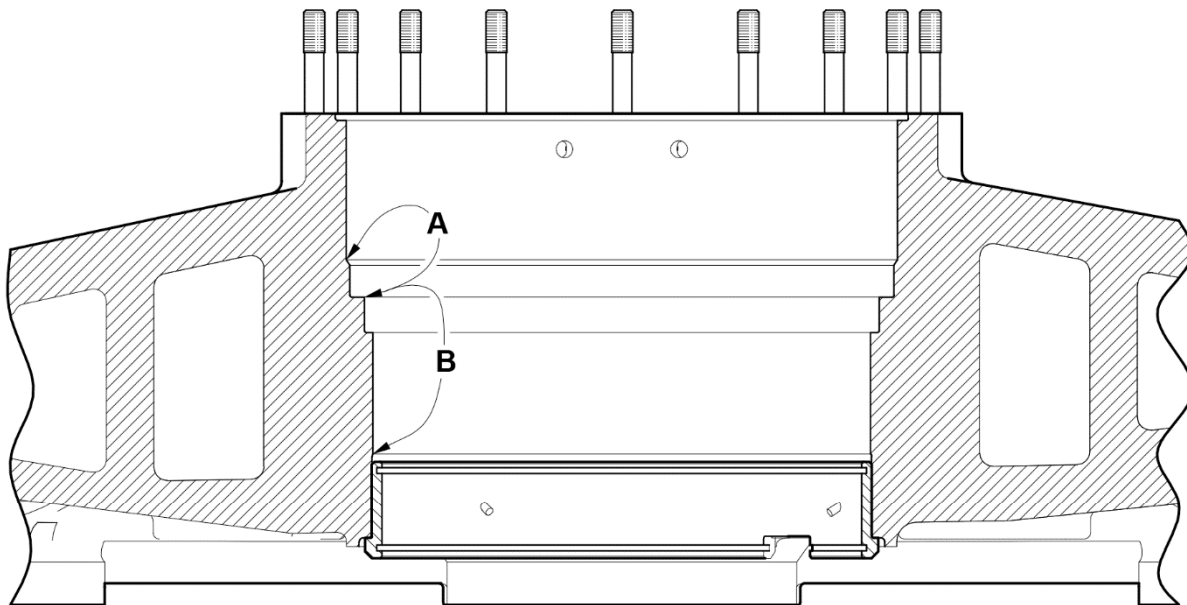
Figure 2 – Debris Pan Seat Damage Limits

11. Inspect the visible internal portions of the transmission assembly for the presence of metal contamination and mechanical damage to the debris pan seat (Figure 2).

NO.	REF LTR	CHARACTERISTIC	INSPECTION METHOD	LIMIT
1.	A	Mechanical/corrosion damage	Visual	None permitted.
2.	B	Mechanical/corrosion damage	Visual/measure	0.010 inch (0.25 mm) maximum depth and no more than 10% of total area of surface or diameter.

- a. Repair mechanical damage with stainless steel wool (C-171) abrasive pad (C-407) or India stone (C-464), as applicable, in accordance with the instructions in the BHT-ALL-SPM, Chapter 3. The surface finish after repair must be 32 Roughness Height Rating (RHR) with a minimum radius of 0.100 inch (2.54 mm), unless otherwise specified.

- b. Remove corrosion with a stainless steel wool (C-171), cleaner (C-344), abrasive pad (C-407), steel wool (C-411), or aluminum wool (C-422), as applicable, in accordance with the instructions provided in the BHT-ALL-SPM, Chapter 3.

- c. If there is presence of metal contamination, the mast assembly must be inspected and repaired. Send the main rotor mast assembly to Bell Customer Property Return by referring to the instructions provided in the [Returns Process User Guide](#) in the MyBell.com Help section.
