Issue 001 2023-07-12

TITLE: EMERGENCY FLOATATION SYSTEM - CHECK OF FLOAT HOSES RETAINING RING

ASB EC120-25-40-0001

TITLE: EQUIPMENT/FURNISHINGS (ATA 25)
EMERGENCY FLOTATION SYSTEMS (EFS)
INSPECTION OF FLOAT HOSES RETAINING RING

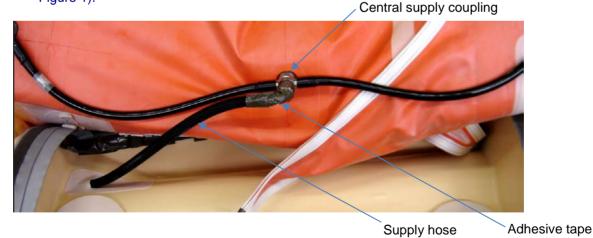
- (1) Locate the position of the central supply coupling on the float bag.
- (2) Remove and discard the adhesive tape that surrounds the supply hose connection (refer to Figure 1).

Figure 1 - Remove the adhesive tape

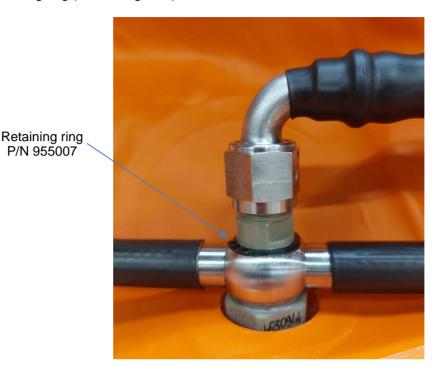
(3) Do the inspection of the supply hose / central supply coupling connection for presence of the retaining ring (refer to Figure 2):

Figure 2 - Retaining ring location

- (a) If the retaining ring is present:
 - 1 Wrap again the supply hose connection with new adhesive tape (refer to section 2.C.(2).).
- (b) If the retaining ring is missing:
 - Remove the supply hose from the central supply coupling.
 NOTE: Refer to the related CMM for disassembly instructions (refer to section 1.K.).
 - Install the retaining ring (P/N 955007) (refer to section 2.1.A.) on the central supply coupling.
 - Re-install the supply hose on the central supply coupling (refer to section 2.C.(2).).
 NOTE: Refer to the related CMM for assembly instructions (refer to section 1.K.).
 - 4 Wrap again the supply hose connection with new adhesive tape (refer to section 2.C.(2).).
