## BOLLETTINO TECNICO

N° **139-467**

DATE December 20, 2016

**TAIL ROTOR DRIVE LINE (TRDL) BEARING SUPPORT BRACKET**

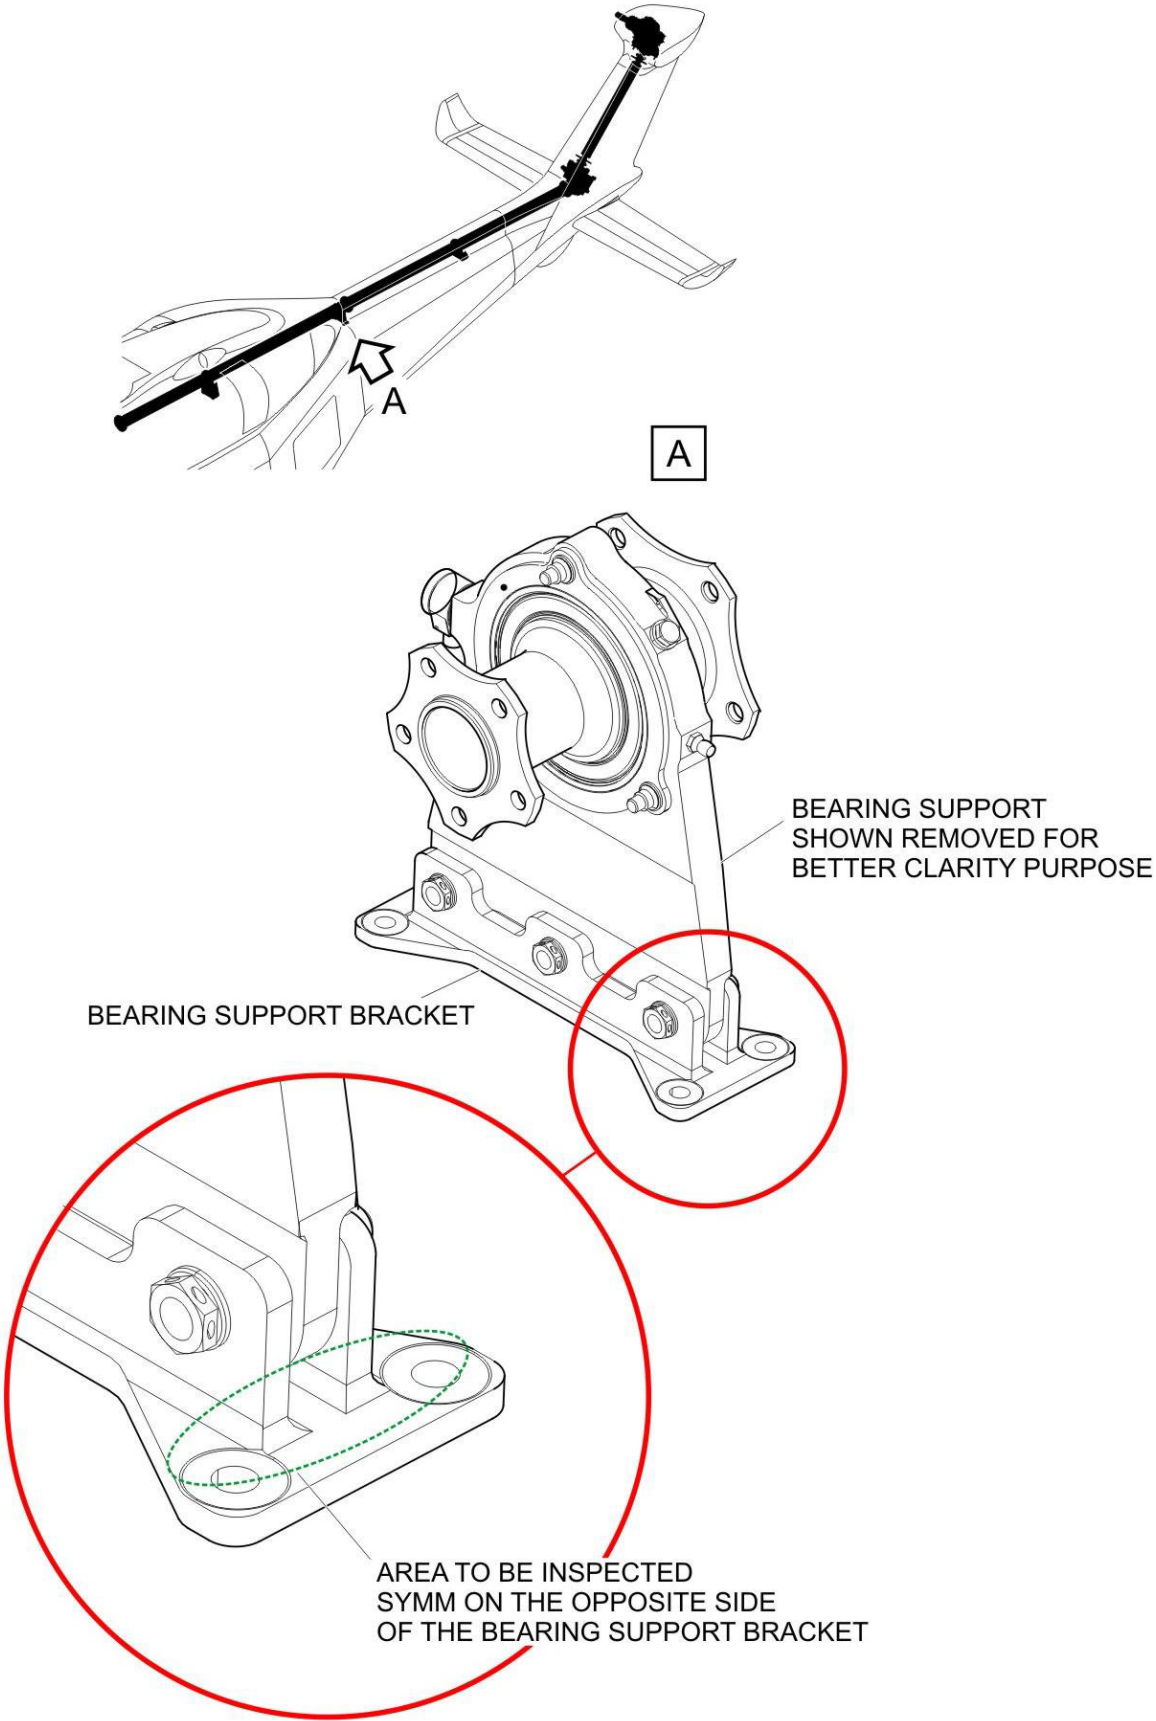
Figure 1

Cases of cracks in the bearing support have been reported in service.

Do not remove paint from the bearing support bracket to perform the inspection at following step 3.2. Even in case of cracks in the paint, replacement of the bearing support bracket is required.

To clean the bearing support bracket to perform the inspection at following step 3.2, refer to figure 1 to identify the areas to be inspected. Remove sealing compound from those areas, if present.

- 3.3 Perform the visual inspection for cracks of the bearing support bracket according to figure 1, using a magnifying glass and a strong light.
4. If you do not find any crack, go to step 5, otherwise do as follows:

- 4.1 Replace the bearing support bracket. Refer to AMP DM n° 39-B-65-11-11-

00A-530A-B and DM n° 39-B-65-11-11-00A-710A-B.

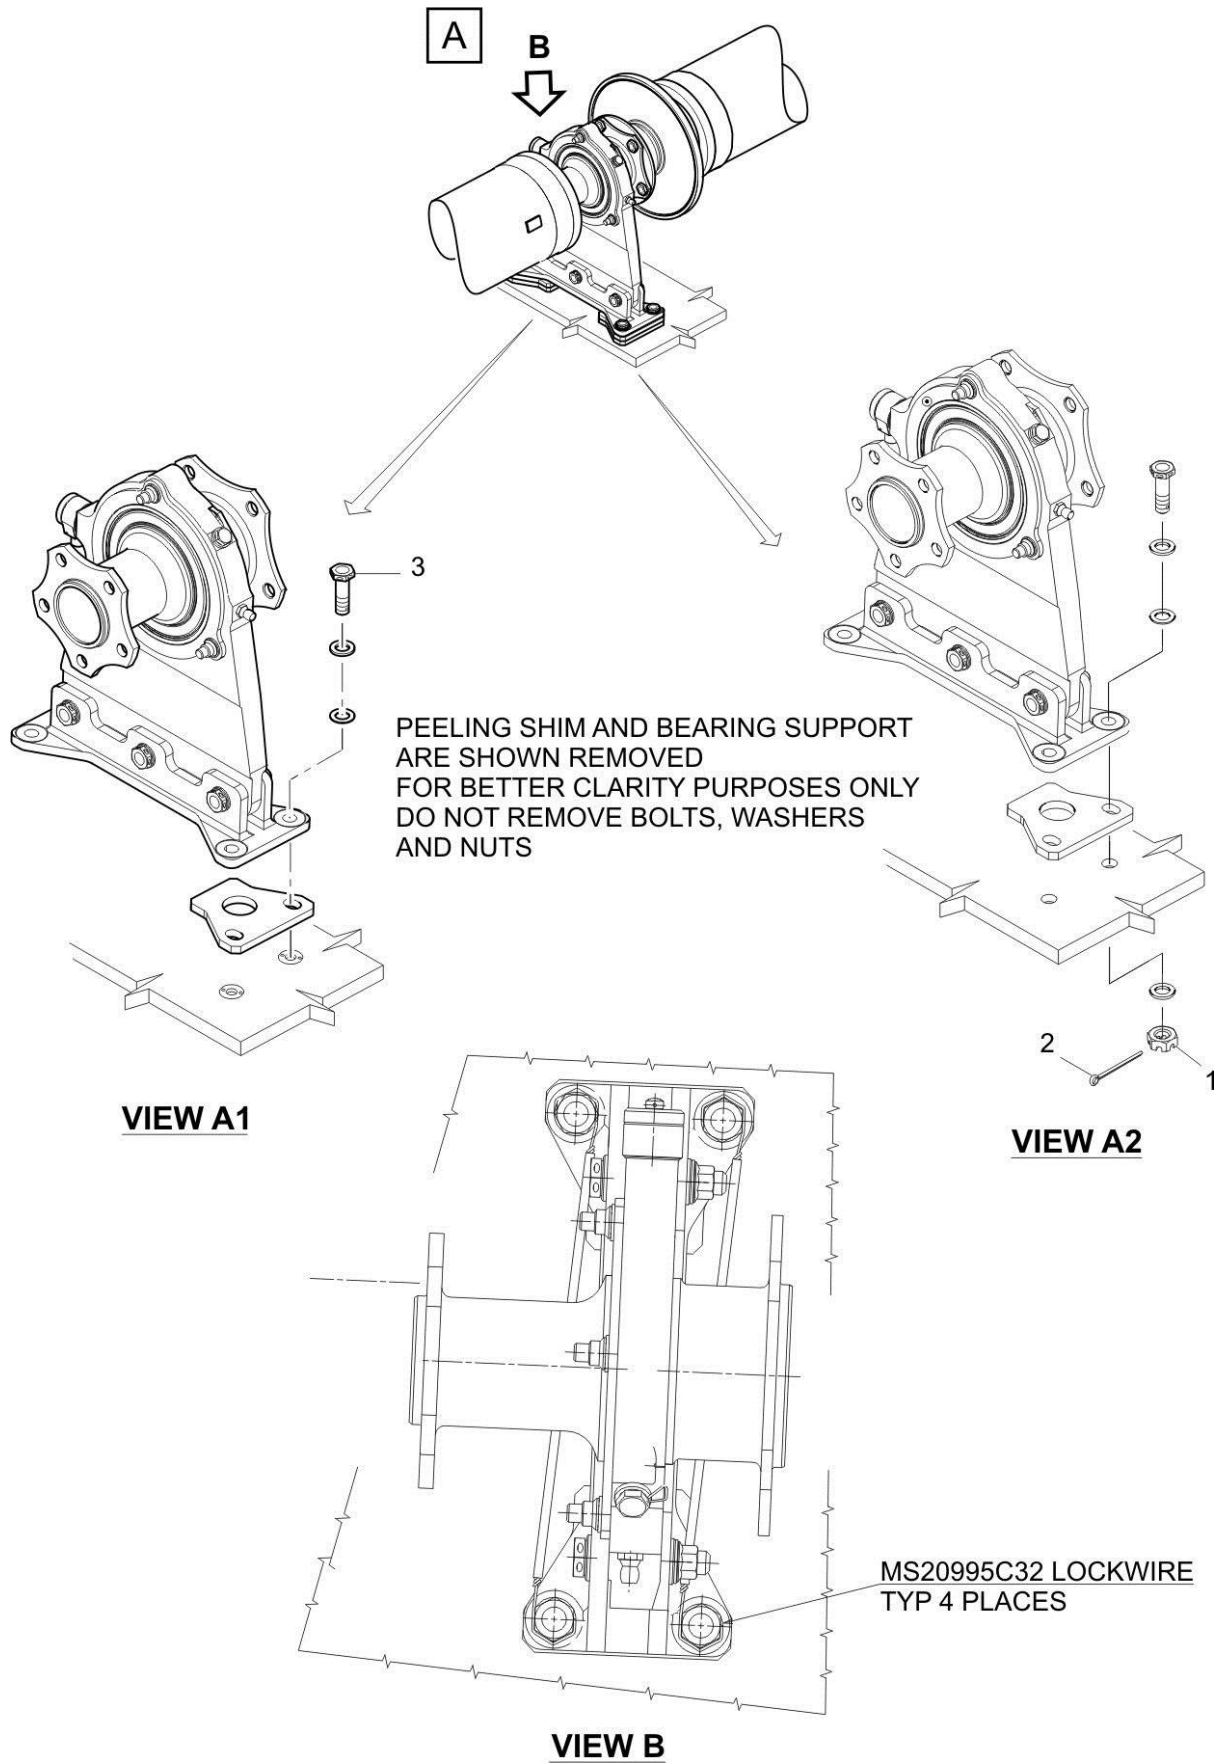
Figure 2

2. With reference to figure 2 view A2, check the torque of the four nuts (1) that fix the bearing support bracket as follows:
  - 2.1 Open access panel 183AL or 184AR and remove access panel 190AL to get access to the work area.

- 2.6 Check the torque of the four nuts. Make sure that the torque value is between 6.78 and 9.60 Nm (60.00 thru 85.00 lbf in).
  - 2.7 Report any under-torque / over-torque cases to LHD; contact Product Support Engineering ([CSE.AW139.AW@leonardocompany.com](mailto:CSE.AW139.AW@leonardocompany.com)). Safety the four nuts with four new cotter pins P/N MS24665-136.

- 3.5 Remove the lockwire from the four bolts (3).
- 3.6 Check the torque of the four bolts. Make sure that the torque value is between 6.78 and 9.60 Nm (60.00 thru 85.00 lbf in).

- 3.8 Safety the four bolts with lockwire P/N MS20995C32 according to figure 2 view B.
- 3.9 Seal the bolts using Proseal 890A or Proseal 700.
- 3.10 Apply corrosion protection compound MIL-PRF-16173 grade 1 on the exposed/not sealed parts of the bolt heads and washers where applicable, ensuring to cover their surface completely with an homogenous and gap free layer. Make sure to guarantee 2 mm overlap over the mating surfaces.
