DISCREPANCY REPORT

AIRCRAFT TYPE: 109E REG. NO: 9M-1308 DR. NO: 1239/BOB

N° 109EP-125

SUBJECT: INSPECTION OF THE RETAINING BOLT P/N 109-8131-09-1.

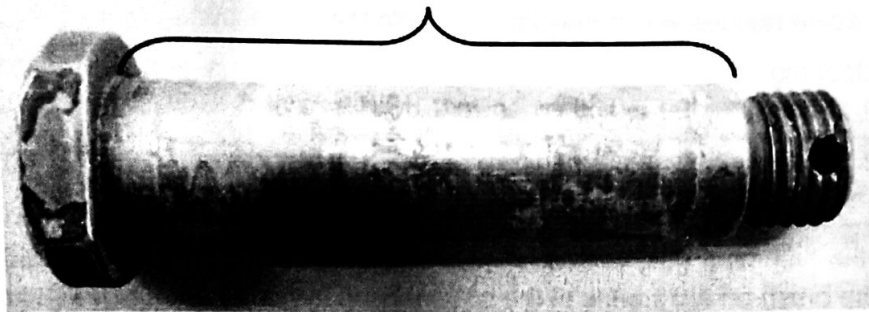
1.0	SCOPE
	This procedure defines the requirements for liquid penetrant inspection of the shank of the bolt P/N 109-8131-09-1 (see figure) for the detection of possible crack propagating along the circumferential direction.

3.1	Part preparation
	<p>The whole surface of the part under inspection (see figure) shall be clean, dry and free of grit or scale residue which may interfere with the inspection. The cleaning shall be performed by means of vigorous and repeated scrubbing with gauze soaked by the indicated solvent. Mechanical means such as sand blasting, plastic media or plastic pads wire brushes is prohibited.</p>

3.5	Viewing and evaluation
	<p>Any fluorescent indication observed on the surface of the part shall be assessed to determine whether it is relevant or not. Use the "wipe off" technique on each indication and re-apply the developer.</p> <p>If the indication initially disappears and does not re-appear after 5 minutes, it can be considered non-relevant; the part shall be carefully cleaned removing any inspection residual and released to service.</p> <p>If the indication reappears, this indication is confirmed to be relevant and the part must be scrapped.</p>
