# DISCREPANCY REPORT

AIRCRAFT TYPE: A109E REG. NO: 9m-BOB DR. NO: 1513 / BOB

BT109EP-143 DTD 25 MARCH 2015 - TAIL ROTOR DRIVE SHAFT P/N: 109-8412-02-01 AND 03.

**SUBJECT:** TAIL ROTOR DRIVE SHAFT P/N 109-8412-02-1 and -3.

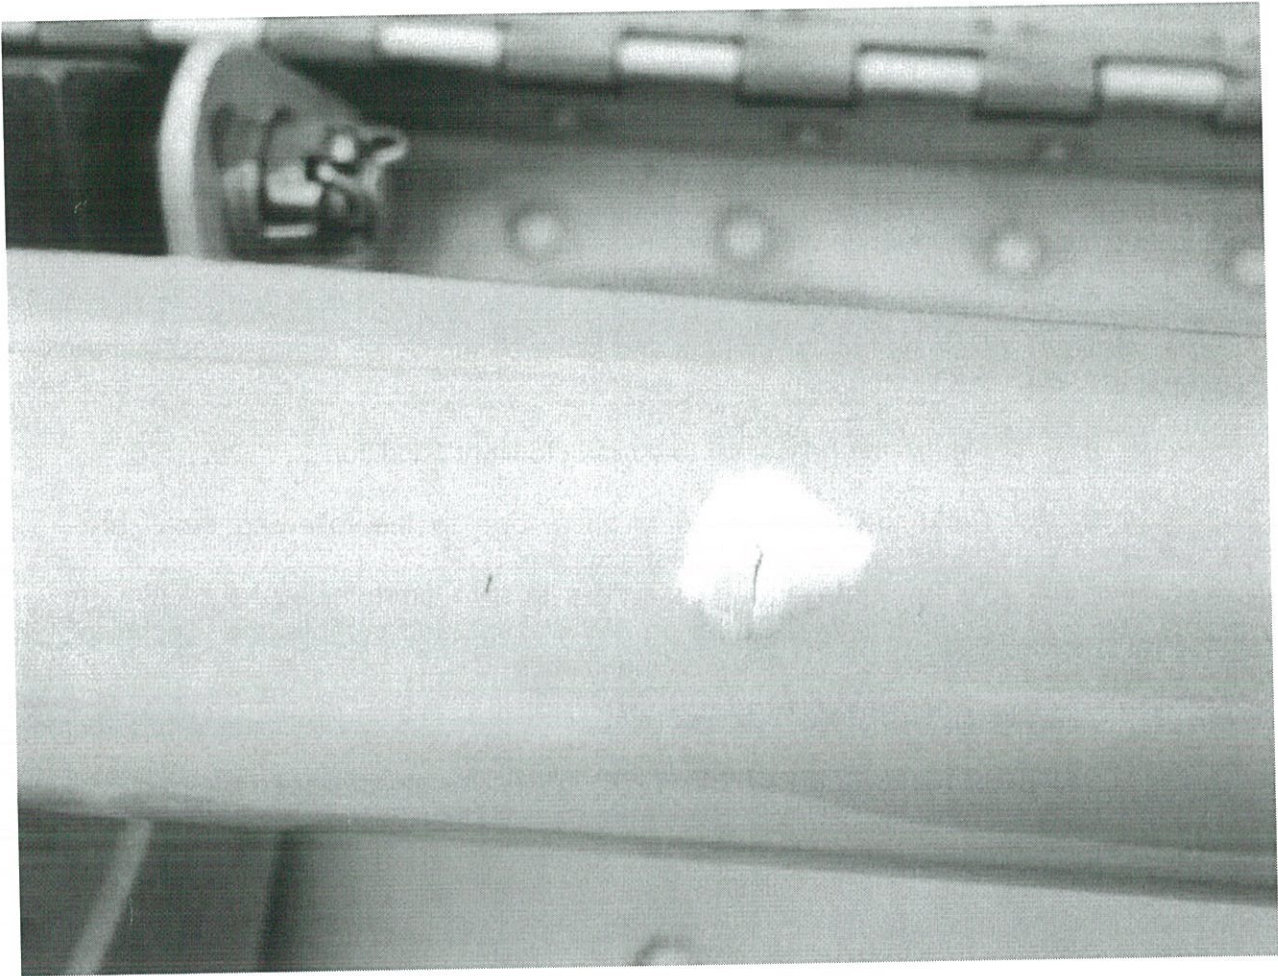
**FIGURE 1**  
**(Crack Example)**

During a scheduled servicing on an A109S three cracks have been found  
on the tail rotor drive shaft assy P/N 109-8412-02-1.

Cracks are not related to fatigue failure of the shaft subject to the design  
loads.

- 4.3. Examine the external surface of the Tail rotor shaft P/N 109-8412-02-1 and -3 for cracks with the help of the Magnifying glass 5X and a source of light.

5. If no cracks are found reinstall the TR drive shaft in accordance with the instructions given in the A 109 E Maintenance Manual and go to step 7.
6. If cracks are found replace the TR drive shaft assy P/N 109-8412-02-1 and/or -3 (depending of inspection results) with a new one in accordance with the instructions given in the A 109 E Maintenance Manual.
