DISCREPANCY REPORT

AIRCRAFT TYPE: A10TE REG. NO: 9M-B0B DR. NO: 1507/B0B
 SOURCE REFERENCE: BT's
 DATE RAISED: 13.03.15 CHECK TYPE: WORK ORDER (JCN): LB0015REP

DISCREPANCY [A/F HRS: 2940.40] [NO.1 ENG: 2940.40] [TSN/TSO] [NO.2 ENG: 623.70] [TSN/TSO]
BT 109EP-141 REV. A DTD 27.02.15 (MANDATORY) - TAIL ROTOR PITCH CONTROL LINK ASSY P/N 109-0130-05-117 TO BE COMPLETED WITH ON PT II ONLY (WITHIN & NOT LATER THAN 5 PLT HRS) DUE AT 2943.70 HRS.
 RAISED BY: HJ. SHAFIZAN BIN HJ. MD. SHARIFF SIGN & STAMP: DATE: 13.03.15

SUBJECT: TAIL ROTOR PITCH CONTROL LINK ASSY P/N 109-0130-05-117.

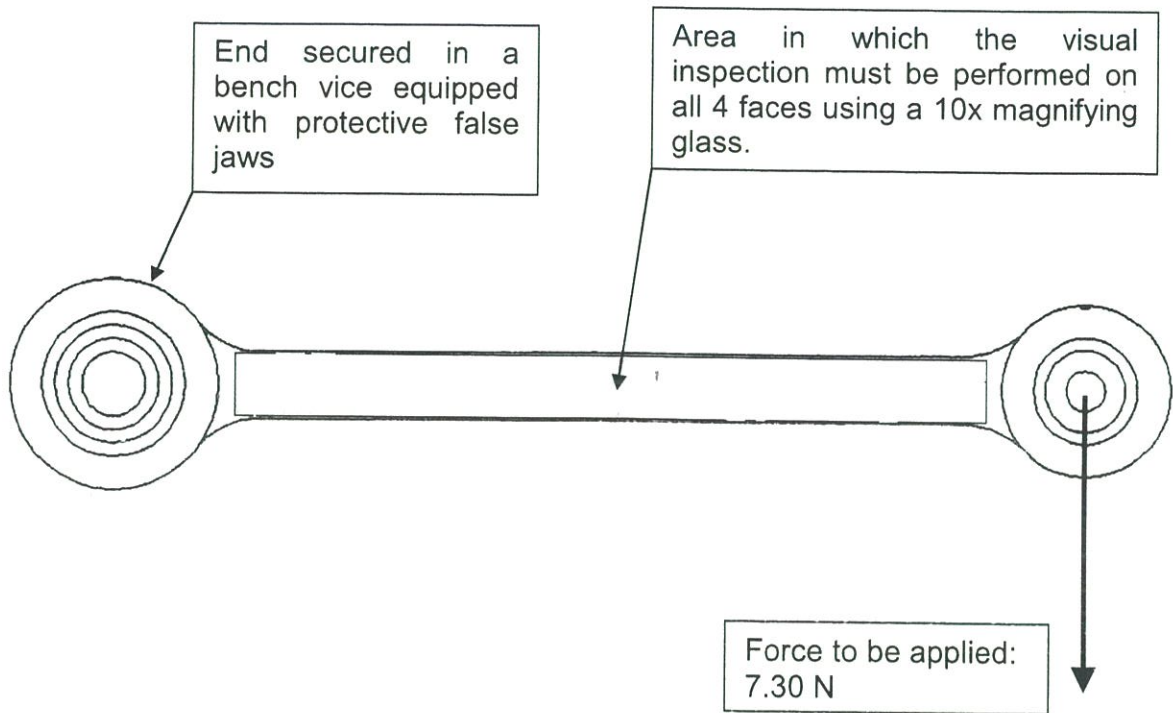
FIGURE 1

- 3.3. Check that the force torsion value is lower than 7.30 N for both the spherical bearings. In case a force torsion value above the limit is detected, even if in only one of the spherical bearings, it is necessary to replace the link with a serviceable one with the same P/N. Proceed with point 7.

Indicative picture.
The force value must be verified on both
spherical bearings.

LINK ASSY P/N 109-0130-05-117

5. Perform a visual inspection of the stem for cracks using a 10x magnifying glass (see figure 1 for the affected area).
