# EMERGENCY AIRWORTHINESS DIRECTIVE

**DATE: November 28, 2003**  
**AD #: 2003-24-51**

**2003-24-51 ROBINSON HELICOPTER COMPANY: Docket No. 2003-SW-48-AD.**

Applicability: Model R44 and R44 II helicopters, certificated in any category.

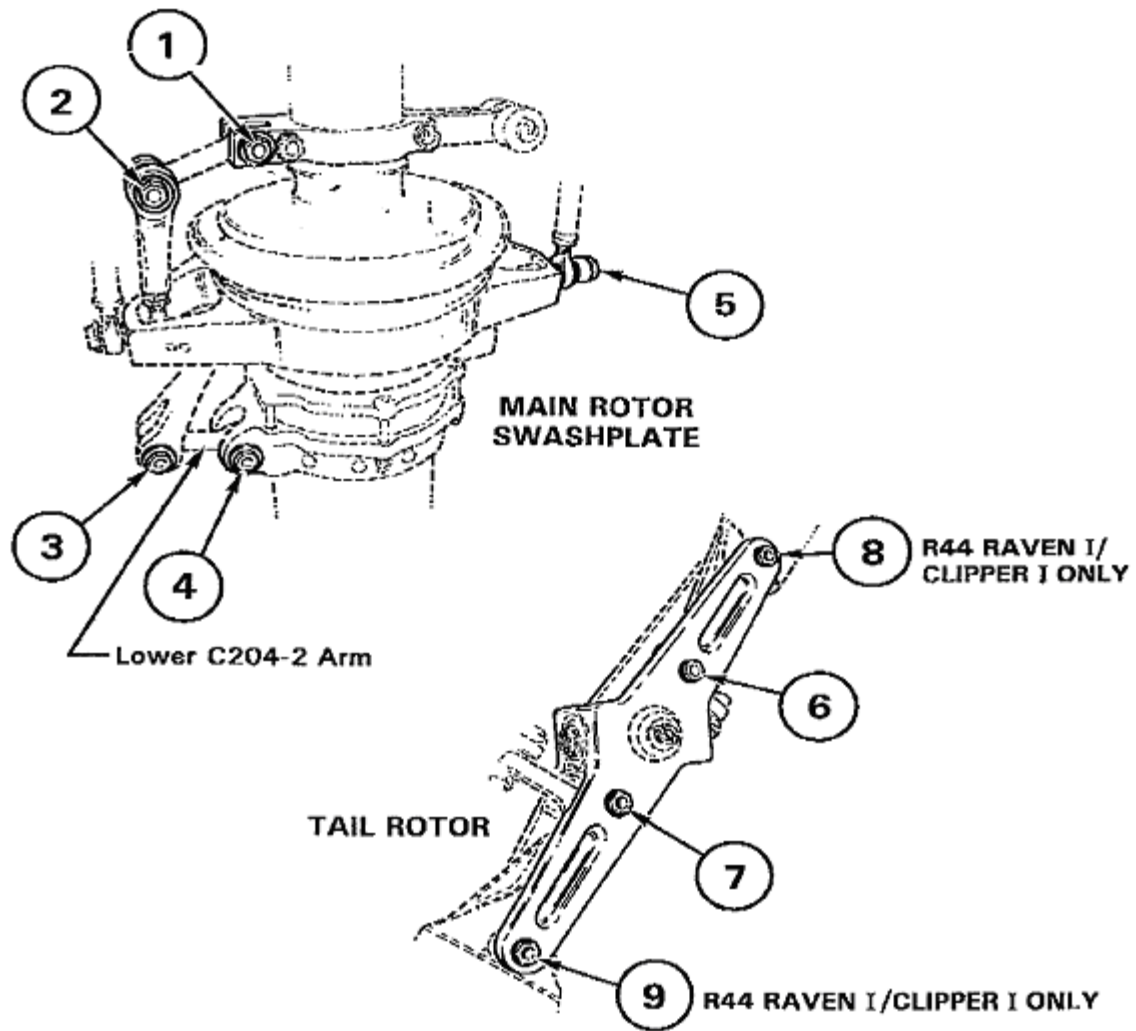
This Emergency Airworthiness Directive (AD) is prompted by a report of the failure of the bolt that secures parts of the main rotor swashplate and attaches the tail rotor blade. An examination revealed that the bolt failed due to hydrogen embrittlement. Hydrogen embrittlement is suspected to have occurred during the cadmium plating process of an entire batch of bolts, which makes the batch suspect. This condition, if not corrected, could result in failure of the bolt that secures parts of the main rotor swashplate and attaches the tail rotor blade, and subsequent loss of control of the helicopter.

(1) Determine if maintenance has been performed after February 7, 2003 on the areas specified in Figure 1 of this AD, and determine if any bolt, part number (P/N) NAS6605-31, shown in Figure 1 has been replaced for any reason.

(1) Visually inspect each bolt for fretting residue under the bolt head, which indicates a loose, potentially cracked bolt.

Suspect NAS6605-31 Bolts

9 Place on R44

7 Places on R44 II

(2) Apply 10-15 ft-lb (13-20 Nm) torque to each bolt head and verify no rotation. See Figure 1 of this AD.

(3) If residue or rotation of the bolt is found, before further flight, replace each unairworthy bolt with an airworthy bolt that does not have a vendor identification marking of 01DO.

(e) For the helicopters specified in paragraphs (b) and (c) of this AD, within 10 hours time-in-service or by December 31, 2003, whichever occurs first, replace each bolt, P/N NAS6605-31, that has vendor identification marking 01DO on the bolt head, with an airworthy bolt, P/N NAS6605-31, that has an alternate vendor identification marking.
