## Airworthiness Directive

**AD No.:** 2015-0226R5

### ATA 25 – Equipment / Furnishings – Hoist – Test / Replacement

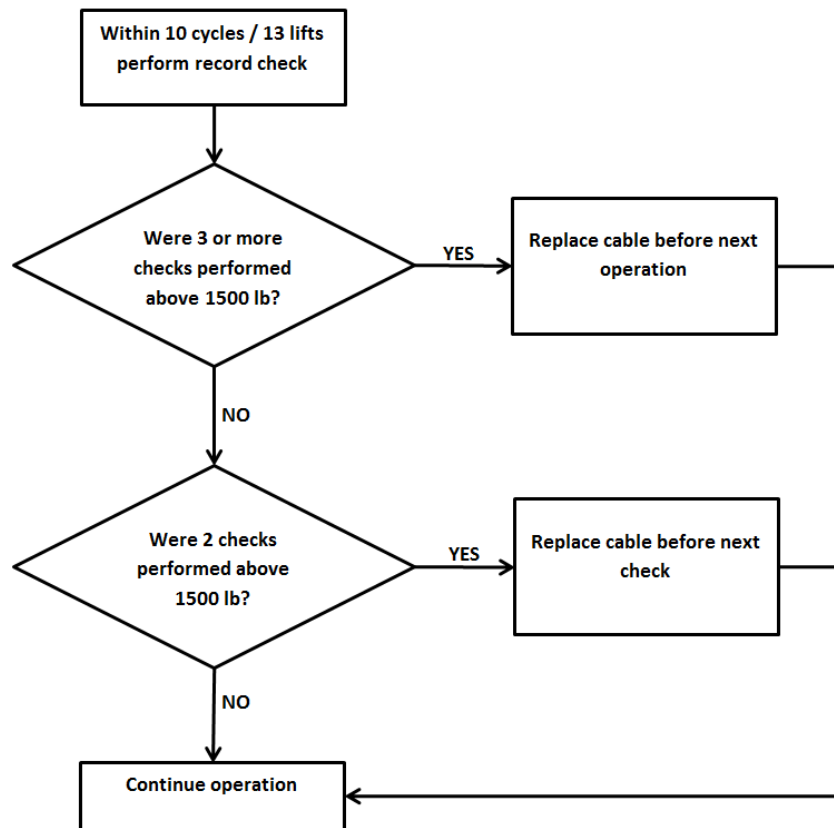
Figure 1

- (1) Within 10 hoist operating cycles or 13 hoist lifts (as applicable, see Note 1 of this AD) after 21 November 2015 [the effective date of the original issue of this AD], determine the P/N of the hoist installed on the helicopter and, if a Goodrich hoist is installed with a P/N listed in Table 1 of this AD, accomplish a records check to determine whether, during any previous hoist load check/test, a cable was load-tested (average of 5 pulls) at 1 500 lb [680 kg] or more. If any cable is identified to have exceeded this limit during three or more hoist load checks/tests, before next hoist operation, replace the affected cable with a serviceable cable. If any cable is identified to have exceeded this limit during two hoist load checks/tests, before the next hoist load check/test, replace the affected cable with a serviceable cable. For replacement of a cable, see figure 1 (flowchart) of this AD.
