Safety Information Bulletin

SIB No.: 2023-07**Issued: 23 June 2023****Subject: Main Cargo Door Opening in Flight****Ref. Publications:**

Boeing 757-200 aeroplanes, converted from passenger to freighter in accordance with EASA Supplemental Type Certificate (STC) 10015539.

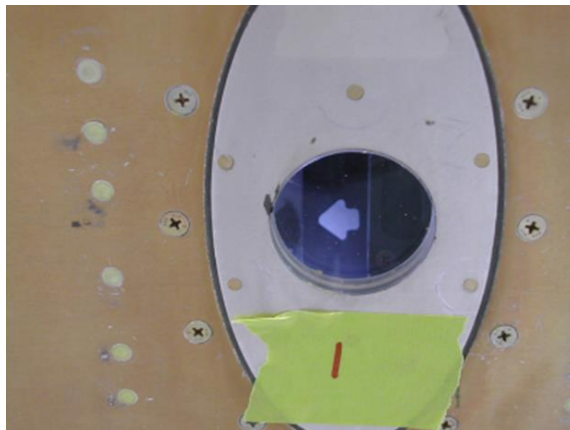
Figure 1. Viewport example.

- Verify that the design improvements described in Precision Conversions LLC SB 757-52-0006 and SB 757-52-0007 have been embodied on the aeroplane (either in service via the SBs, or in production as a forward fit) and, if not, implement the changes at the first opportunity.
- Verify that the condition of the MCD View Ports of the MCD still warrants a good viewing of the latch/lock mechanism position (e.g. glass condition, scratches), and restore as necessary.
- Check if the features described in Precision Conversions LLC SB 757-52-0007 are still present and in good condition (e.g. mirrors, colour contrast paint on the tip of the lock-pin) – see Figure 1 and Figure 2 below.

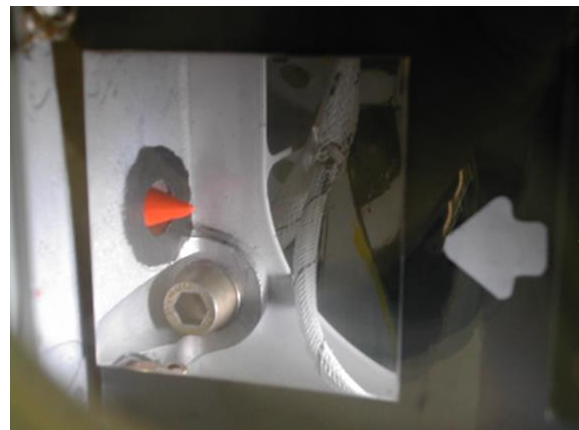
Figure 2. Colored tip of lock-pin as seen in installed mirror.
