EMERGENCY ALERT SERVICE BULLETIN

TIME LIMITS - MAINTENANCE CHECKS - Upper fin
Inspection of the spar and attachment screws of the upper fin
 ATA: 55

HELICOPTER CONCERNED	NUMBER	Version(s)	
		Civil	Military
AS350	05.00.90	B3	/
AS355	05.00.76	E, F, F1, F2, N, NP	/
AS550	05.00.66	/	C3
AS555	05.00.56	/	AF, AN, AP, SN, UF, UN

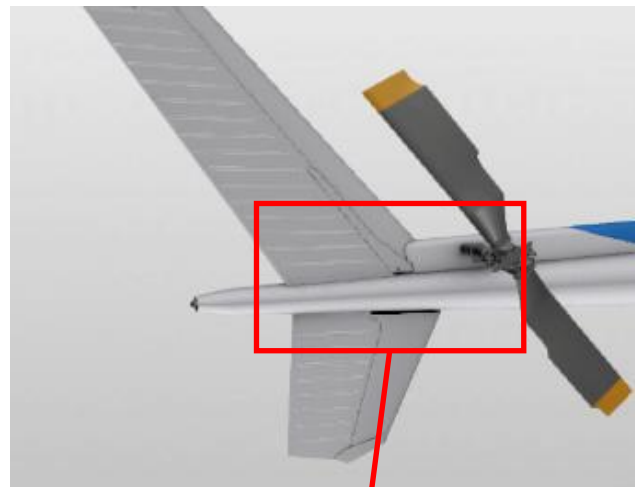
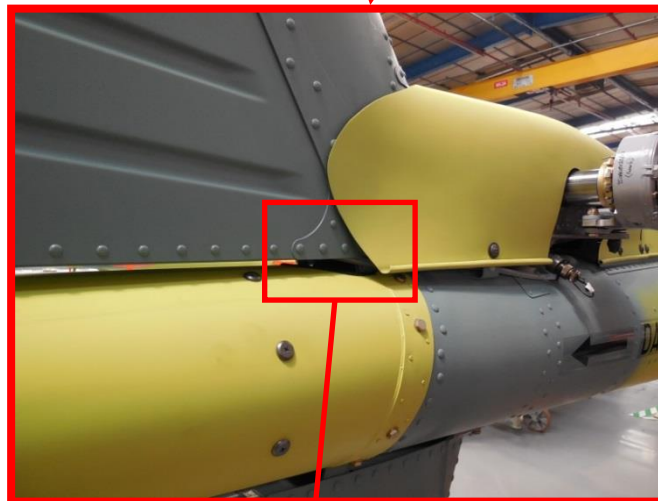
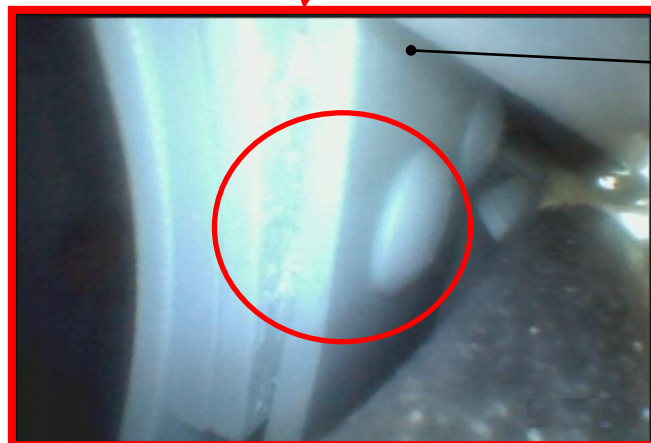
Figure 1: visual inspection

- Without removing the rear and the TGB fairings, visually check that there are no cracks on the RH side of spar (a) (see [Figure 1](#)) and if needed, clean the area, refer to Work Card 20-04-01-102 (MTC):

- . If you are not sure, remove the rear fairings and the TGB fairings to do a detailed inspection.
- . Do a dye-penetrant inspection, refer to Work Card 20-02-09-601 (MTC):
 - .. If there are no cracks, leave as is.
 - .. If there are cracks, **before continuing flights**, get in communication with the Airbus Helicopters Customer Service Technical Support: refer to Note 2 to get a repair solution.

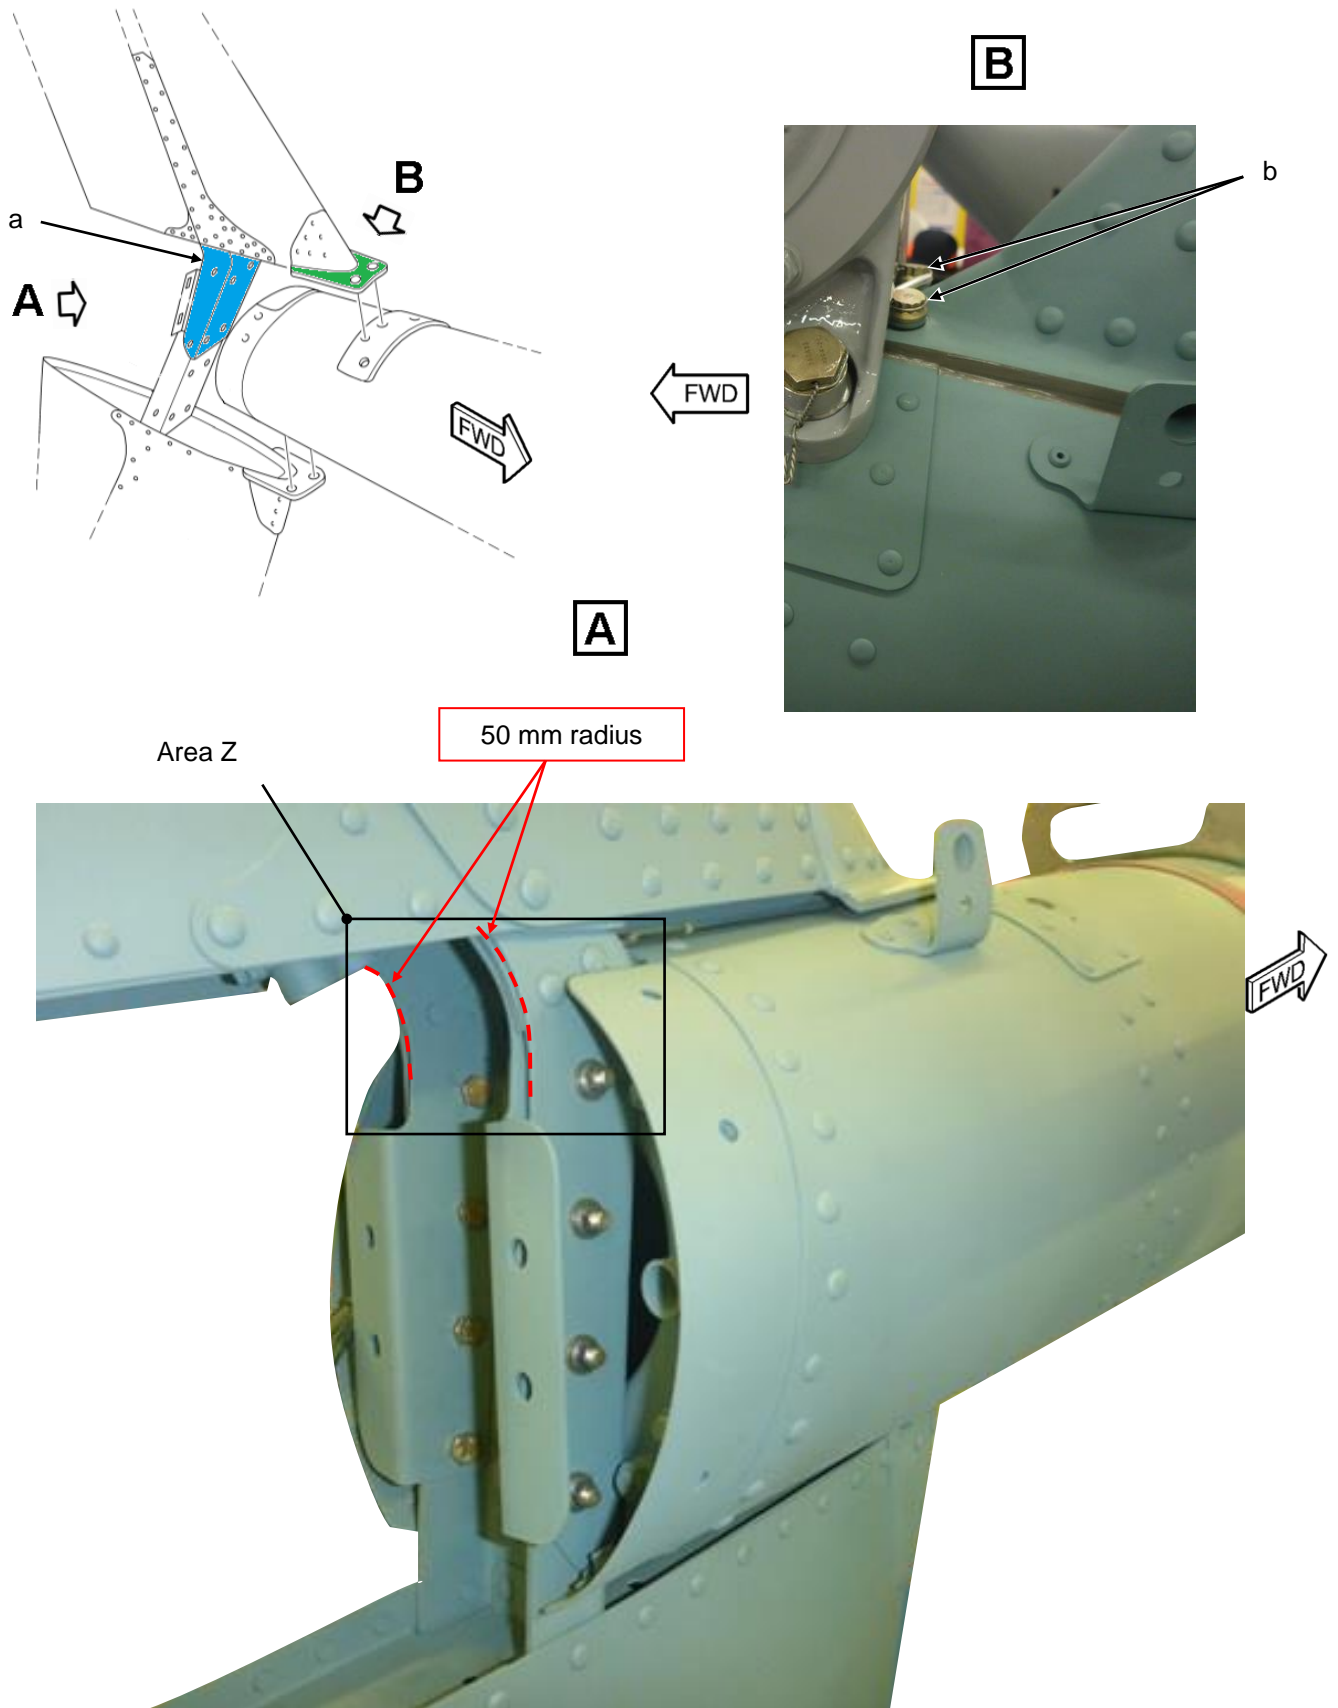
Figure 2: definition of the inspection areas

- Remove the rear fairing from the tail boom.
- Remove the TGB fairing.
- Disconnect the cut-off connector of the tail position light.
- Clean (refer to Work Card 20-04-01-102 (MTC)):
 - . The spar (a) ([Figure 2](#))
 - . Area Z ([Detail A](#), Figure 2)
 - . The heads of the attachment screws (b) ([Detail B](#), Figure 2) of the upper fin.
- Do a visual check for cracks in the spar (a) of the top and bottom fins (see example of crack: refer to [Figure 3](#)): refer to Work Card 55-00-00-601 (MET) or Task 55-20-00, 6-2 (AMM):
 - . If you are not sure, do a dye-penetrant inspection: refer to Work Card 20-02-09-101 (MTC):

PAY PARTICULAR ATTENTION TO THE 50 MM RADIUS, SEE AREA Z, [DETAIL A](#).

- . If there are no cracks, leave as is.
- . If there are cracks, **before continuing flights**, contact the Airbus Helicopters Customer Service Technical Support: refer to [Note 2](#).
- Check the integrity of the two thrust pad attachment screws (b) ([Detail B](#), Figure 2):
 - . If no damage is found, leave as is.
 - . If damage is found, **before continuing flights**, contact the Airbus Helicopters Customer Service Technical Support: refer to [Note 2](#).
- Connect the cut-off connector of the tail position light.
- Do a functional test: refer to Work Card 33-41-00-501 (MET) or Task 33-41-00, 5-1 (AMM).
- Install the TGB fairing.
- Install the rear fairing of the tail boom.
- Do the final steps: refer to paragraph [3.B.4](#).

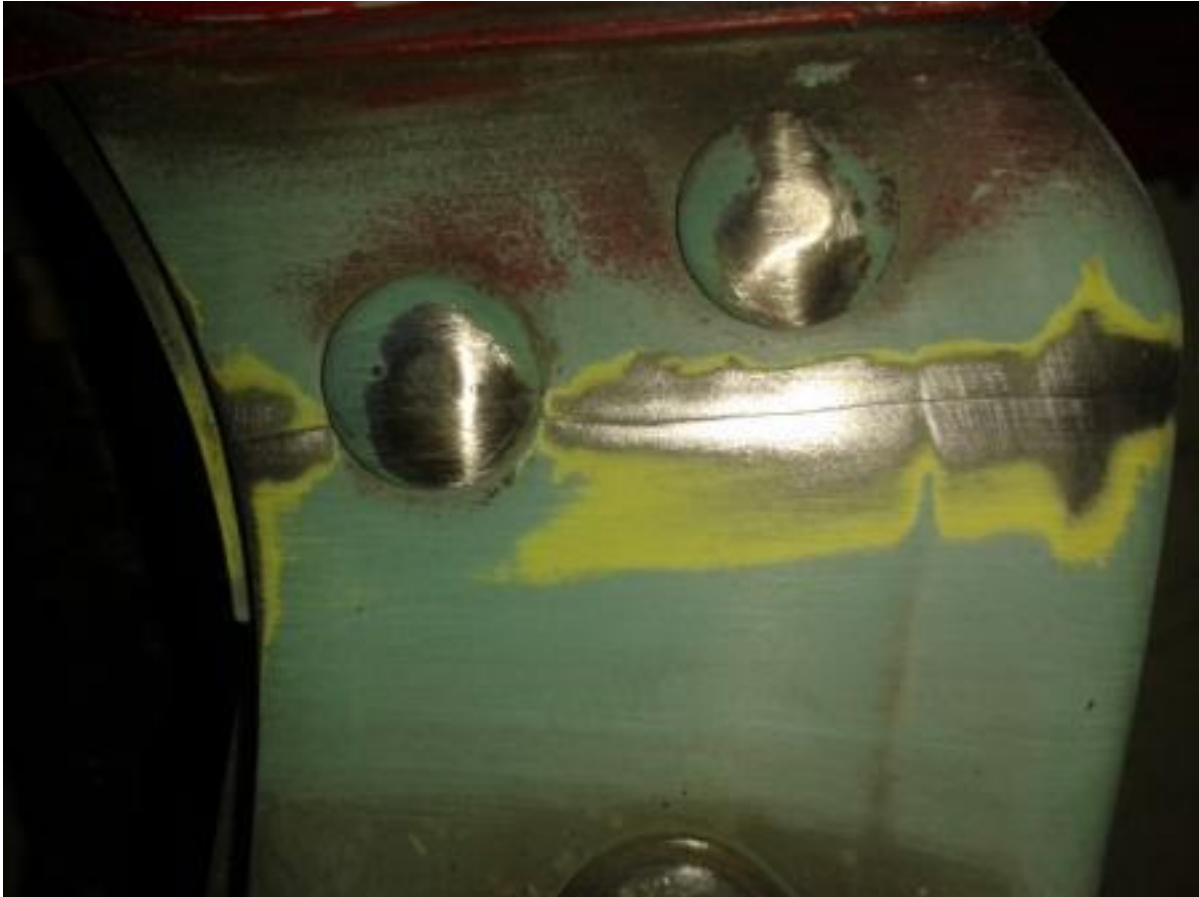
Inspections revealed a crack in the spar of the upper fin and the fracture of the two front attachment screws of the fin.

Figure 3: example of a crack in the spar of the upper fin
