# EMERGENCY ALERT SERVICE BULLETIN

### TIME LIMITS - MAINTENANCE CHECKS - Tail Rotor Hub

#### Check of the tail rotor hub body

HELICOPTER CONCERNED	NUMBER	Version(s)	
		Civil	Military
EC120	05A020	B

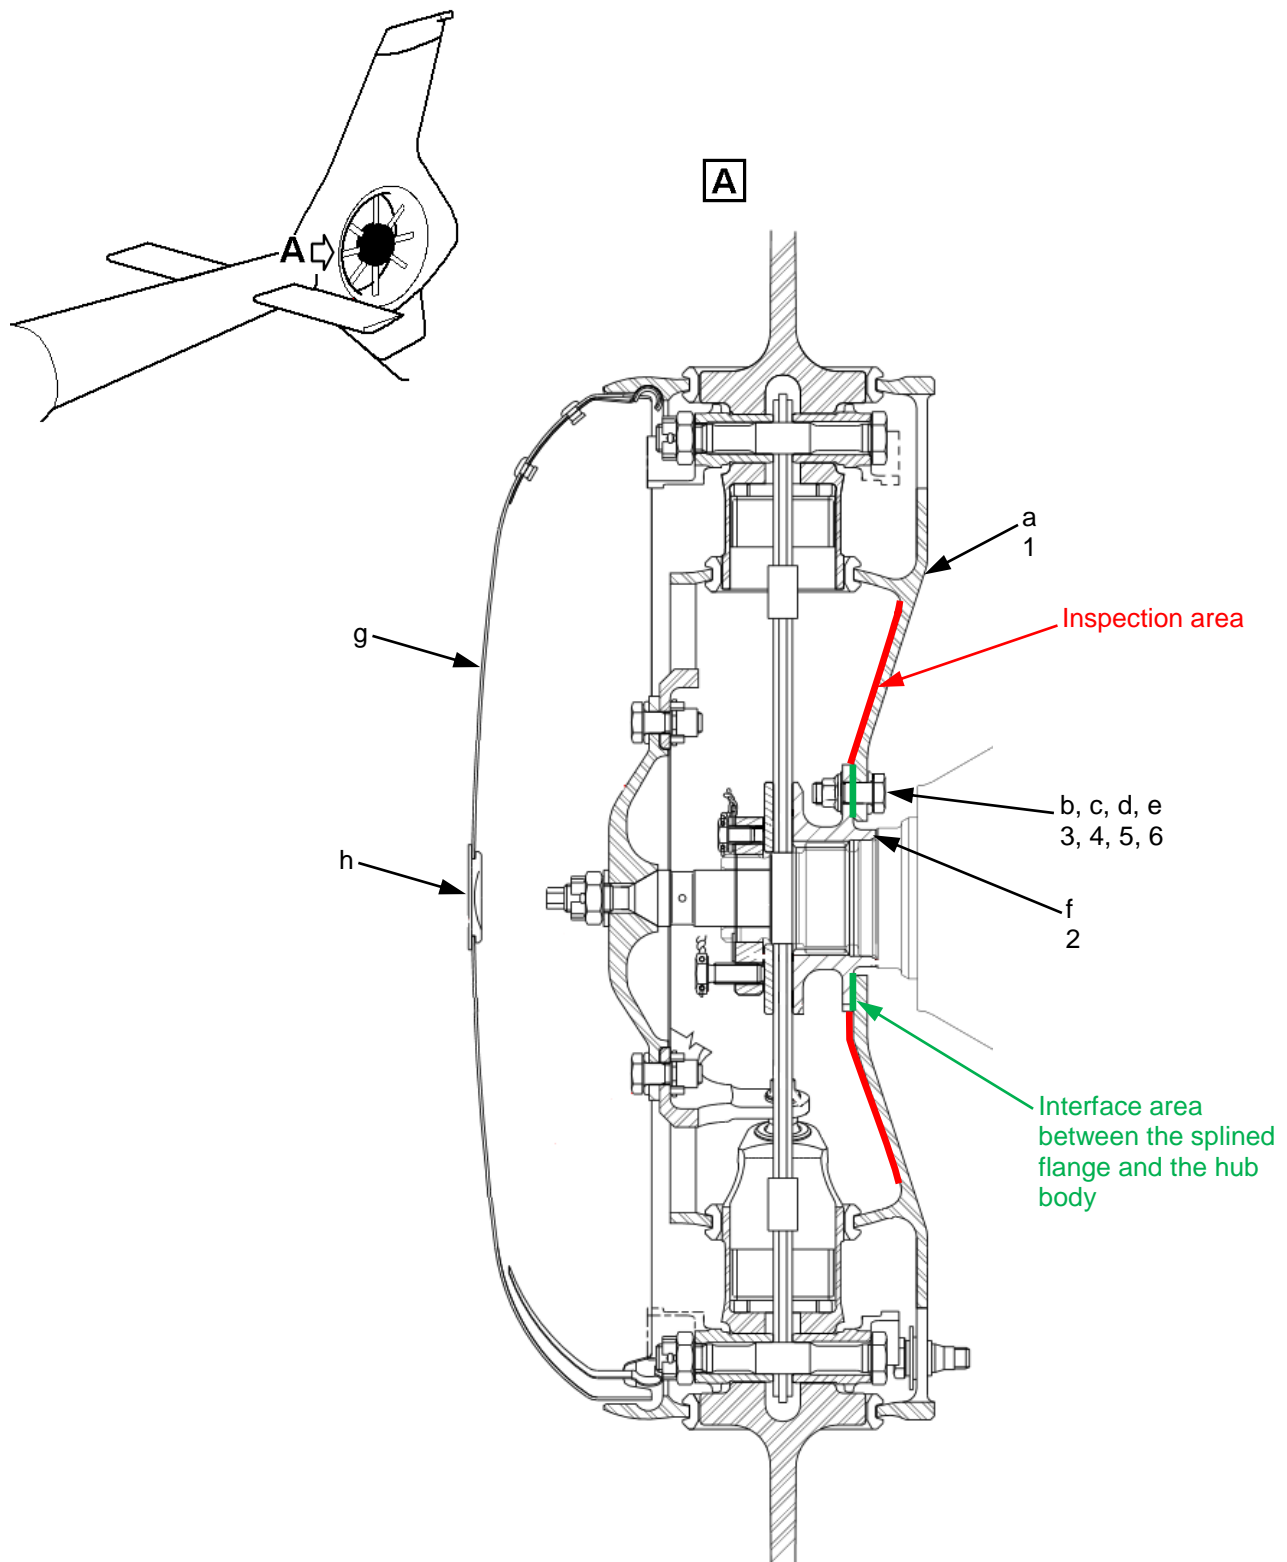
Figure 1

Following analysis, Airbus Helicopters came to the conclusion that a non-detected case of loss of tightening torque can cause the development of cracks and lead to the loss of the tail rotor drive, which results in the loss of control of the helicopter.

- performing a check for cracks on the tail rotor hub body, in the zones defined in [Figure 1](#),
- replacing the attachment bolts, washers and nuts of the tail rotor hub body,
- performing a check of the interface between the splined flange and the tail rotor hub body.

- Perform a visual inspection of the hub body (a), (Figure 1).
  - . Using a light source and, if necessary, a mirror (zz) (e.g. dentist's mirror), make sure that there are no cracks in the hub body, in the inspection area defined as per [Figure 1](#).
- Turn the tail rotor by hand to check the entire inspection area defined as per Figure 1.
- Interpret the results as per [paragraph 1.E.2](#).

- Remove and discard the hub body (a), ([Figure 1](#)) as per Task 64-21-00, 4-3 (AMM).
- Discard the bolts (b), the washers (c) and (d) and the nuts (e).
- Install the hub body (1) as per Task 64-21-00, 4-4 (AMM) with bolts (3), washers (4) and (5) and nuts (6).

- Remove the splined flange (f) ([Figure 1](#)) as per Task 64-21-00, 4-3 (AMM).
- Install the splined flange (2) as per Task 64-21-00, 4-4 (AMM).
