EMERGENCY ALERT SERVICE BULLETIN

TIME LIMITS - MAINTENANCE CHECKS - Tail Rotor Hub

Check of the tail rotor hub body

HELICOPTER CONCERNED	NUMBER	Version(s)	
		Civil	Military
EC120	05A020	B

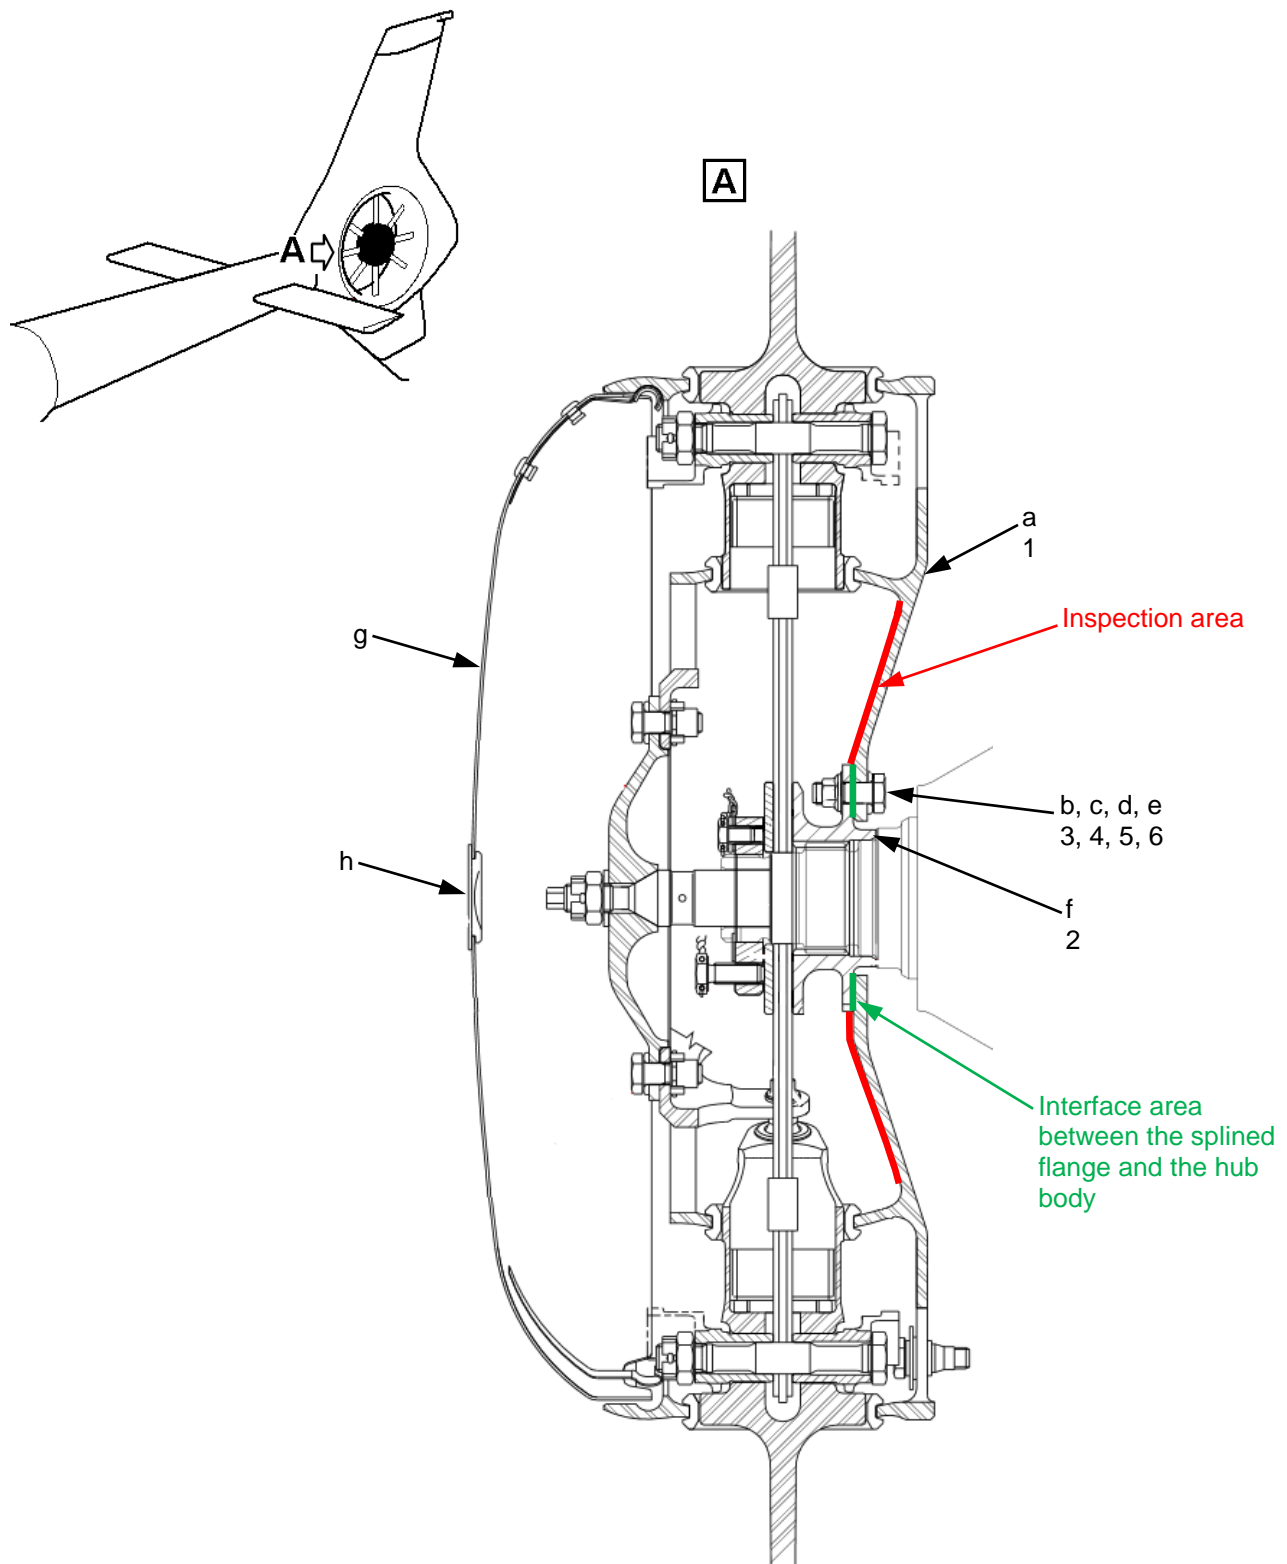
Figure 1

Following analysis, Airbus Helicopters came to the conclusion that a non-detected case of loss of tightening torque can cause the development of cracks and lead to the loss of the tail rotor drive, which results in the loss of control of the helicopter.

- performing a check for cracks on the tail rotor hub body, in the zones defined in [Figure 1](#),
- replacing the attachment bolts, washers and nuts of the tail rotor hub body,
- performing a check of the interface between the splined flange and the tail rotor hub body.

- Perform a visual inspection of the hub body (a), (Figure 1).
 - . Using a light source and, if necessary, a mirror (zz) (e.g. dentist's mirror), make sure that there are no cracks in the hub body, in the inspection area defined as per [Figure 1](#).
- Turn the tail rotor by hand to check the entire inspection area defined as per Figure 1.
- Interpret the results as per [paragraph 1.E.2](#).

- Remove and discard the hub body (a), ([Figure 1](#)) as per Task 64-21-00, 4-3 (AMM).
- Discard the bolts (b), the washers (c) and (d) and the nuts (e).
- Install the hub body (1) as per Task 64-21-00, 4-4 (AMM) with bolts (3), washers (4) and (5) and nuts (6).

- Remove the splined flange (f) ([Figure 1](#)) as per Task 64-21-00, 4-3 (AMM).
- Install the splined flange (2) as per Task 64-21-00, 4-4 (AMM).
