# EMERGENCY ALERT SERVICE BULLETIN

**Tail Gear Box (TGB) P/Nos. 365A33-6005-09 and 365A33-6005-10**

ATA 65

HELICOPTER(S) CONCERNED	NUMBER	Version(s)	
		Civil	Military
AS365	01.00.71	N, N1, N2, N3	F, Fi, Fs, K, K2
AS565	01.00.24		CA, MA, MB, MBe, SA, SB, UB
EC155	04A016	B, B1	
SA366	01.31		GA

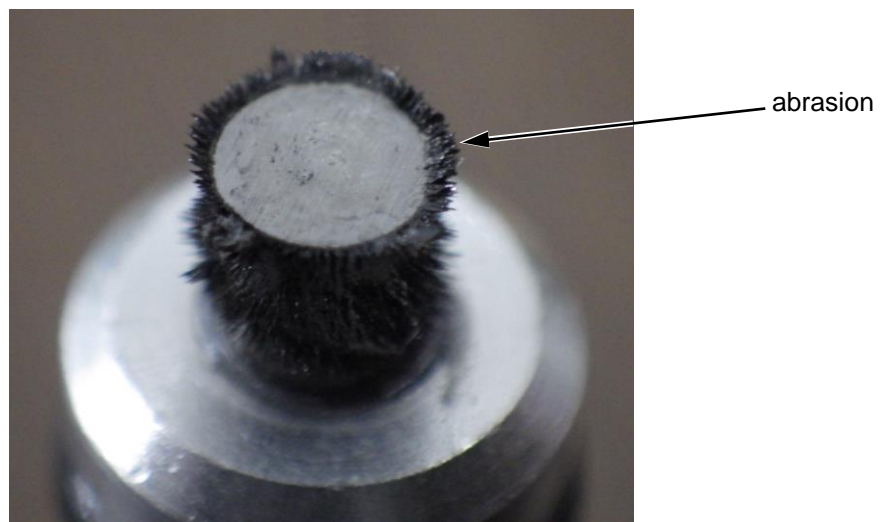
Figure 1: Example of abrasion on the chip detector

**IN THE FLOW CHART, THE ABRASION PARTICLES (CLASS g AS PER MTC) MUST BE TAKEN INTO ACCOUNT IN ADDITION TO THE PARTICLE TYPES USUALLY TAKEN INTO ACCOUNT.**
