EMERGENCY ALERT SERVICE BULLETIN

Tail Gear Box (TGB) P/Nos. 365A33-6005-09 and 365A33-6005-10
ATA 65

HELICOPTER(S) CONCERNED	NUMBER	Version(s)	
		Civil	Military
AS365	01.00.71	N1, N2, N3	F, Fi, K, K2
AS565	01.00.24		MA, MB, MBe, SA, SB, UB
EC155	04A016	B, B1	
SA366	01.31		GA

Airbus Helicopters has recently been informed of a case of chip detection on a control rod double bearing of a TGB P/N 365A33-6005-09.

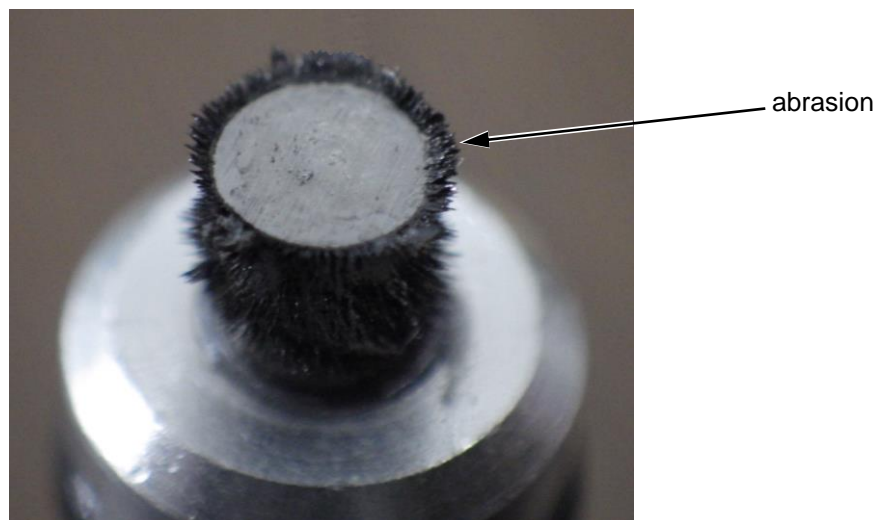
IN THE FLOW CHART, THE ABRASION PARTICLES (CLASS g AS PER MTC) MUST BE TAKEN INTO ACCOUNT IN ADDITION TO THE PARTICLE TYPES USUALLY TAKEN INTO ACCOUNT.

Figure 1: Example of abrasion on the chip detector

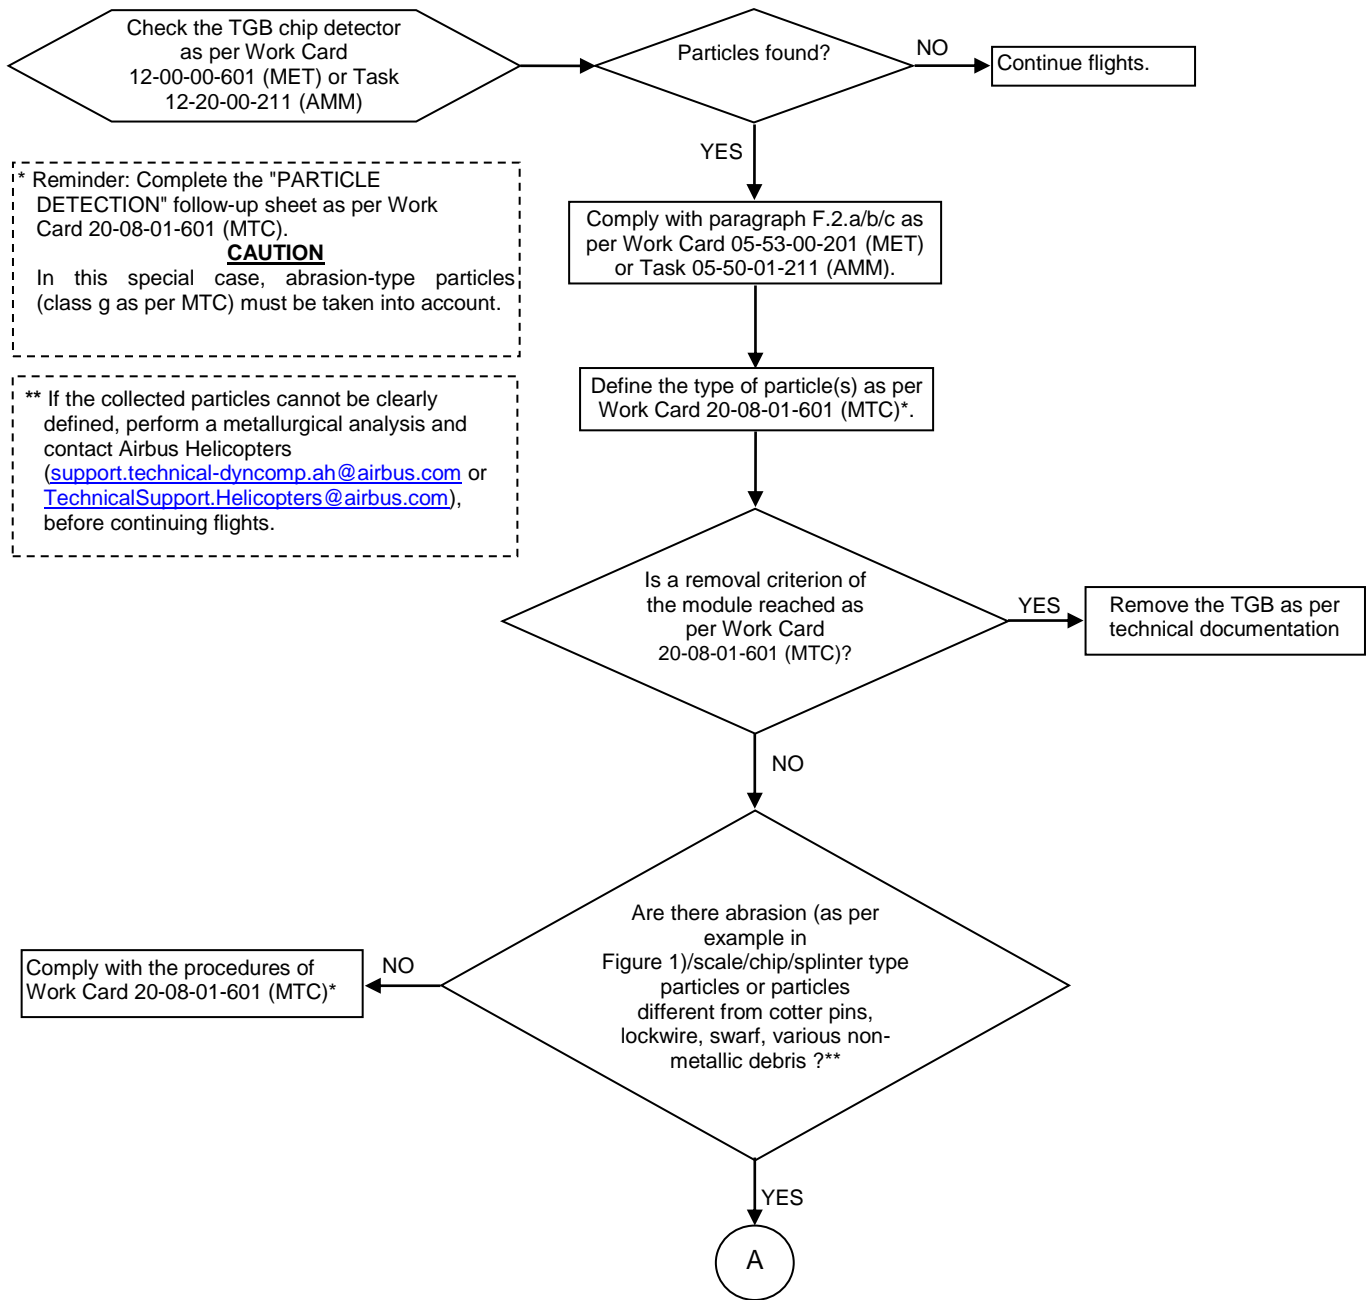
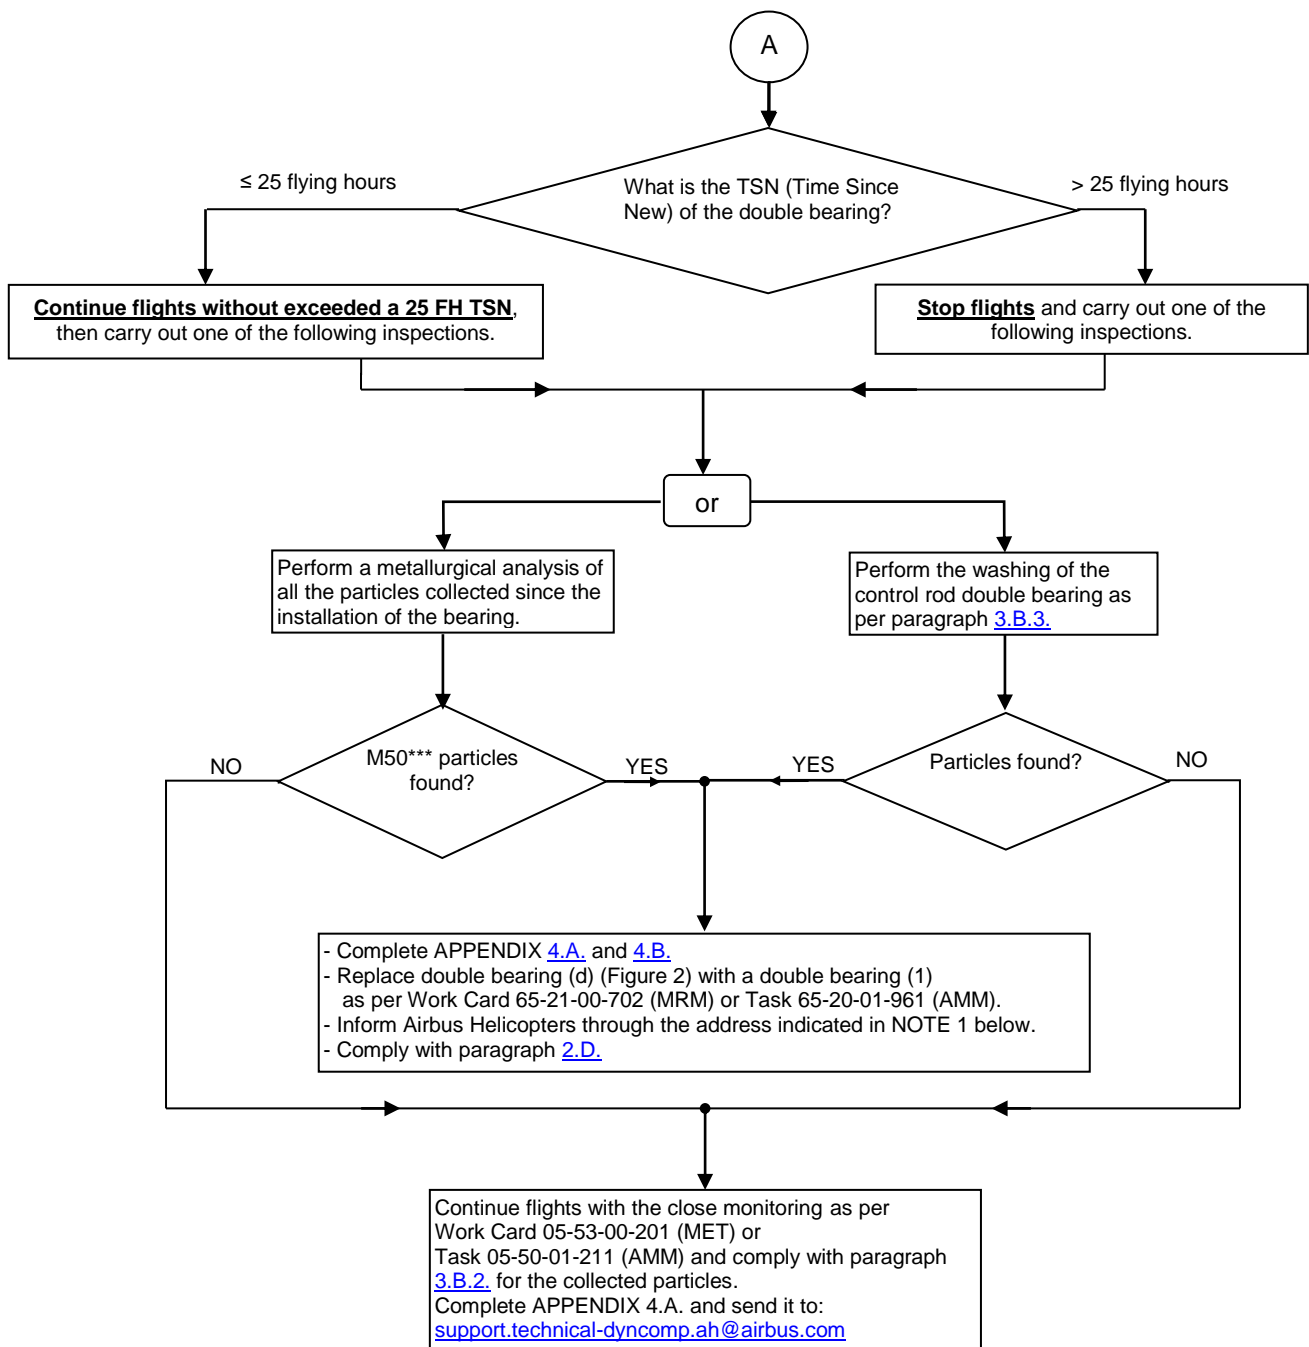
3.B.2. Check of the manual chip detector or chip detector with electrical indicating of the TGB

*** Other designations for material M50:
 - AMS6490
 - 80DCV40

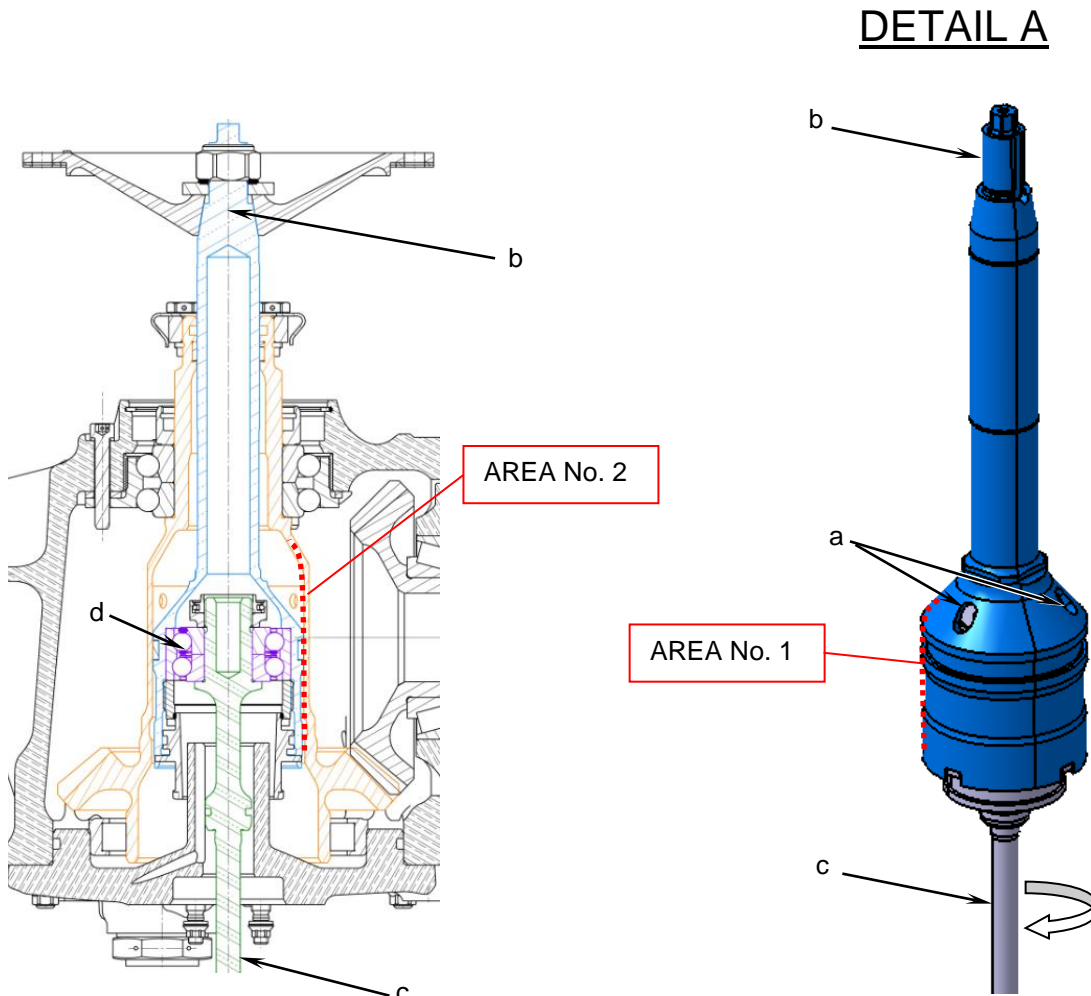
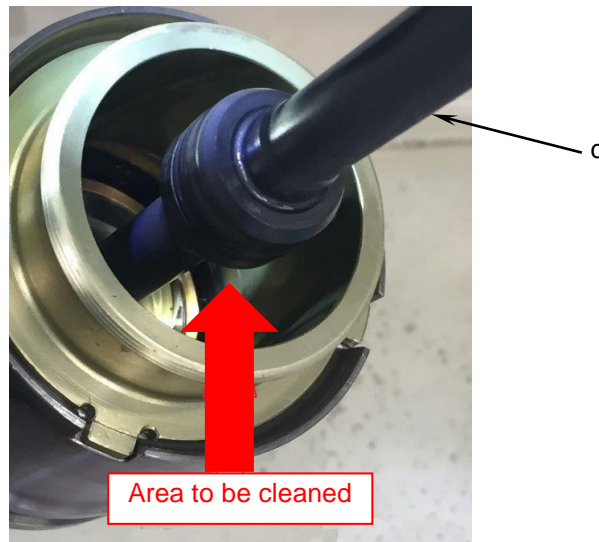
Figure 2 (Washing of the double bearing)

Make sure that the area pointed out in [DETAIL B Figure 2](#) is clean.

- 1) Insert WHITE SPIRIT (2) under pressure (for example using a can) in the hole (a) of the control shaft (b). **(See [DETAIL A Figure 2](#)).**
 - . Manually turn the control rod (c) several times to wash the double bearing (d) by draining the WHITE SPIRIT (2) through the bearing. **(See [Detail A Figure 2](#))**

- 2) Insert WHITE SPIRIT (2) (for example using a can) in the area of the control shaft (b) that must be cleaned. **(See [DETAIL B Figure 2](#)).**
 - . Manually turn the control rod (c) several times to wash the double bearing (d) by draining the WHITE SPIRIT (2).
